**APPENDIX D: THE ARONSON BUILDING,
SAN FRANCISCO, CALIFORNIA,
HISTORIC STRUCTURE REPORT**

THE ARONSON BUILDING
SAN FRANCISCO, CALIFORNIA

HISTORIC STRUCTURE REPORT
FINAL DRAFT [08197]

DECEMBER 2, 2010

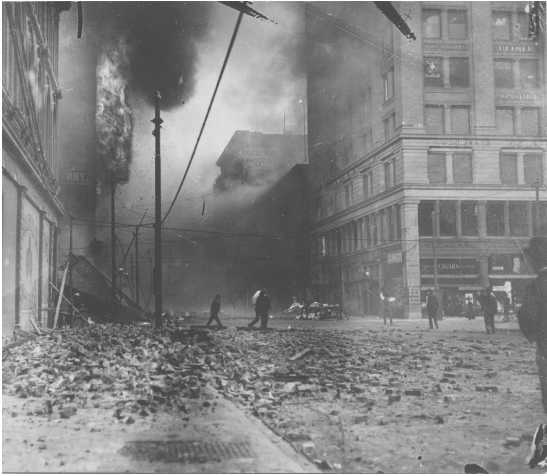
The sand-stone of both fronts is badly spalled by the fire, and on the Third Street side is considerably cracked by the quake. The pressed brick and terra cotta above is in good condition. At the third-story level the walls between window openings are badly cracked by the earthquake. The northeast corner at the first story is badly racked. The north and west walls of common brick are in fair condition. All the walls are practically plumb, the greatest variation from the plumb being at the southeast corner, where the south front leans to the north about 3/8". The levels on the water table do not disclose any material displacement of the foundation.

Figure 10. During and after the 1906 Earthquake and Fire. The Aronson Building is located on the right.
Source: California Historical Society

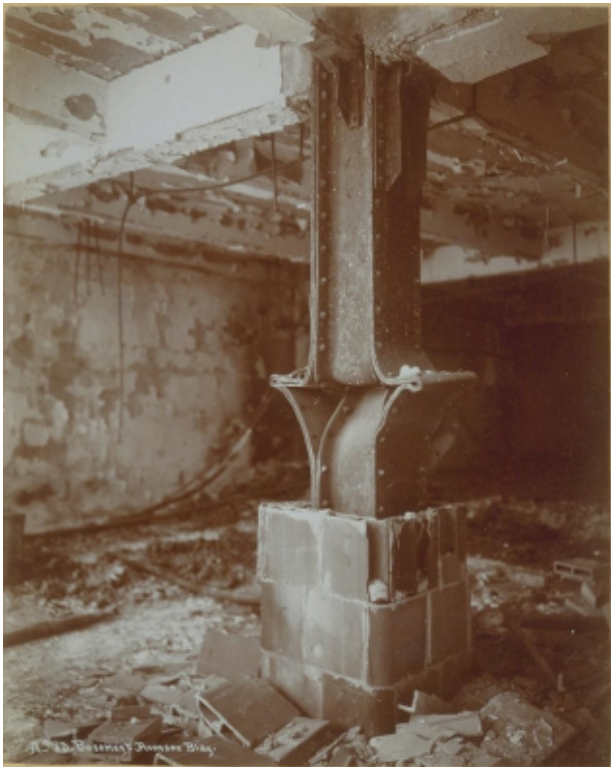
An opportunity of comparing the efficiency of hollow tile blocks and concrete for column protection was afforded in the basement, where both materials were used for this purpose. One of the columns covered with hollow tile blocks buckled very badly, and the protection is damaged around other columns. The columns protected by concrete remain straight and uninjured, although one of them is within 15 ft. of the badly buckled column referred to and was apparently subjected to the same conditions.²⁸

Figure 13. Buckled I-beam encased in failed hollow tiles in the basement, 1906.
Source: Bancroft Library.

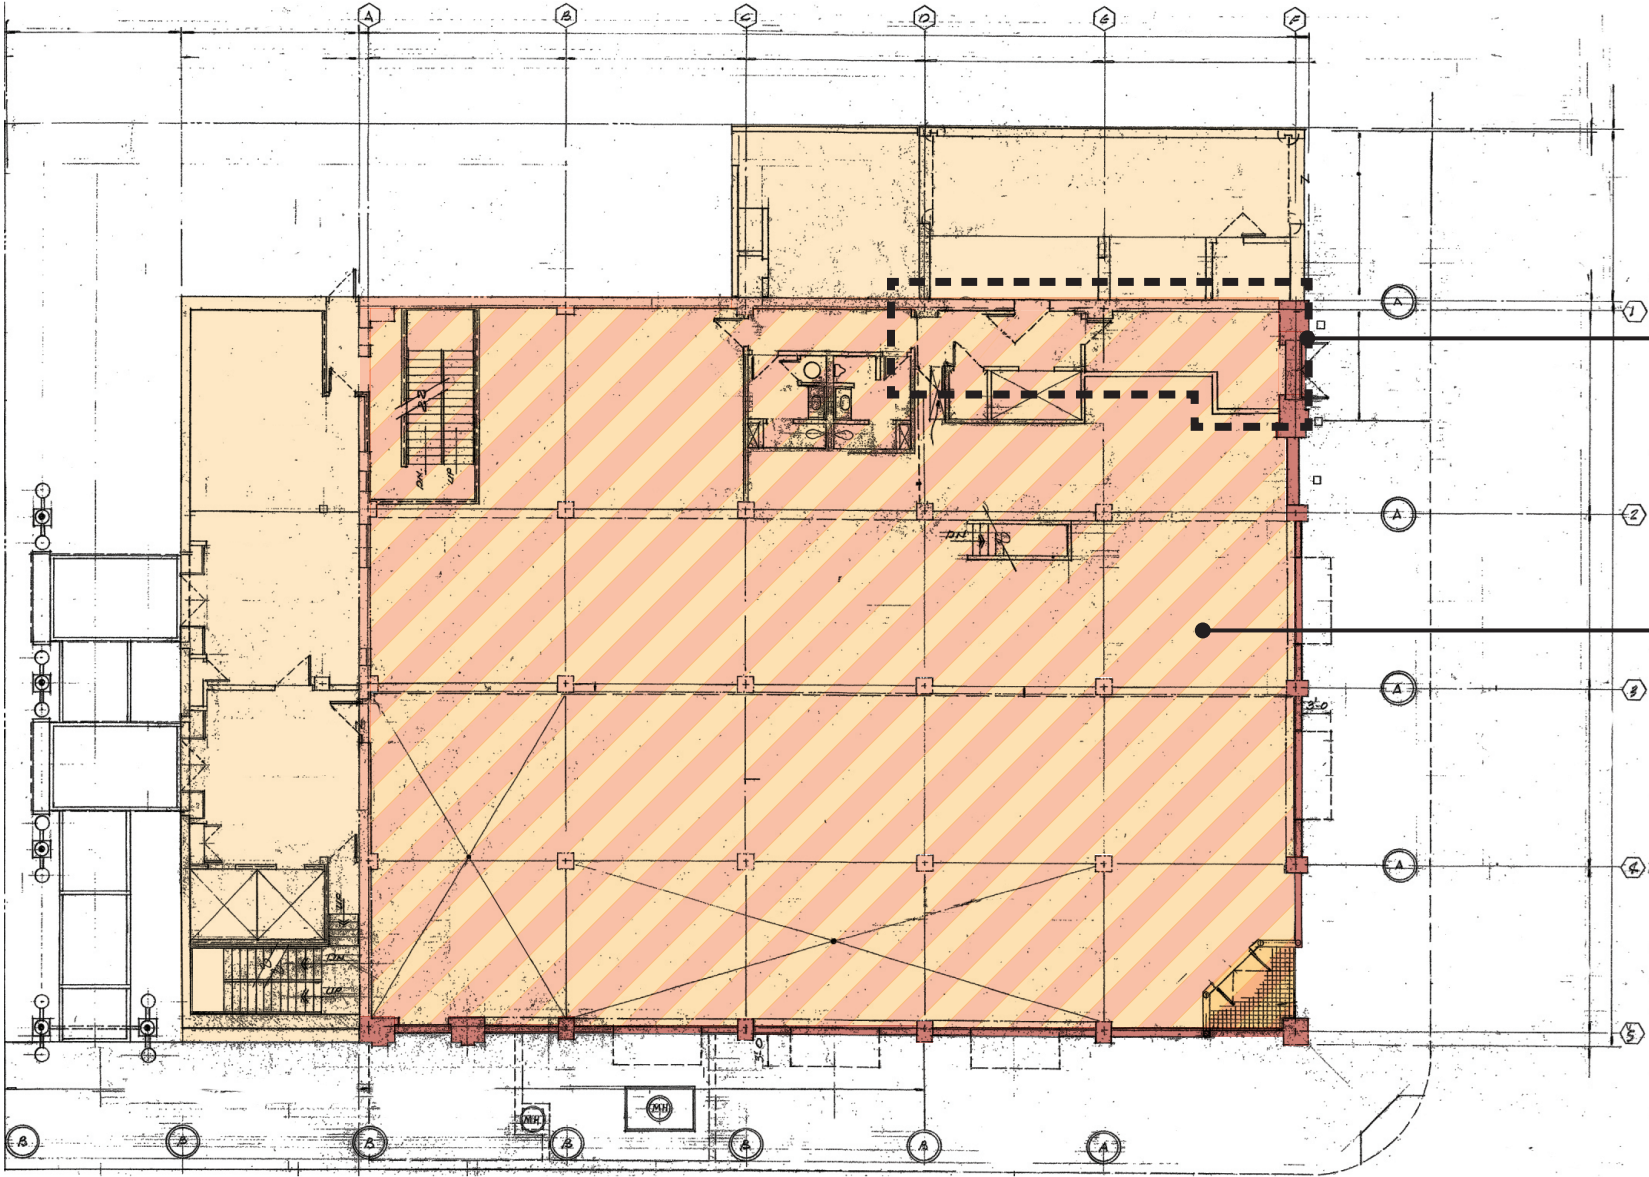
Ceramic mosaic tile floor is non-contributing historic fabric. Although original, it is a fragment and portions have been altered.

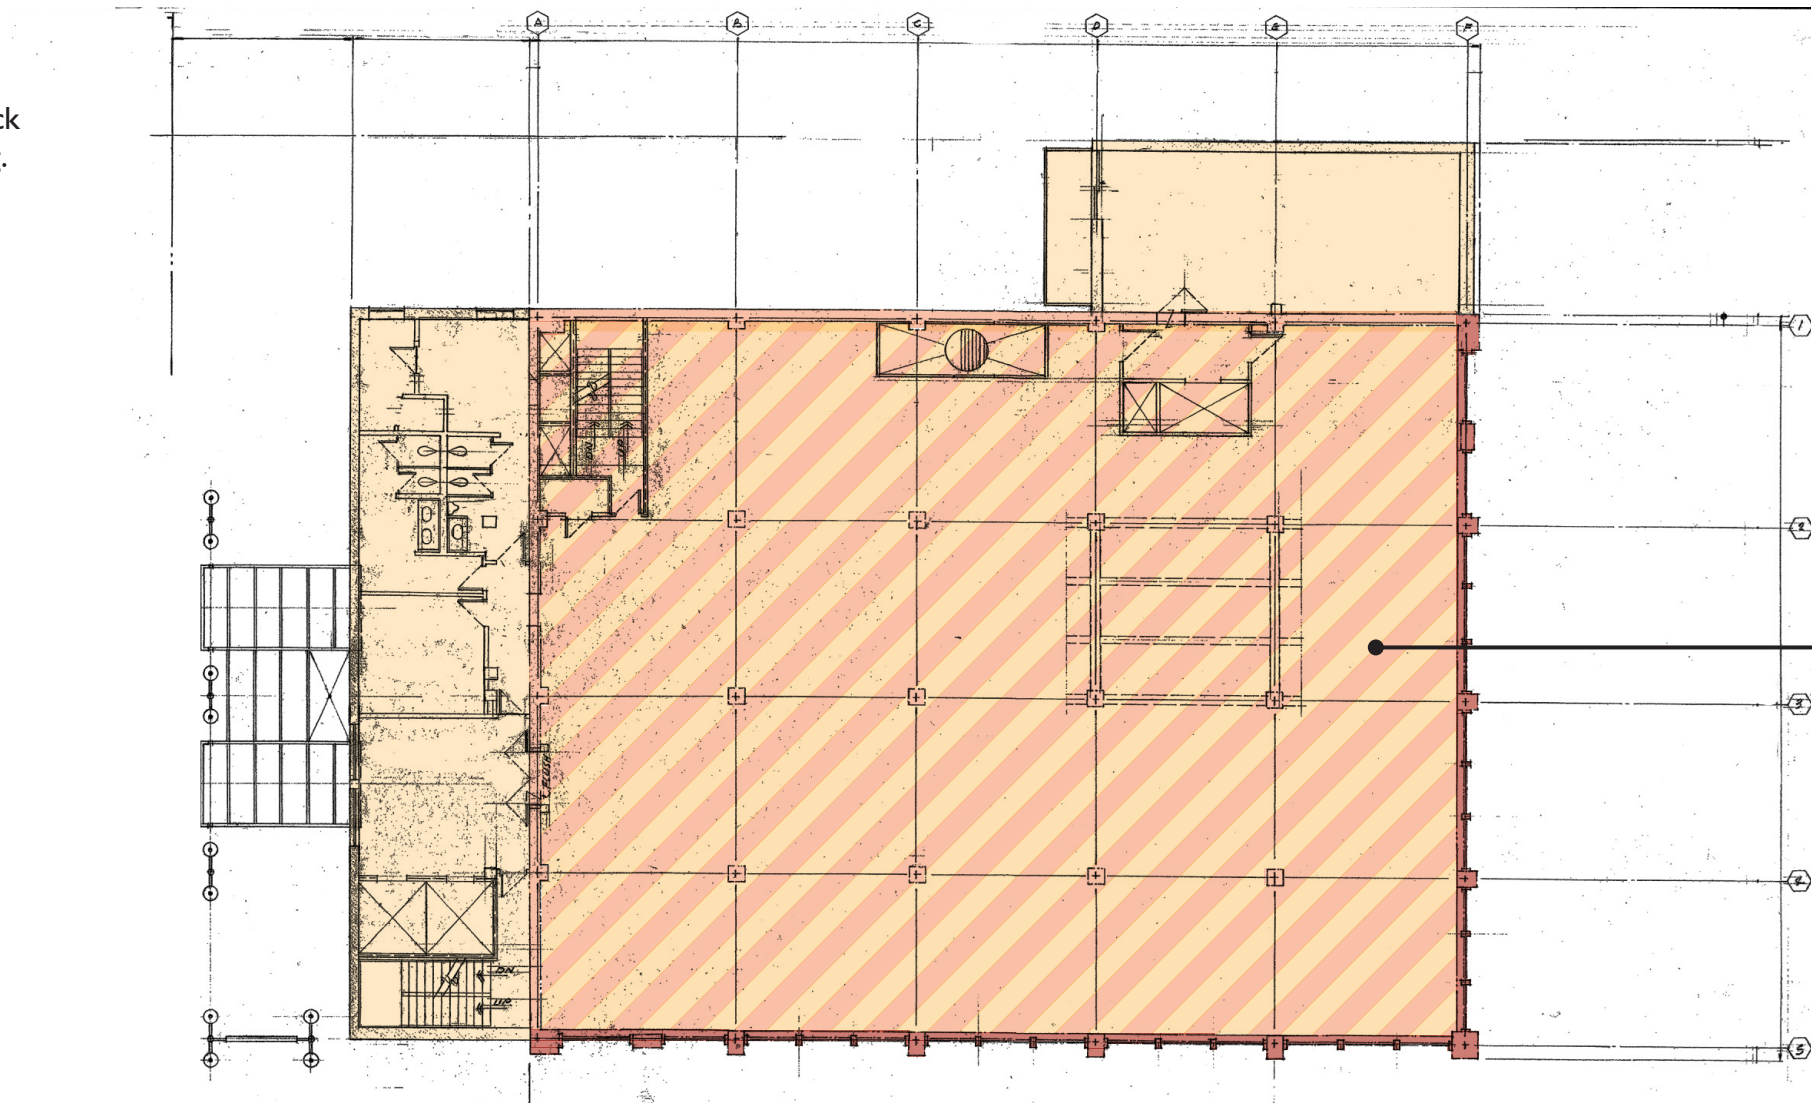
Volume and associated finishes are non-contributing, but the concrete floor slabs are contributing. Columns are also contributing.
