## **F. CONDITIONS ASSESSMENT**

This section records the existing conditions of the building as surveyed in March 2010. Architectural elements of the Aronson Building are categorized by exterior and interior materials and assemblies. Character-defining features (as noted in the Character-Defining Features section) are the primary focus of this assessment.

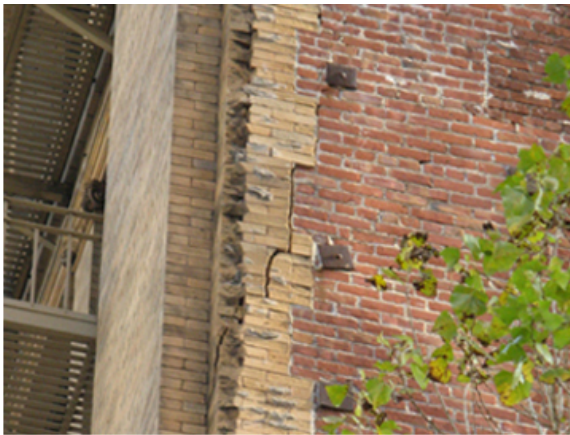
- Vertical cracking at the northeast corner where the brick wall meets the terra cotta clad 3<sup>rd</sup> Street façade (**Figure 35**);
- Evidence of abrasive blasting of the brick face at the exterior, confirmed by an annotation in the 1979 construction documents (**Figure 36**);
- Evidence of moisture at roof parapet, as seen by organic growth (**Figure 37**);
- Evidence of abrasive blasting of brick face at the interior, resulting in loss of mortar, pitting of the brick face, and rounded brick edges (**Figure 38**);
- Poor joint condition due to abrasive blasting.

**Figure 35. Cracking at terra cotta to brick interface.**  
Source: Page & Turnbull, March 2010.

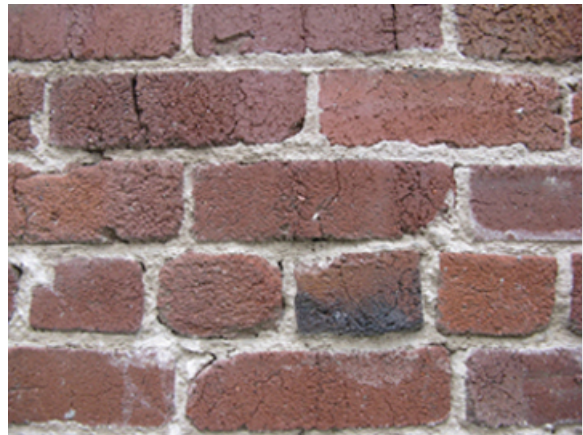
**Figure 36. Exterior brick face.**  
Source: Page & Turnbull, March 2010.

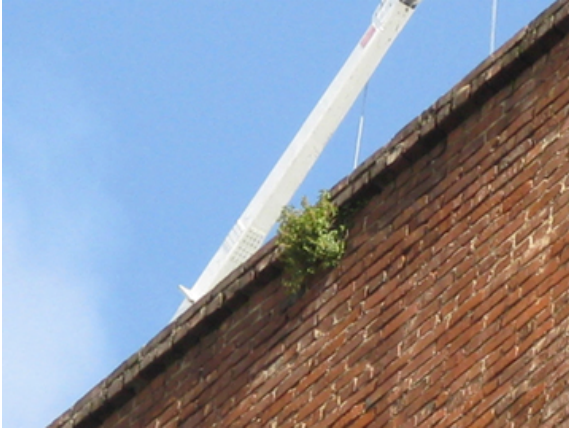
Figure 37. Weeds growing out of a parapet wall.  
Source: Page & Turnbull, March 2010.

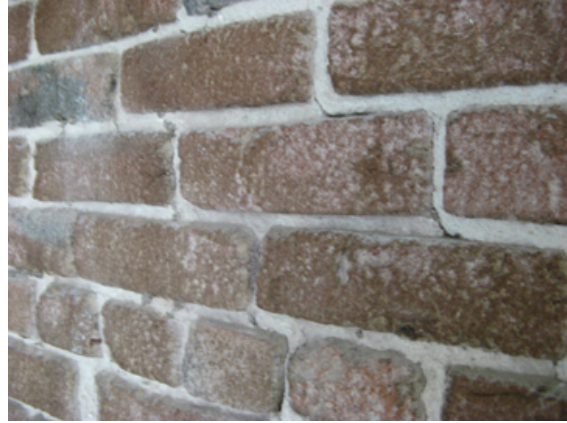
Figure 38. Interior brick face.  
Source: Page & Turnbull, March 2010.

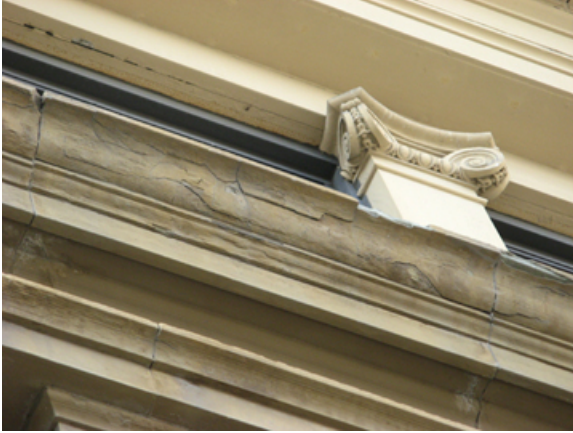
- Cracking of the stone, particularly at the overhang edges (**Figure 39**);
- Corrosion of steel cramps and anchors (**Figure 40**);
- Spalling of edges and corners (**Figure 41**);
- Exfoliation of crust at the top side (horizontal surface) of the stone (**Figure 42**);
- Delaminating paint coating;
- Loss of / missing mortar at joints.

Figure 39. Cracking and spalling of sandstone at edge. Source: Page & Turnbull, March 2010.

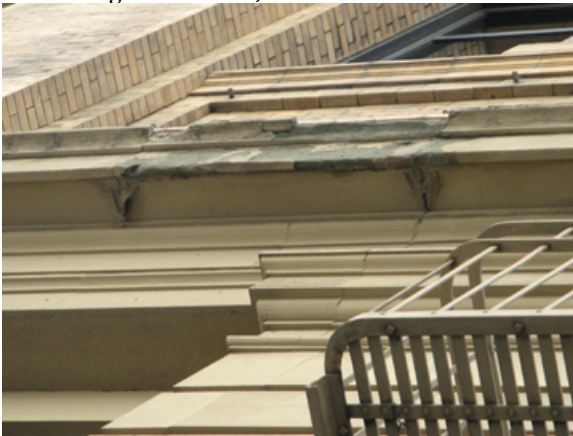
Figure 41. Spalling of sandstone at edge. Source: Page & Turnbull, March 2010.

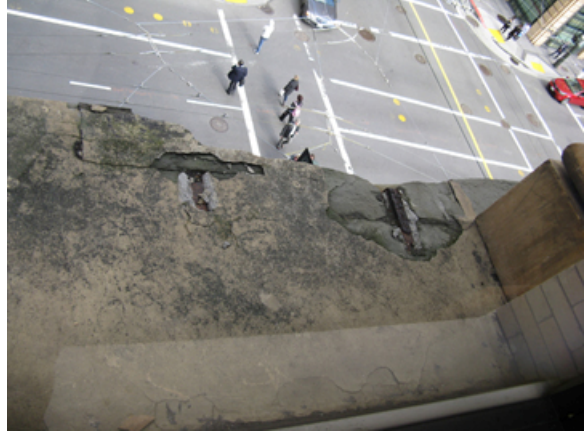
Figure 40. Cracking/spalling of concrete at steel corrosion. Source: Page & Turnbull, March 2010.

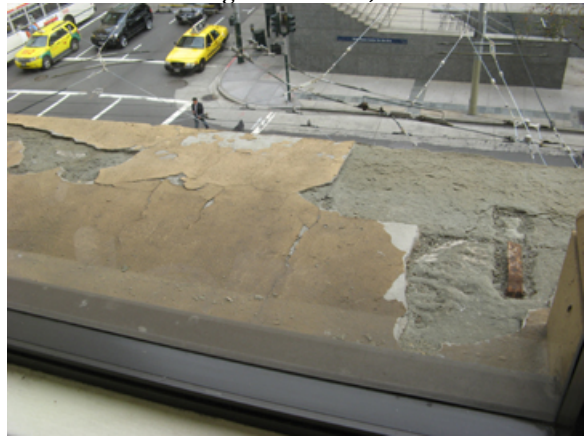
Figure 42. Exfoliation of crust. Source: Page & Turnbull, March 2010.

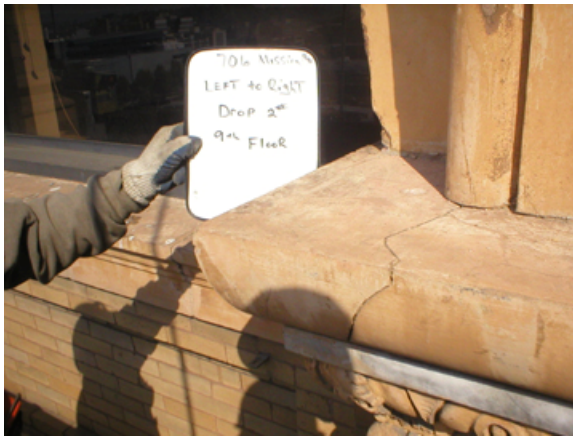
Figure 44. Cracking at cornice. Source: Rainbow Waterproofing, 2006.

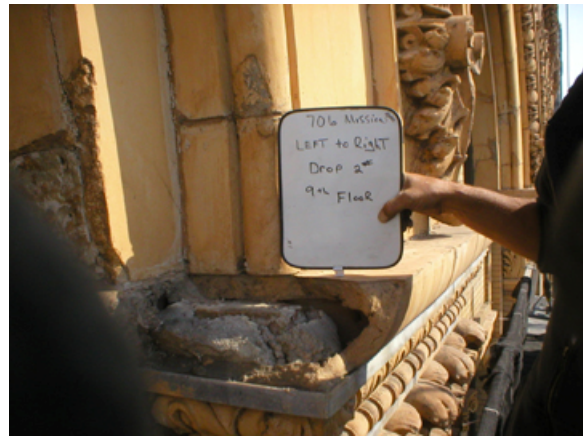
Figure 45. Removal of cracked piece shown at left. Source: Rainbow Waterproofing, 2006.

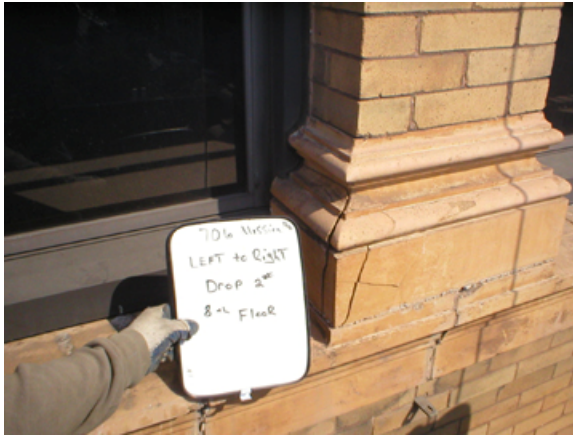
Figure 46. Cracking at column base.  
Source: Rainbow Waterproofing, 2006.

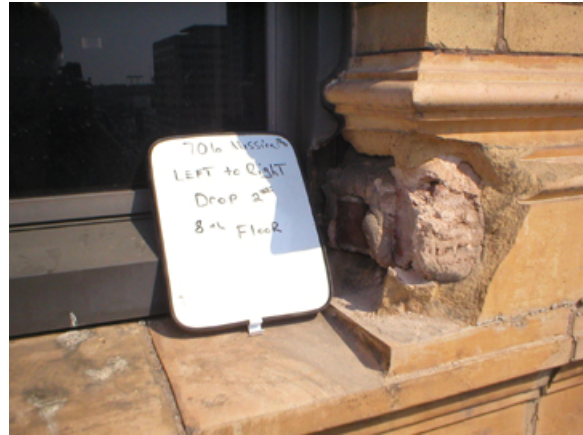
Figure 47. Removal of cracked piece shown at left.  
Source: Rainbow Waterproofing, 2006.

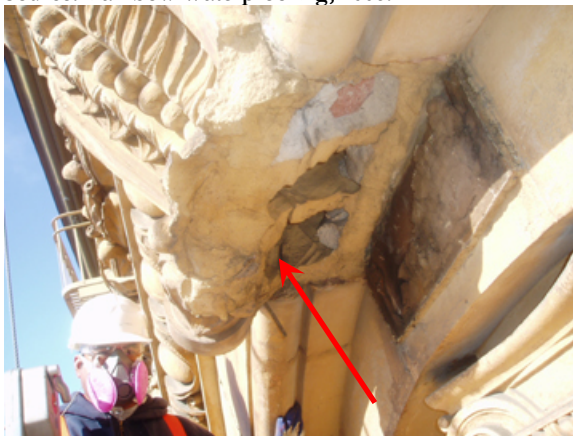
Figure 48. In-plane cracking of keystone.  
Source: Rainbow Waterproofing, 2006.

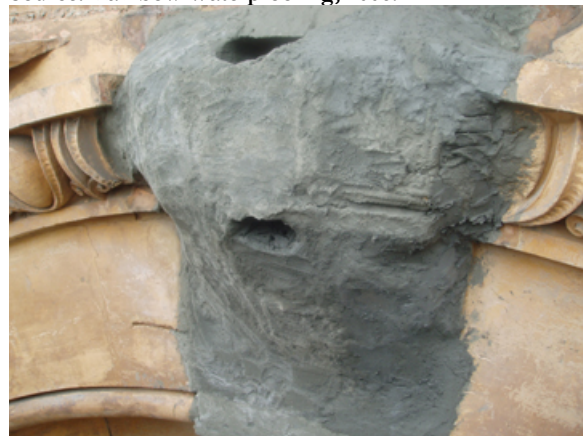
Figure 49. Removal of cracked and mortar patch of piece shown at left. Source: Rainbow Waterproofing, 2006.

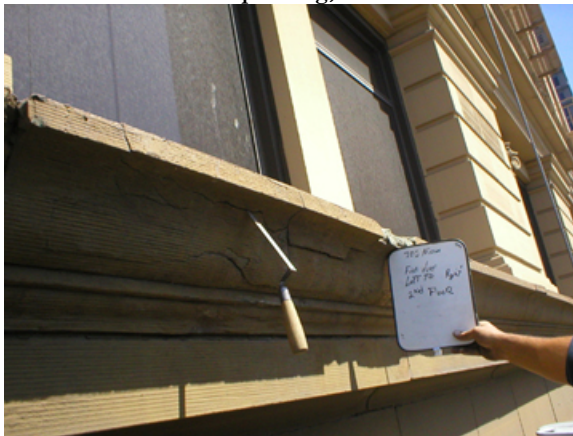
Figure 50. Cracking of sandstone.  
Source: Rainbow Waterproofing, 2006.

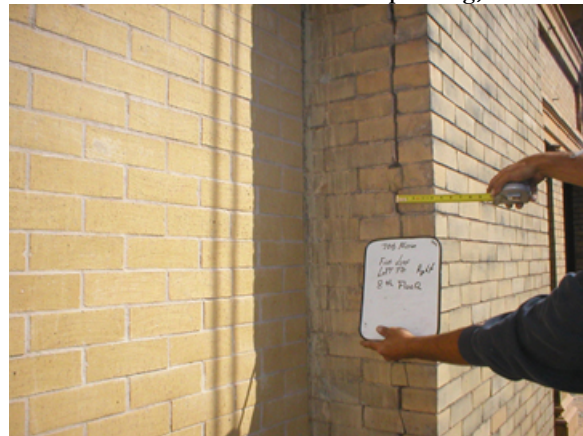
Figure 51. Cracking of terra cotta brick.  
Source: Rainbow Waterproofing, 2006.

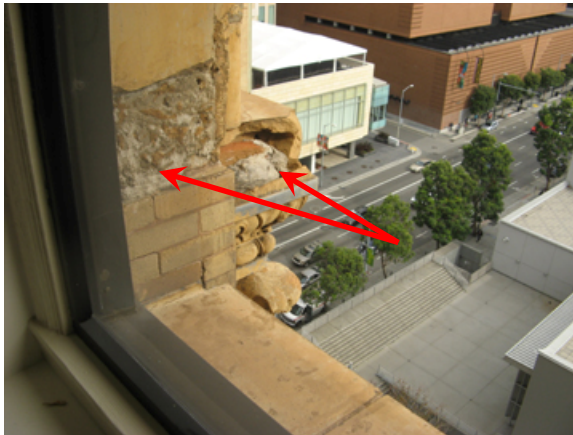
- Shallower bisque spalls occur at joints, particularly at window sills and the ninth floor arches (**Figures 52 & 53**). Typically bisque spalls of this nature are due to past pointing of the joint with a mortar that is too hard. If mortar is too hard, the terra cotta is unable to expand and contract, resulting in a spall or crack at the joint;

Figure 52. Deep bisque spall exposing void filler.  
Source: Page & Turnbull, March 2010.

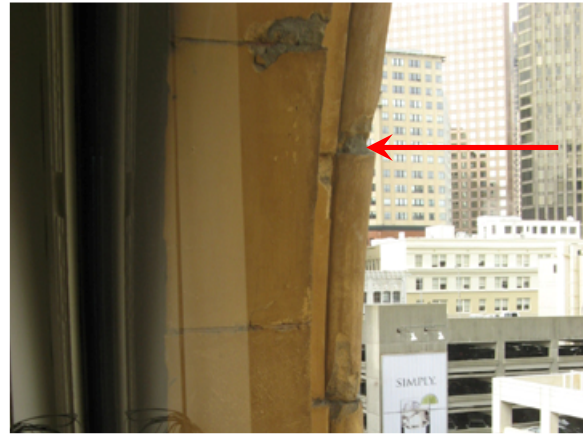
Figure 53. Shallow bisque spalls at joints.  
Source: Page & Turnbull, March 2010.

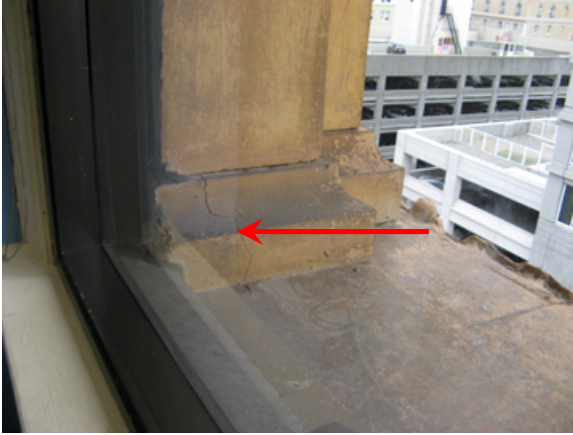
- Cracking of the terra cotta can be seen at the surface of many terra cotta units. While some hairline cracking is present, the majority of cracks are larger, penetrating into the clay body. Also observed were in-plane cracking, seen at a bisque spall (**Figures 54 & 54**);

Figure 54. Cracking at column base.  
Source: Page & Turnbull, March 2010.

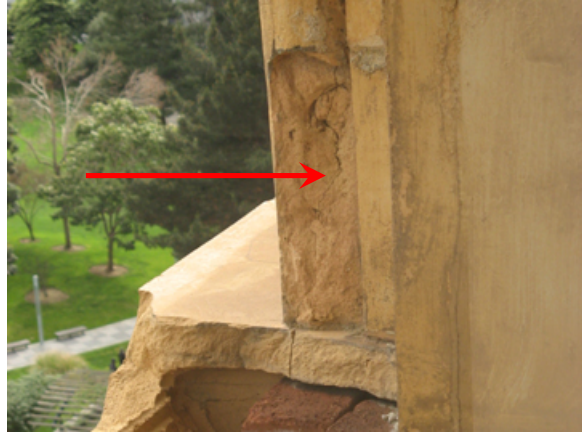
Figure 55. In-plane cracking at bisque spall.  
Source: Page & Turnbull, March 2010.

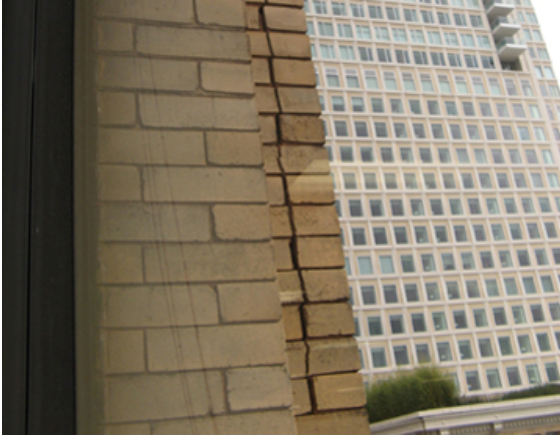
- o Cracking of the glazed brick can be seen at vertical corners of the building, for example, at the columns which extend between the fourth and eighth floors. In some areas these cracks are continuous and extend multiple floor levels (**Figure 58**);
- o Spalling of the brick occurs at the cracked areas described above. Localized to the corners of the window openings;
- o Missing brick units also occur at the cracked areas described above. Localized to the corners of the window openings (**Figure 59**).

**Figure 58. Cracking at column corner.**  
Source: Page & Turnbull, March 2010.

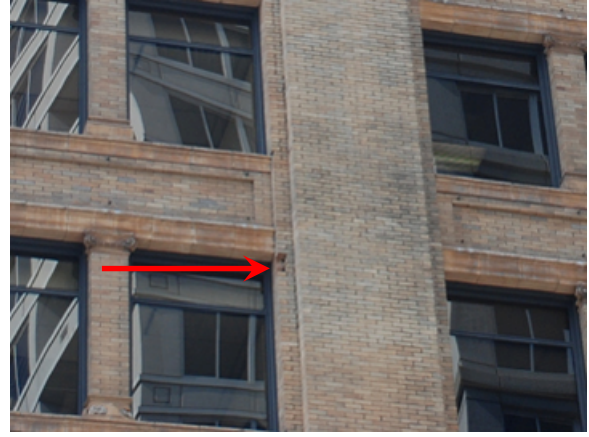
**Figure 59. Missing brick.**  
Source: Page & Turnbull, March 2010.

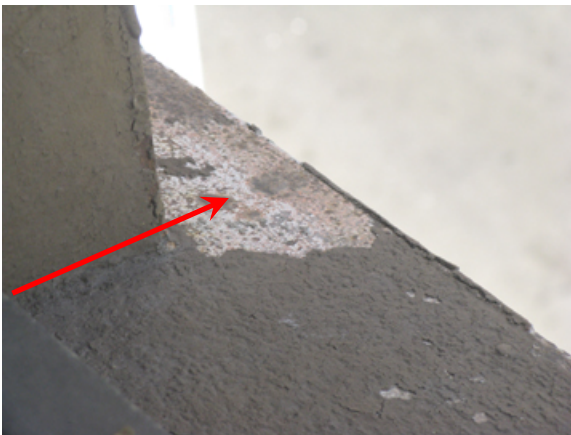
- Minor corrosion due to oxidization located at areas of paint failure (**Figure 60**);
- Paint failure, particularly at the second story horizontal surfaces (**Figure 61 & 62**);
- Missing elements (**Figure 63**).

**Figure 60. Corrosion of cast iron.**  
Source: Page & Turnbull, March 2010.

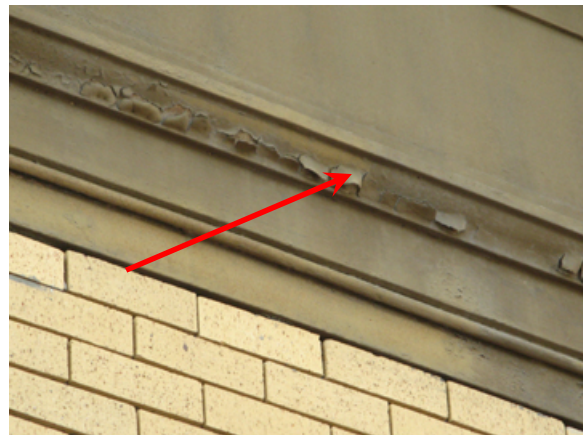
**Figure 61. Delaminating paint.**  
Source: Page & Turnbull, March 2010.

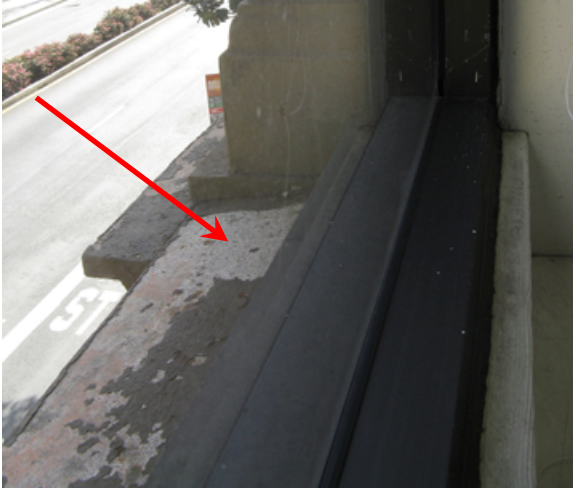
Figure 62. Area of exposed cast iron with no paint.  
Source: Page & Turnbull, March 2010.

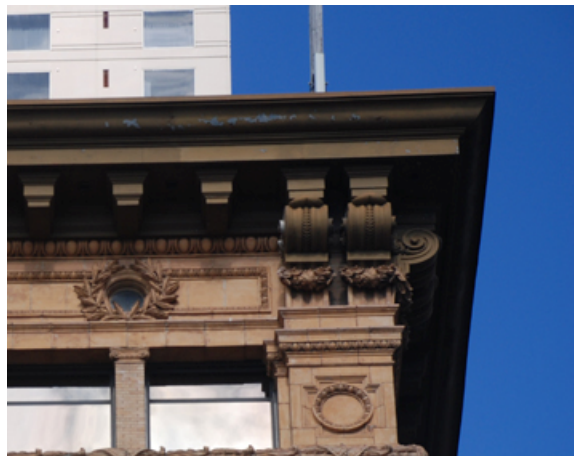
- o Minor corrosion due to oxidization located at areas of paint failure;
- o Paint failure, particularly at the second story horizontal surfaces (**Figure 64**);

Figure 64. Area of exposed sheet metal with no paint.  
Source: Page & Turnbull, March 2010.

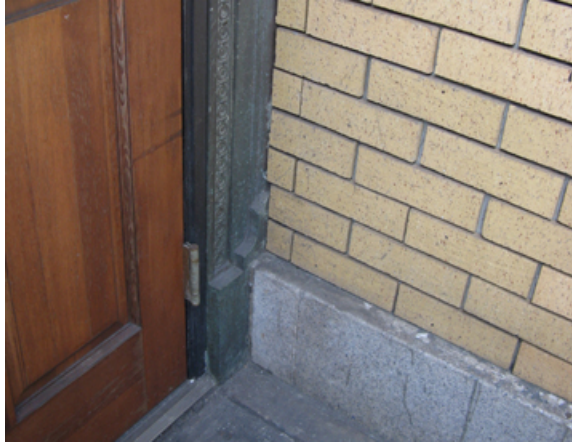
- o General loose particulate soiling;
- o Active corrosion in the form of greenish streaks and pits in the bronze surface (**Figure 65**);

Figure 65. Corrosion of bronze frame.  
Source: Page & Turnbull, March 2010.

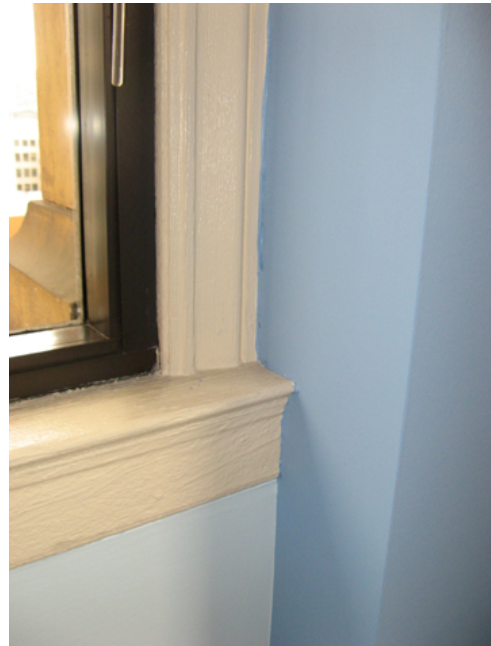
- o Raised grain, likely due to past sandblasting;

Figure 66. Interior window trim.  
Source: Page & Turnbull, March 2010.

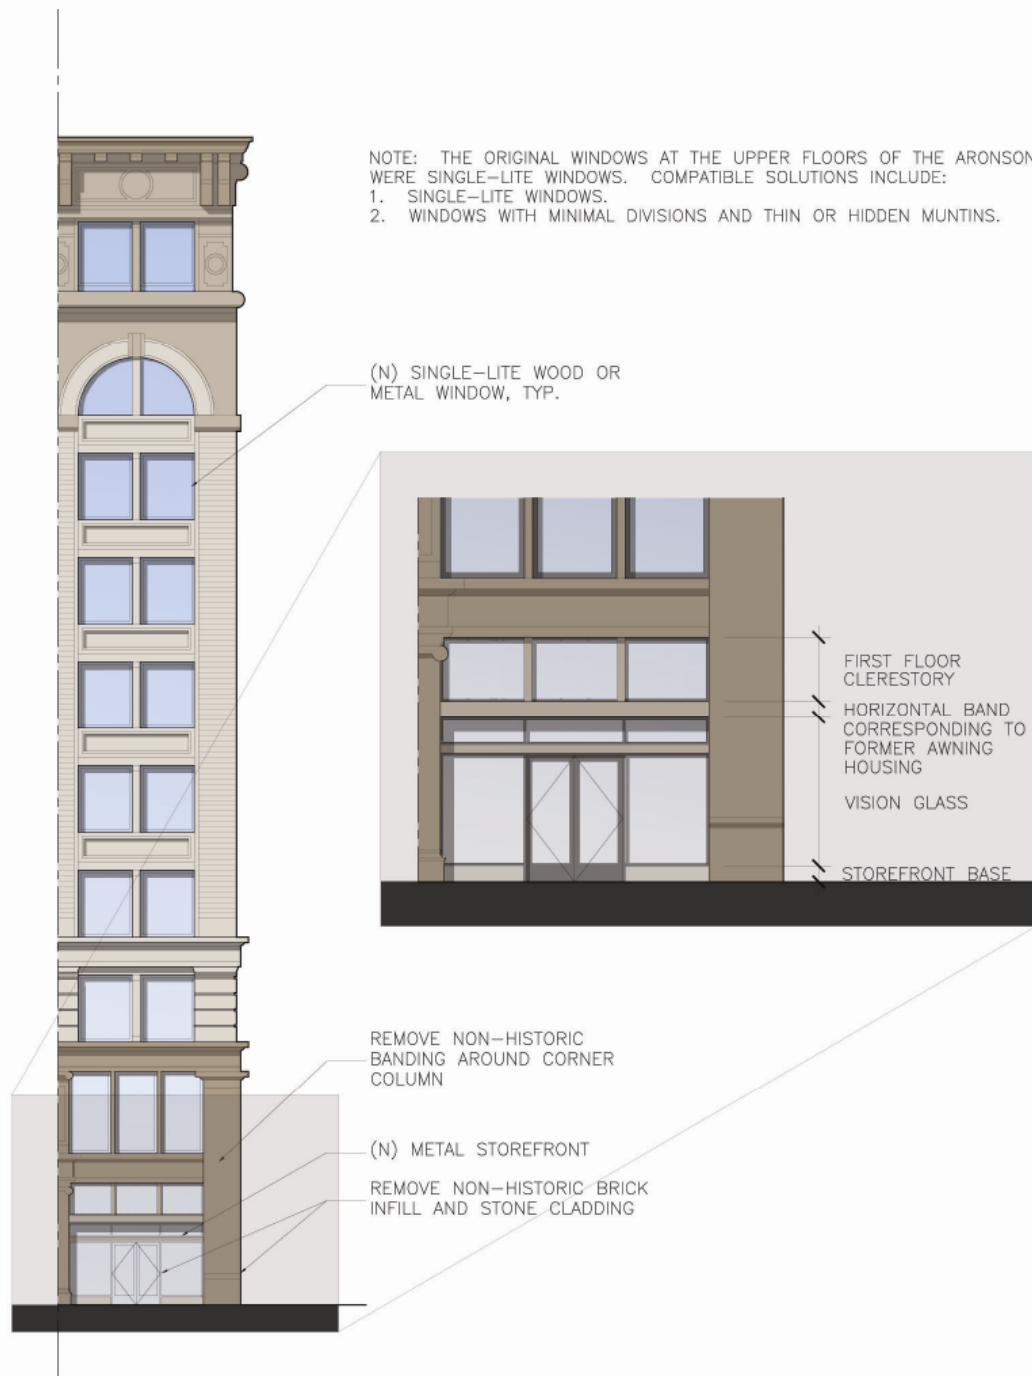
**Figure 68. Page & Turnbull sketch of a recommended design option for storefront and windows.**

*Design new storefronts at ground level to replace existing non-original storefront enclosures.* The existing cast-iron storefront elements should be maintained and protected. The new storefronts may be contemporary in design; however, they should be designed so that they are compatible with the historic character of the building. Historic photographs (**Figure 10**) should be referenced and any divisions or patterns in the fenestration should be compatible with the historic design. Materials to consider include steel and painted aluminum. See the provided sketch for guidance on design of this feature (**Figure 68**).
