SITE HISTORY REPORT

APRIL 2014

Seawall Lot 337/Pier 48
Mixed-Use Project
San Francisco, California

BASELINE ENVIRONMENTAL CONSULTING

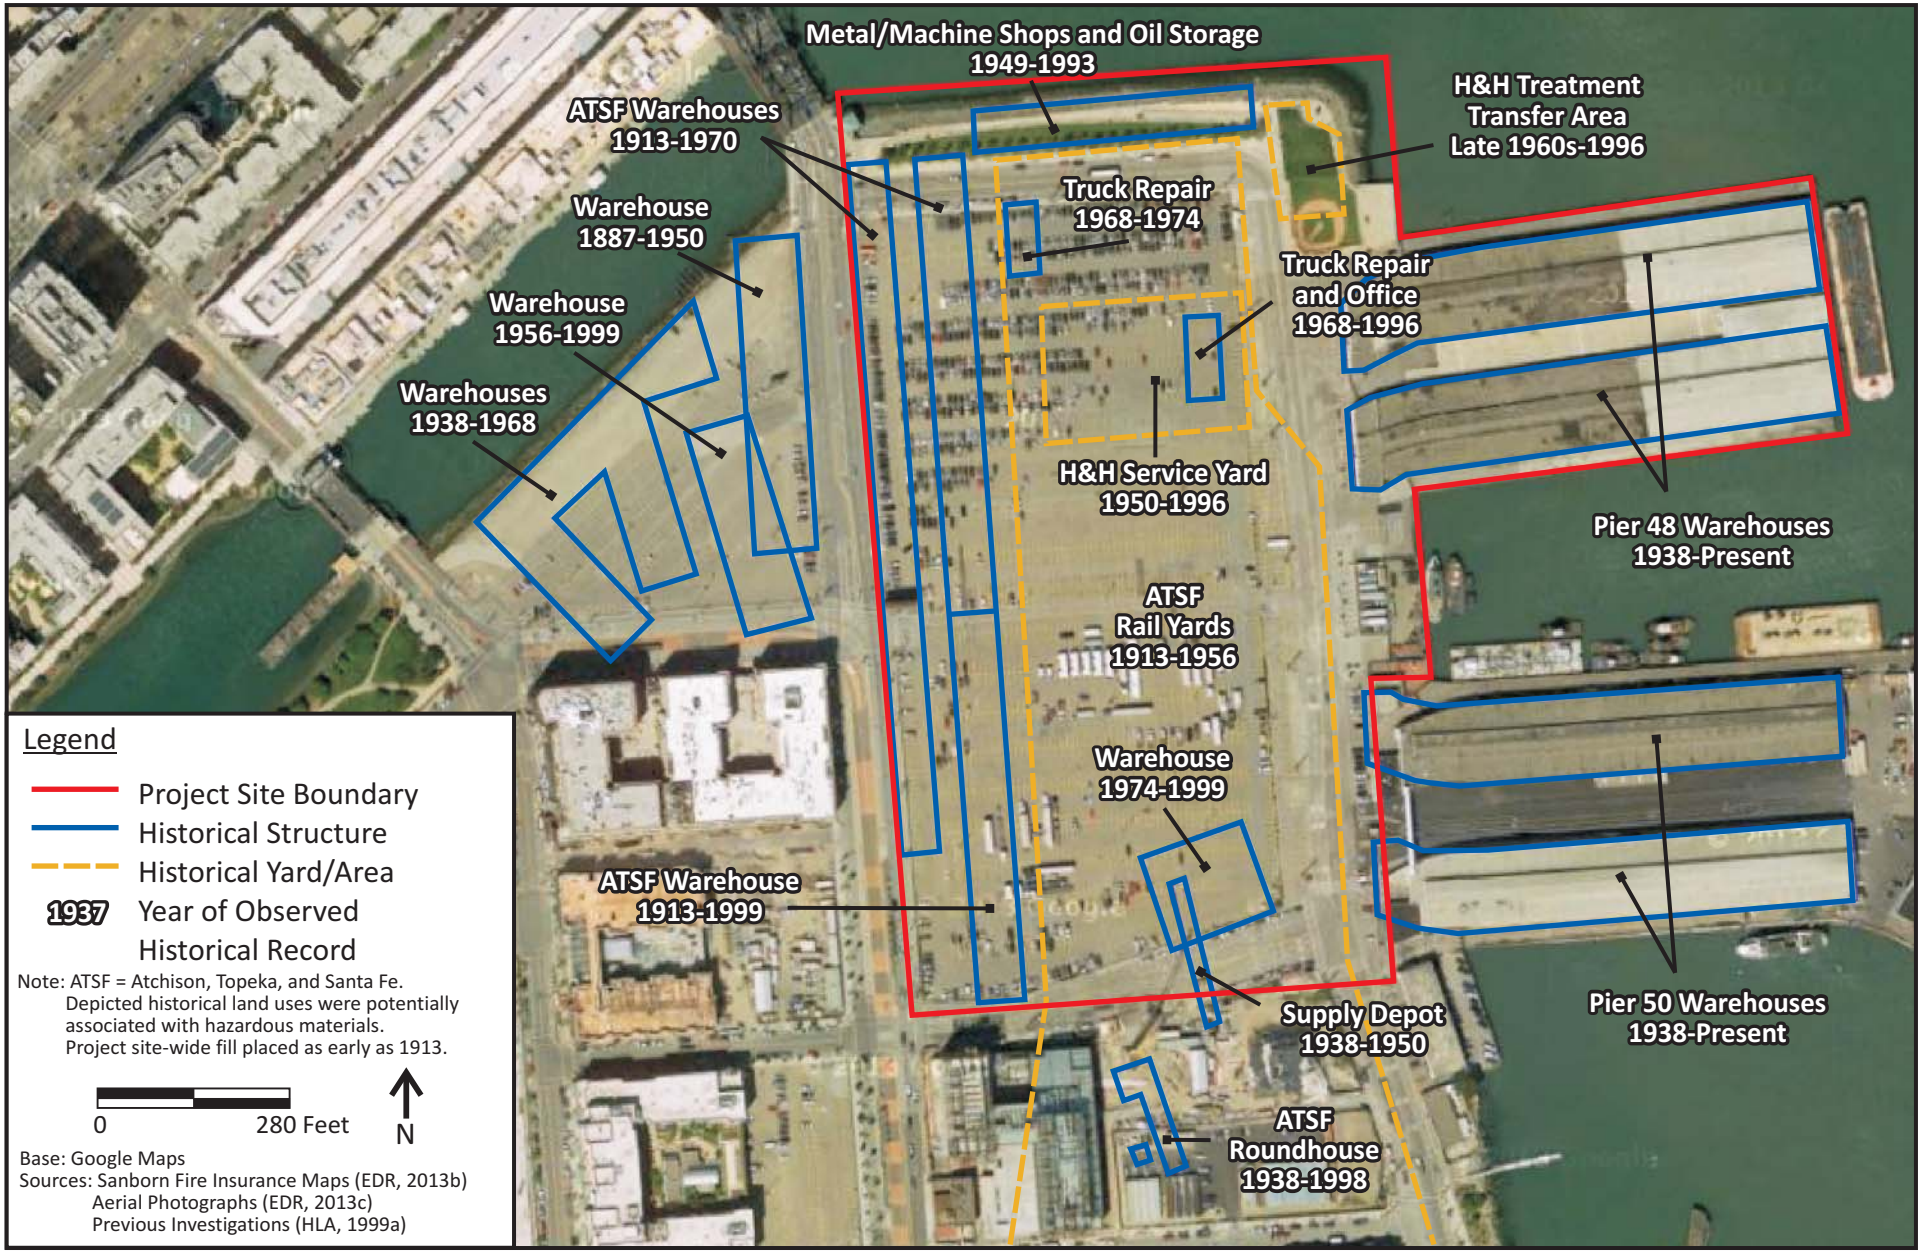
Figure 3

Two truck repair shops were located in the northern portion of the Project Site in the 1960s and 1970s (Figure 3). The primary contaminants of concern associated with former truck repair shops located on the Project Site include TPHd, TPHmo, chlorinated solvents, and acids (Oregon DEQ, 2001). Potential impacts to soil and groundwater quality from the former truck repair shops are summarized in Table 1.

- Former metal/machine shops;
- Former truck repair shops; and
- A former hazardous waste treatment facility (H&H service yard and TTA).
