**APPENDIX D: THE ARONSON BUILDING,
SAN FRANCISCO, CALIFORNIA,
HISTORIC STRUCTURE REPORT**

THE ARONSON BUILDING
SAN FRANCISCO, CALIFORNIA

HISTORIC STRUCTURE REPORT
FINAL DRAFT [08197]

DECEMBER 2, 2010

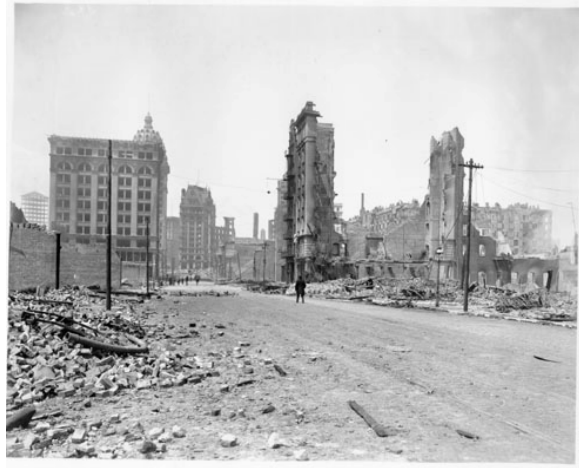
When the 1906 Earthquake hit, ensuing fires obliterated nearly every building in the South of Market, Downtown, and into the Mission District. Due to the fireproof construction of the Aronson Building's structure, however, the building survived the disaster (**Figures 10, 11, 12, and 13**).

Figure 11. The Aronson Building is on the left.
Source: San Francisco Historical Photograph Collection, AAC-3600.

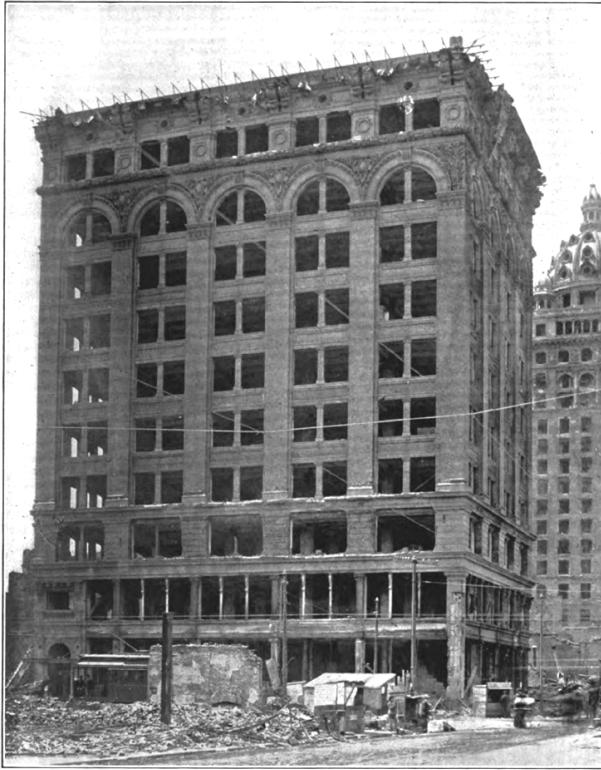
Figure 12. The caption to this 1906 newspaper photo reads: "ARONSON BUILDING. Northwest Corner Third and Mission Streets. The facades for the three lower stories consist of Colusa sand-stone, which is badly spalled and damaged. The upper stories of buff terra cotta pressed brick, with terra cotta ornaments, are but slightly injured, the terra cotta being spalled and cracked in a few places. The metal cornice is completely wrecked. The rear walls of common brick were considerably racked and damaged by the earthquake. All the walls remain practically plumb. Columns in the basement, first, fifth, eighth and tenth stories have buckled on account of the failure of the hollow tile protection. The Roebling concrete floors, with crimped wire lath and cement plastered soffit protection, remain in first-class condition throughout, notwithstanding the warped condition of the steel work, due to the buckling of the columns. The 4" hollow tile partitions are badly wrecked throughout, about 80 percent of the entire work having fallen down. The failure of the hollow tile partitions totally wrecked the cast-iron and marble tread stairways." Source: Unknown (clipped file).

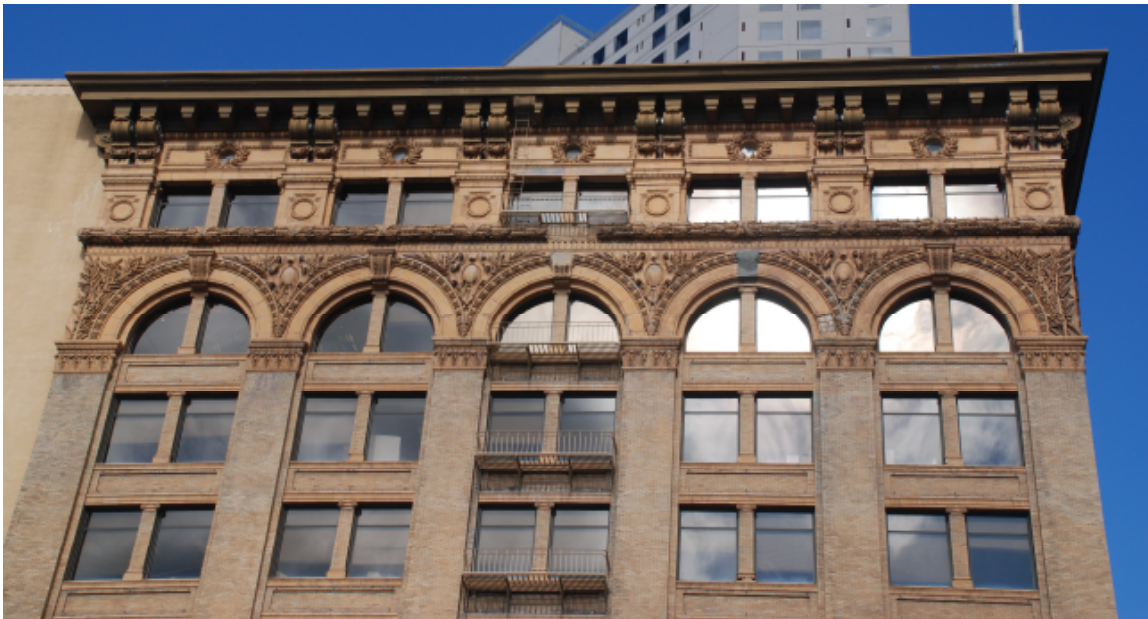
The ninth and tenth floors form the ornamented capital of the building's composition, and are clad in terra cotta (**Figure 26**). The ninth floor features pairs of fixed windows within an arcade of molded arches that spring from the Corinthian capitals below. The arches feature keystones (some partially or fully removed) and egg-and-dart molding. Bas reliefs featuring cartouches, scrolls, and olive leaves ornament the spandrels, and brick Ionic pilasters divide the windows within the arches. The ninth floor terminates in a banded bay leaf garland molding. The tenth floor features pairs of fixed windows like those of the lower floors, divided by brick pilasters. Wall panels and oval egg-and-dart moldings separate each bay. The primary façade terminates in a massive entablature with a frieze of egg-and-dart molding and oculi framed in olive leaf swags; large egg-and-dart molding; pairs of scrolled brackets above molded swags and consoles; block modillions; and a cornice. The brackets, modillions, and cornice are made of galvanized sheet steel that is painted (the originals were copper).

Figure 26. Ninth and tenth stories, southeast (Mission Street) façade.
Source: Page & Turnbull, March 2010.

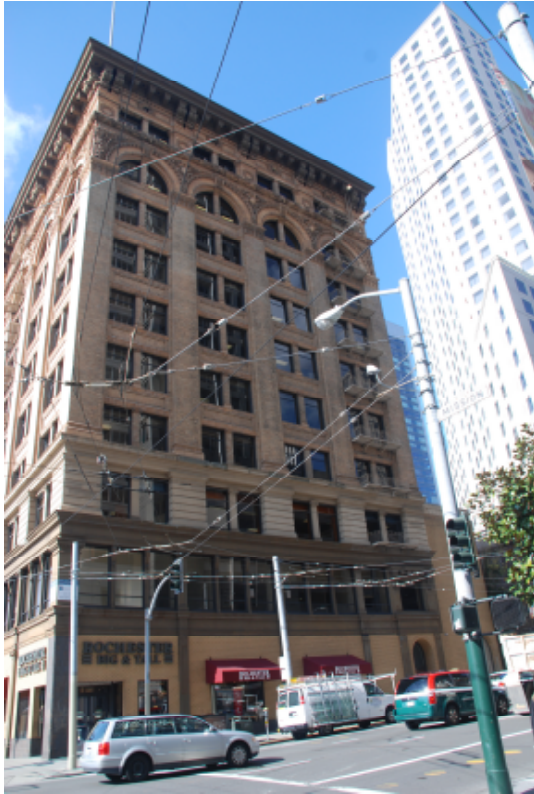
The northeast façade faces 3rd Street, and features four structural bays (**Figure 27**). The organization, fenestration, and ornament are identical to that on the primary façade. The capitals of the Ionic

pilasters on the ground floor are missing. The original primary entrance of this façade is located in the fourth bay at the north end. Paneled wood double doors and an arched glazed transom are recessed within an arched entryway, which is clad in buff colored brick tile veneer. The bronze door frame and transom frame are original and display a chain band pattern on the face of the frame. A cast iron gate is located in front of the entryway. A non-original metal fire escape is located in the northern-most bay.

Figure 27. Northeast (3rd Street) façade.
Source: Page & Turnbull, March 2010.

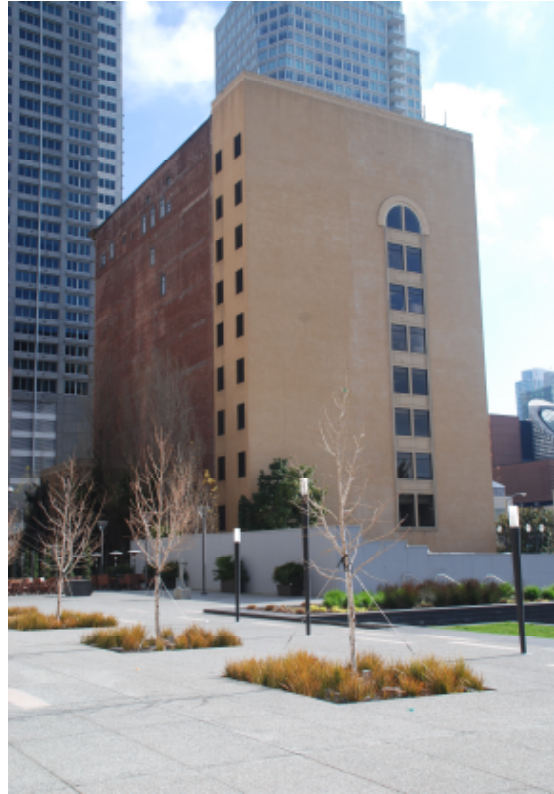
Figure 28. Northwest and southwest facades.
Source: Page & Turnbull, March 2010.

The northwest façade of the original building is clad in common red brick, and has bronze anodized aluminum-sash windows that are inserted in random locations at the eighth through tenth stories (**Figure 28**). Two segmental arch openings have been infilled at the seventh and eighth stories, and another was re-used for a smaller window at the tenth story.

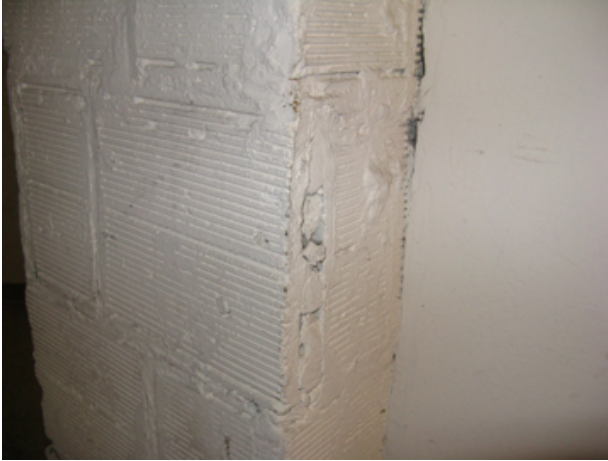
The interior retains few original features, and has been altered to modern retail and office spaces. The basement includes brick walls and steel columns encased in terra cotta and concrete (**Figure 32**).

Figure 32. Column encased with terra cotta tile.
Source: Page & Turnbull, March 2010.

Description: Non-Contributing elements are generally non-historic elements or elements that have been altered to the extent that their original character is absent. Examples of historic fabric that are non-contributing include the patterned ceramic mosaic tile flooring at the 86 3rd Street entrance (Figures 33 and 66) and the hollow clay tile at the basement level (Figure 32). The ceramic mosaic tile

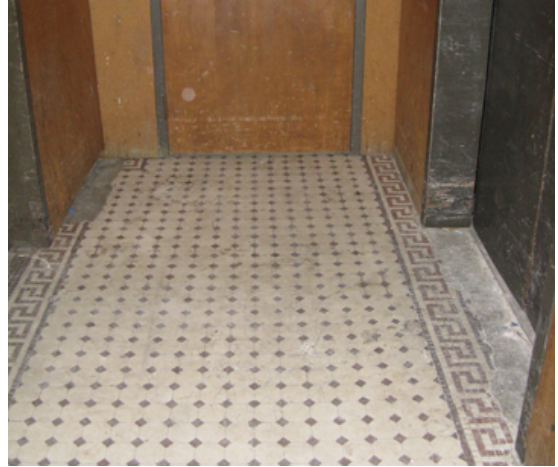
Original patterned ceramic mosaic tile flooring is located inside the 3rd Street entrance, and continues into the freight elevator lobby, which used to be the building's primary elevator core and stair (**Figure 33**). A red-brown field border with white tile is laid out in a Greek key fretwork pattern. The center of the flooring features white octagonal-shaped tiles inset with red-brown square tiles set on the diagonal.

Figure 33. Mosaic tile floor at 3rd Street lobby.
Source: Page & Turnbull, March 2010.

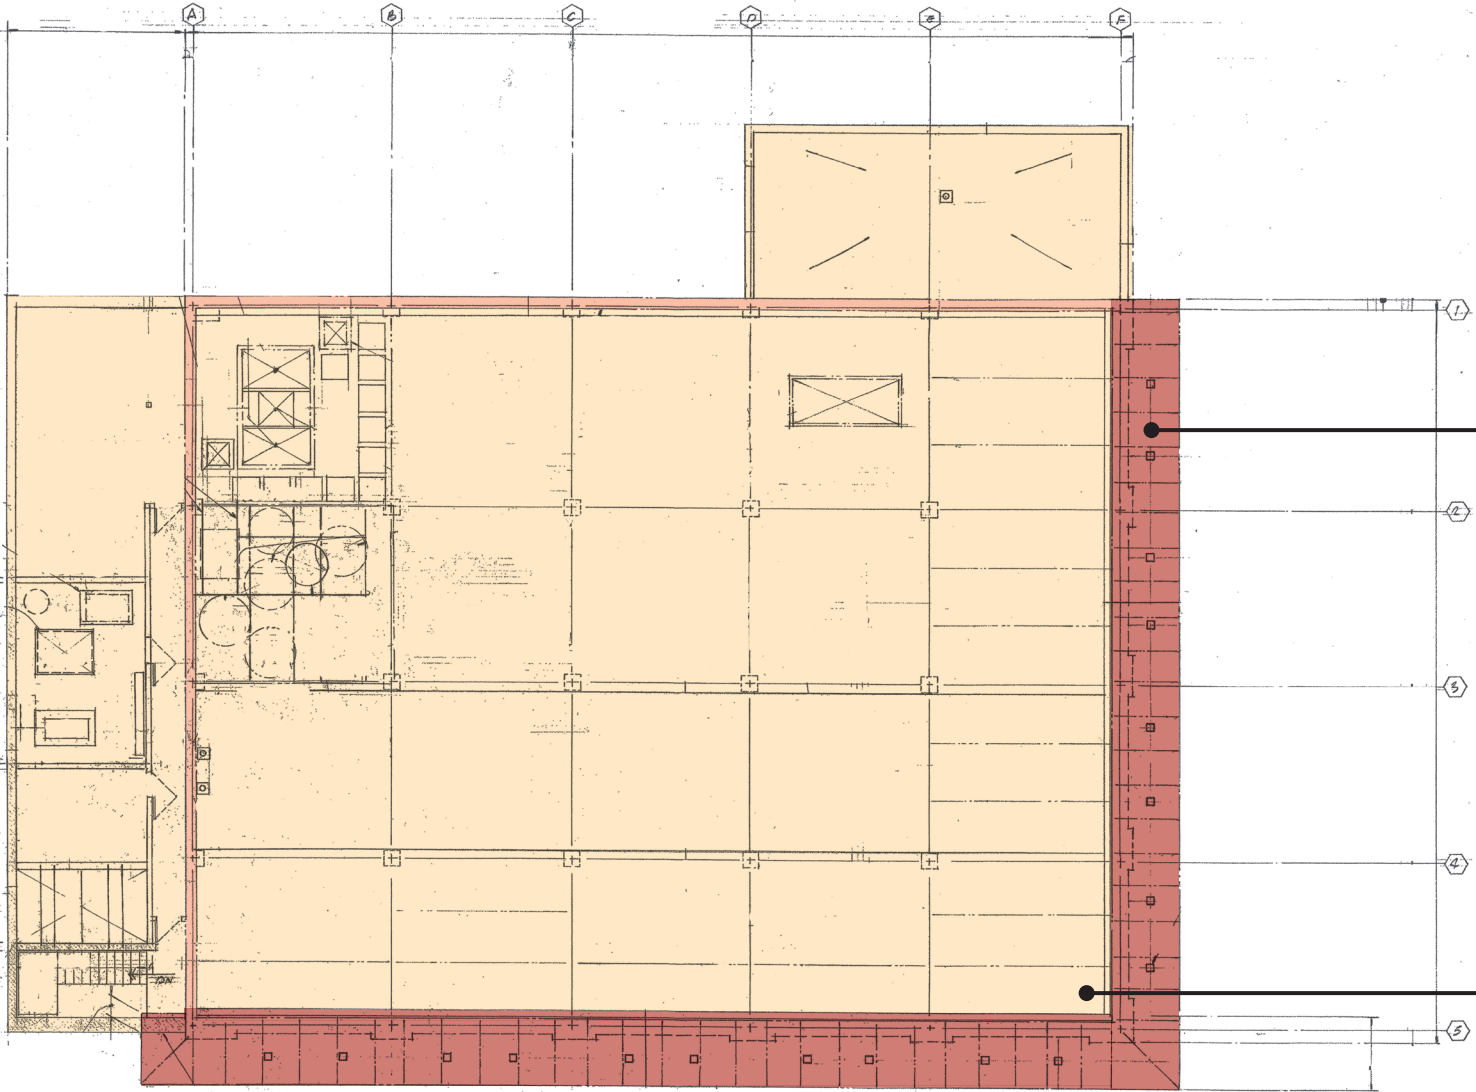
Sheet metal cornice.

Wood flagpole is a contributing character defining feature.
