APPENDIX HR:
Historic Resource Evaluations

Overview of Historical Resources Review and Findings

410 BUSH STREET (ES-26)

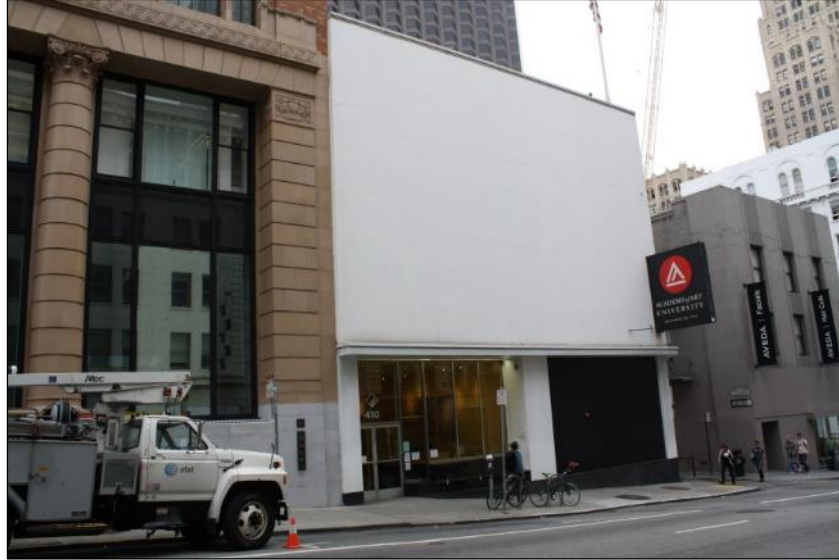
The building is capped with a flat roof, terminating in shallow copping along the roofline. Spanning the façade, a cantilevered, unadorned wall projection divides the ground-floor entrance and windows with the smooth stucco-clad walls on the top stories. Characteristic of the style, the structure features smooth, unornamented wall surfaces with minimal detailing.

Figure 1. 410 Bush Street. (Source: SWCA)

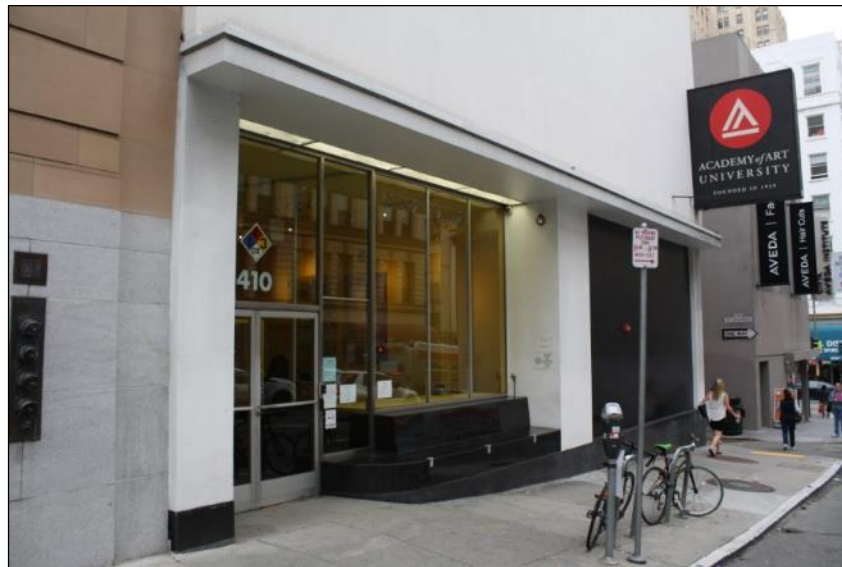
On the first floor, the primary elevation consists of a recessed storefront entrance, with full-length aluminum-framed windows and paired entrance doors, in the western portion of the facade. Two smooth, stucco-clad piers flank the storefront and entrance. On the southeast corner of the building are recessed panels clad in decorative tile (based on historic photos, the tiles appear to have been glazed and possibly earth-toned in color; the tiles were painted over at an unknown date). Directly above the first story is a boxed overhang, which turns the corner and partly extends along the secondary elevation in the alley. The second and third stories are clad in smooth stucco with no fenestration.

Figure 2. 410 Bush Street, detail, first story of the primary elevation. (Source: SWCA)

- The extant façade was designed by San Francisco architect Albert F. Roller in 1946/1947 for Westinghouse Electric (Permit 93411)
- Main entry doors appear to have been replaced since 1946 remodel (AAU, Memo to SWCA, 2/2/2016)

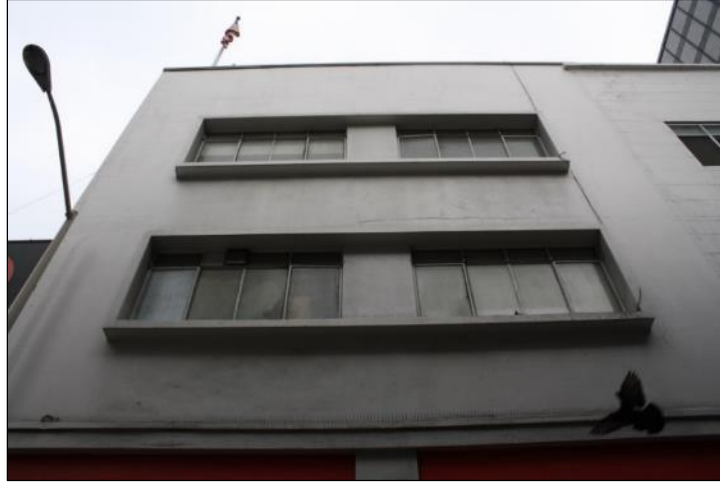
The smooth-stucco sheathing of the primary elevation extends on the side (eastern) elevation partially, approximately one bay deep. On the east elevation, the first floor displays ribbon windows on the first and second stories, with each set enclosed by a stucco-clad frame. East elevation fenestration generally consists of single, rectangular, flushed casement windows and aluminum sliders. Exterior walls along the eastern and northern (rear) elevation, facing Pine Street, display traces of board-formed concrete.

Figure 3. 410 Bush Street, close up of ribbon casement windows on the east elevation. (Source: SWCA)

- Windows on the east elevation (alley) replaced in 2010 (Permit 201008098351)
- Painted signage approved in 1994 (Permit 09725277)
- Box sign attached to perimeter fence (visual observation)

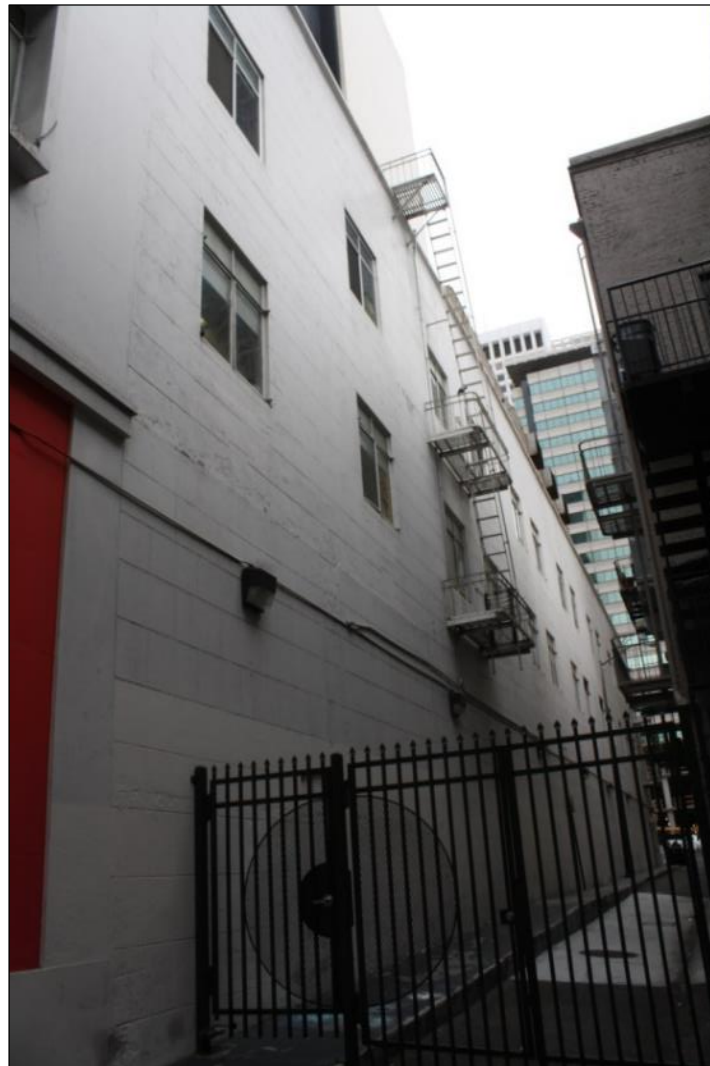
Figure 4. 410 Bush Street, northwest perspective of the eastern elevation and alley. Shows traces of board-formed concrete. (Source: SWCA)

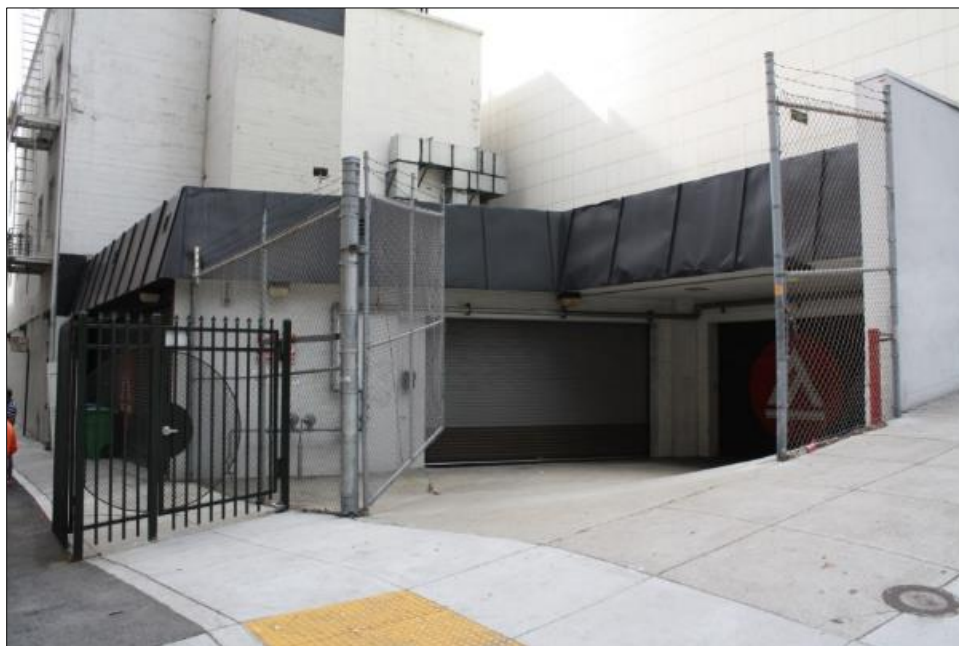
The rear elevation along Pine Street has a one-story portion featuring three roll-up doors of varying sizes and a mansard roofline. The traces of board-formed concrete are visible throughout the rear elevation. A metal chain-link fence restricts access to the roll-up doors from Pine Street.

Figure 5. Pine Street elevation of subject property. (Source: SWCA)

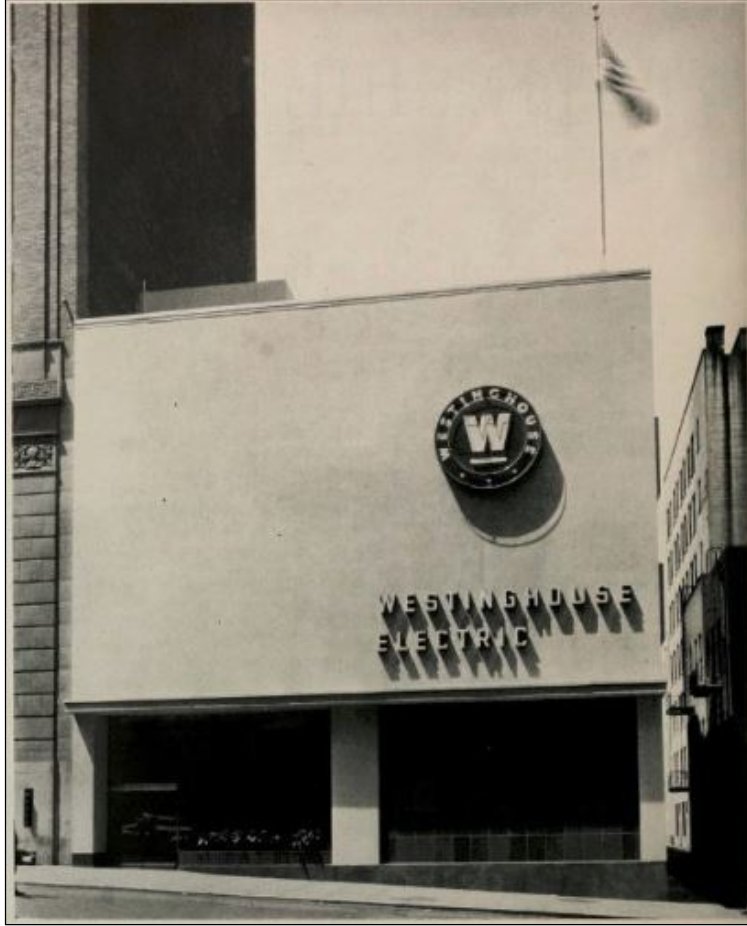
Figure 6. 410 Bush Street, as shown in *Architect and Engineer*, November 1949.

In the immediate postwar period, in 1946/1947, the St. George Garage was converted to office space by the Westinghouse Electric Company.² The early-twentieth-century appearance and features of the building were replaced, and the façade underwent a \$150,000, Mid-Century Modern make-over by San Francisco architect Albert F. Roller, in collaboration with contractors Barrett & Hilp.

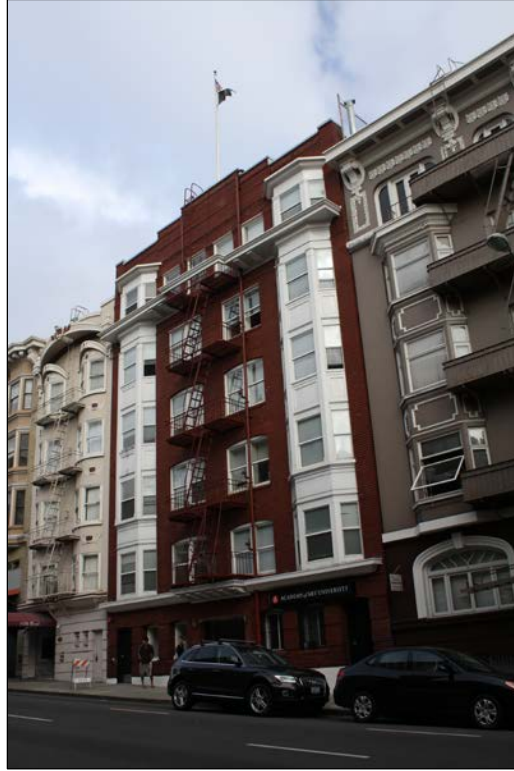
Figure 14. 1080 Bush Street, detail. (Source: SWCA)

The exterior walls exhibit decorative variations in brick patterning, including alternating rows of stretcher bond brick veneer punctuated with recessed rows of header bond. Arched window and door openings throughout the façade consist of header bond.

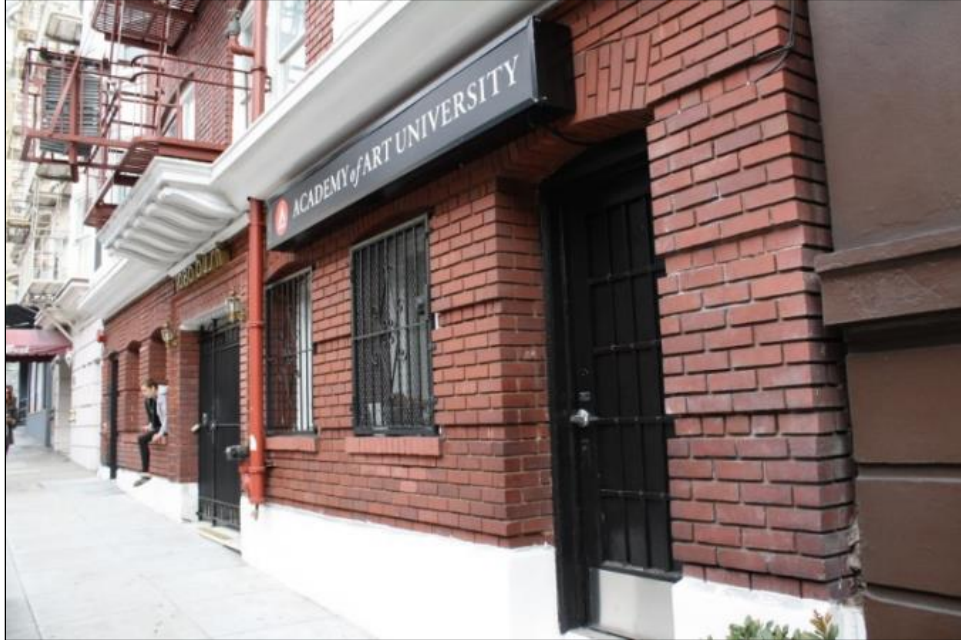
Fenestration generally consists of single-pane double-hung windows, as well as fixed and sliding windows. One original metal, paneled door is located on the first floor. Doors on the first floor and some windows feature segmental arched openings. Noncontributing metal security gates have been installed in front of the main entry and two of the first story windows.

Figure 15. 1080 Bush Street, detail, first story of the primary elevation. (Source: SWCA)

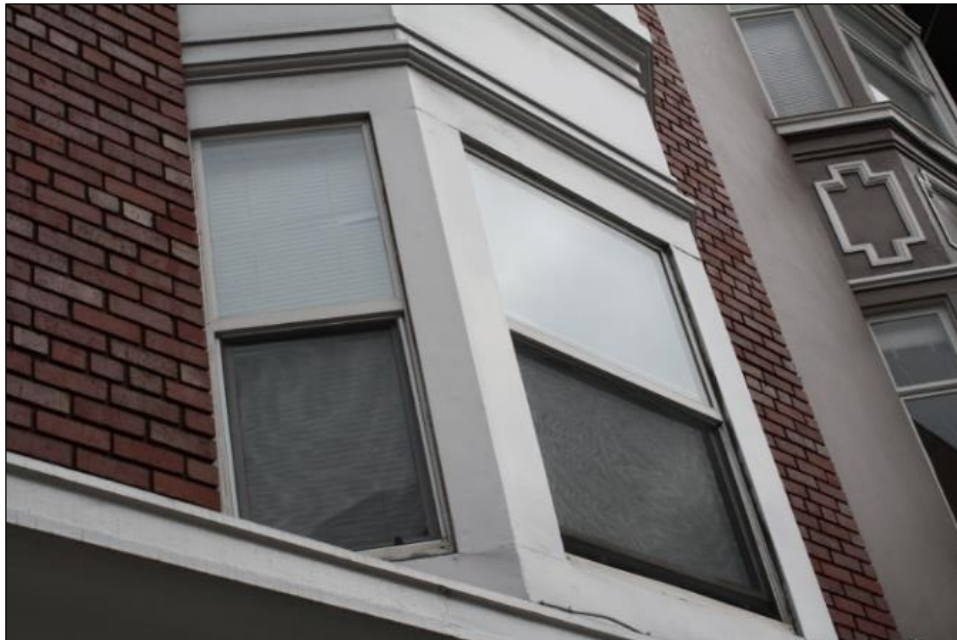
Figure 16. 1080 Bush Street, detail, projecting bay windows of the primary elevation. (Source: SWCA)

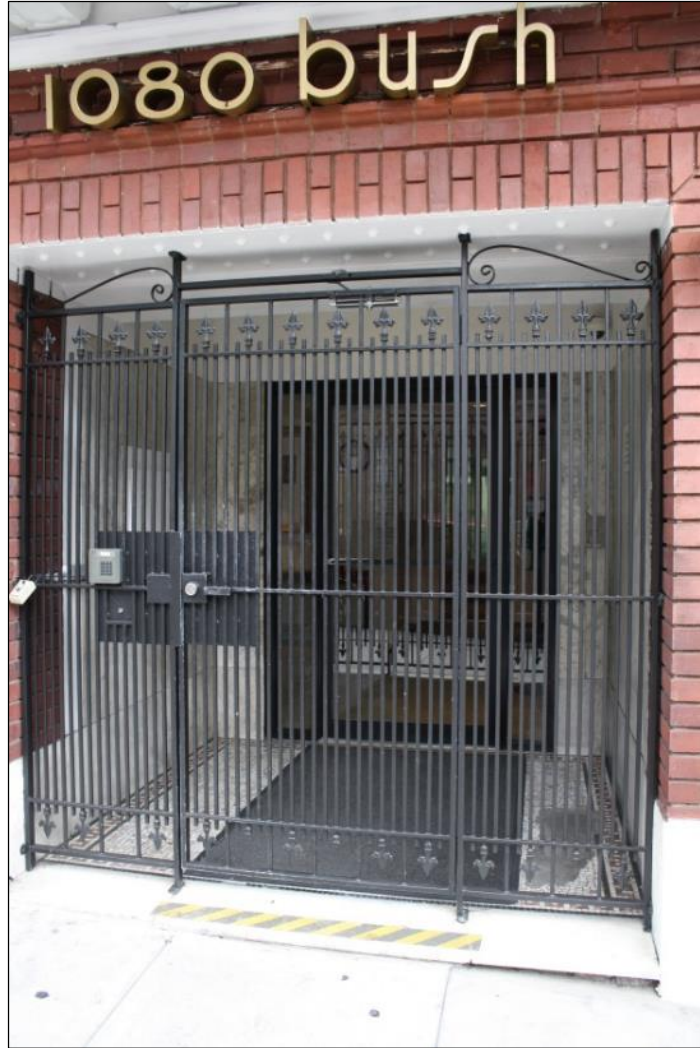
Figure 17. 1080 Bush Street, detail, main entry on the primary elevation. (Source: SWCA)

- Accordion-type drop ladder installed to fire escape in 1958 (Permit 210821)
- Primary door replaced by 1982 (SF Heritage Survey)
- Installation of dry standpipe with hose valves and roof manifold in 1997 (Permit 8916291)
- Windows replaced (vinyl) between 1989 and 1999 (AAU, Memo to SWCA, 2/2/2016)
- Modern light fixtures on ground level (AAU, Memo to SWCA, 2/2/2016)
- Security gates at main entry and bars on ground-level windows (AAU, Memo to SWCA, 2/2/2016)

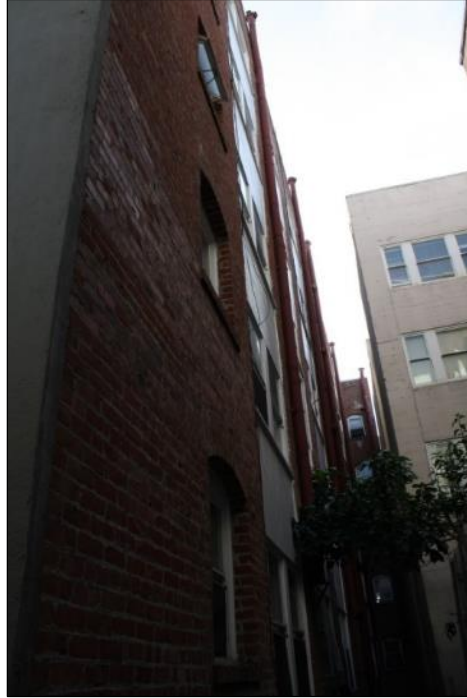
The secondary elevations are only visible from small pathways constructed alongside the building leading to a small unbuilt area at the rear of the property. Similar to the primary elevation, the east and west elevations feature stacks of windows with molded recessed panels spanning from the second to the sixth story. Smaller, single windows with segmental arched opening are also present.

Figure 18. 1080 Bush Street, northwest perspective of the eastern elevation. (Source: SWCA)

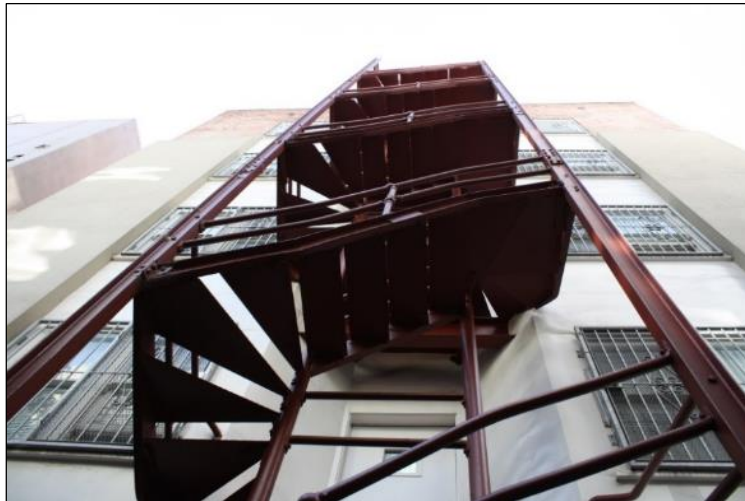
On the north (rear) elevation, each story displays a central single-door with a pair of windows on either side. A metal staircase extends from the façade. Metal and aluminum sliders, awning, vinyl double-hung, and wood double-hung windows are present on the secondary elevations in a variety of configurations. Various styles of metal security gates have been added over the first story windows on the east and west elevations and all windows on the north elevations.

Figure 19. 1080 Bush Street, southern perspective of the north elevation. (Source: SWCA)

- Replacement metal doors on north elevation; awaiting data (AAU, Memo to SWCA, 2/2/2016)
- Replacement windows (aluminum, vinyl sliders) on east and west elevations (AAU, Memo to SWCA, 2/2/2016)
- Security gates on north elevation and some ground-level windows on east and west elevations (AAU, Memo to SWCA, 2/2/2016)

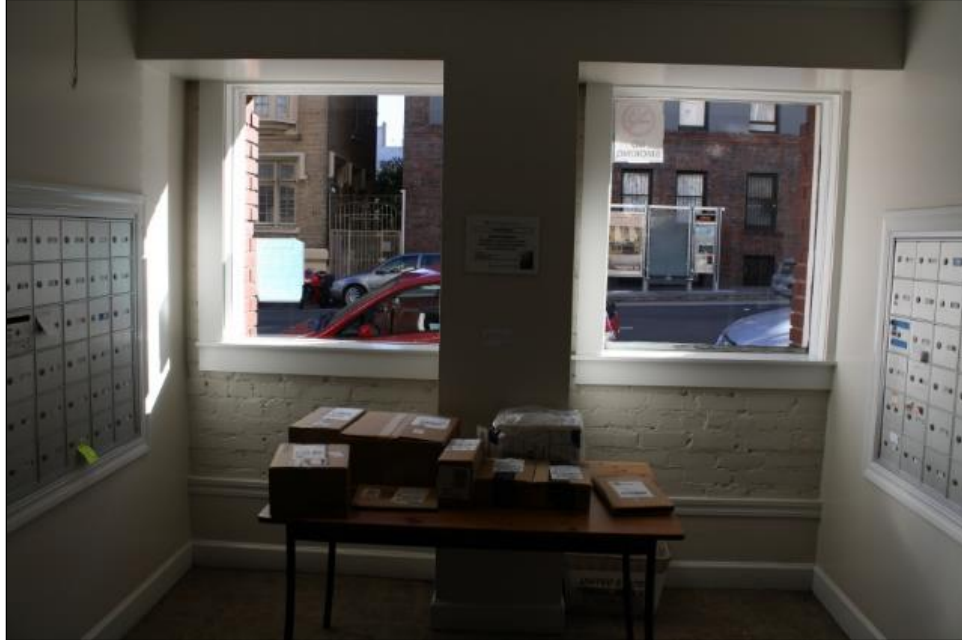
The main entry leads to a lobby with a small alcove immediately next to the main door for resident's mail boxes. As the lobby has been renovated since its original construction, the current finishes include laminate floors, sheetrock walls and ceiling, and recessed lighting. Visible under the fixed windows in the alcove is an area of exposed brick. An original Otis elevator is extant; however, the elevator doors have been replaced. The staircase from the lobby features a wood balustrade. The stairs and upper hallways have been carpeted and the doors replaced and trim replaced.

Figure 20. Interior lobby of subject property. (Source: SWCA)

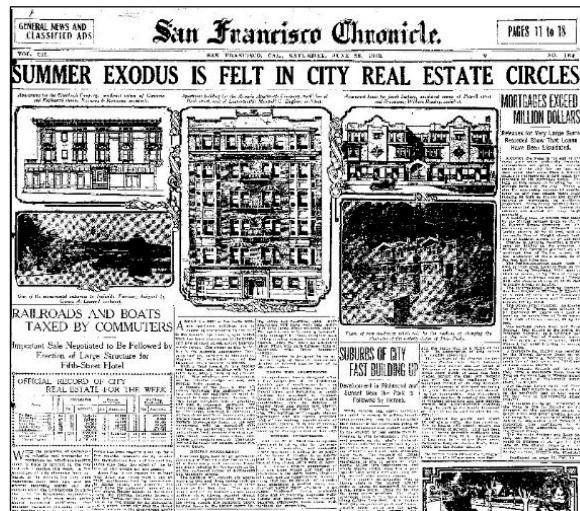
Figure 23. When it was constructed in 1913, the Ansonia Apartments (appearing in the center image) at 1080 Bush Street made the front page of the *San Francisco Chronicle*. On file with San Francisco Heritage.

While early photographs are not available, the 1913 illustration shows a basic window configuration of one-over-one double-hung windows through the two central bays. The two flanking rows of stacked bay windows appear to have had a similar configuration, of single-light, double-hung panes. The only window feature that appears on the 1913 image that is no longer extant (assuming it was constructed) was a multi-light transom centered on each bay window. All windows appear to have been replaced with vinyl windows between 1989 and 1999.

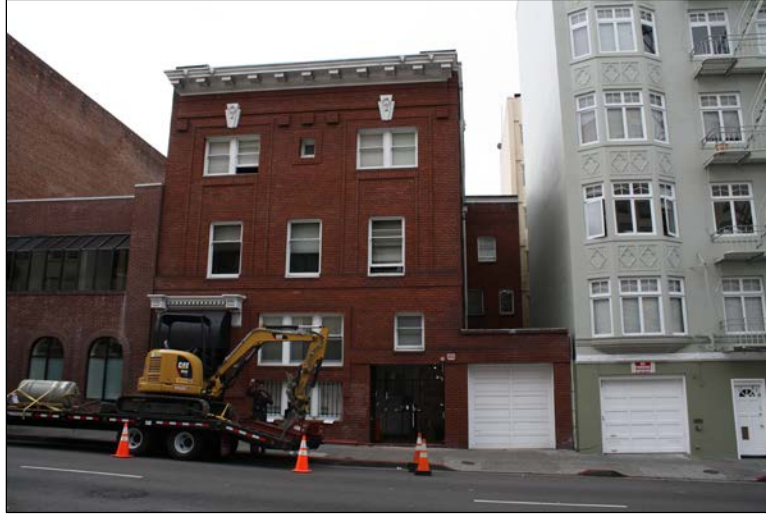
Originally serving as a doctor's office and multifamily residence, 1153 Bush Street is a three-story brick building constructed in 1911. The building is L-shaped in plan and capped with a flat roof, trimmed along the façade with a Classical Revival cornice with scrolled modillions and applied ornamental detailing. A one-story brick-clad garage occupies the western portion of the lot. The building is set flush to the sidewalk, with an open space at the rear of the property.

With its Classical Revival-inspired style, the building displays a symmetrical design composition and fenestration pattern. On the primary elevation, the focal point of the design is the first-floor entrance, which is marked by a recessed door framed beneath an elaborate entablature, accented with a dentil course and attached partial pilasters. The entrance consists of a wood door with a large glass panel and side lights. A second recessed entry to the basement is located on the western portion of the facade. While the ornamental program of the building is spare, aesthetic effect is achieved through the subtle variations in patterns and profile of the brick sheathing. Brick belt courses and a thin projecting row of bricks frame the window openings on the second and third stories. Serving a keystone-like accents above the third-story windows are two attached plaster emblems.

Figure 30. 1153 Bush Street. (Source: SWCA)

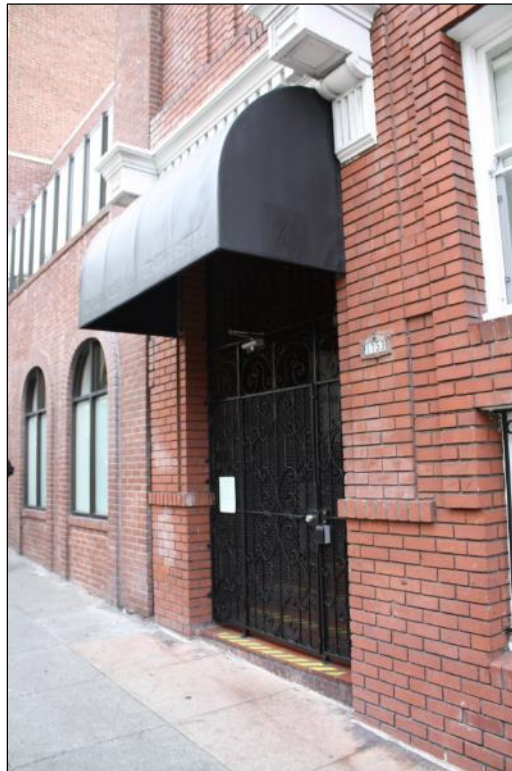
Fenestration generally consists of wood double-hung and fixed-pane windows, as well as vinyl double-hung windows. Security gates have been added in front of the doors and security bars in front of the basement windows.

Figure 31. 1153 Bush Street, primary entrance detail. (Source: SWCA)

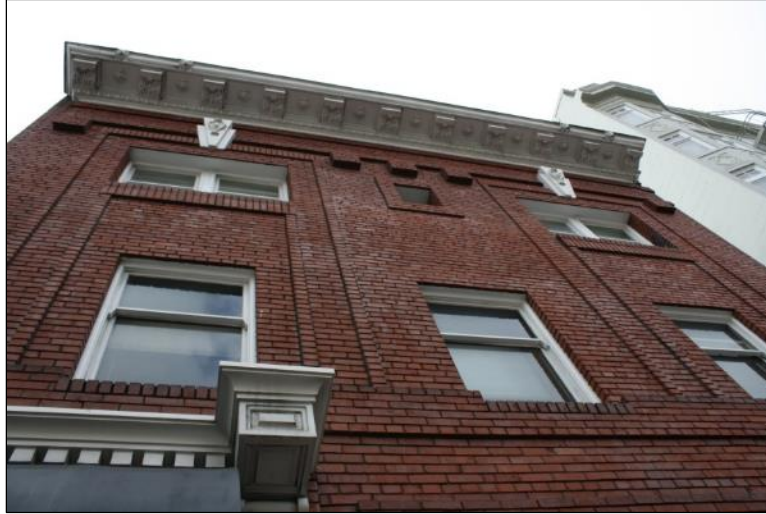
Figure 32. 1153 Bush Street, view from the sidewalk highlights the subtle aesthetic effect achieved through brick patterning. (Source: SWCA)

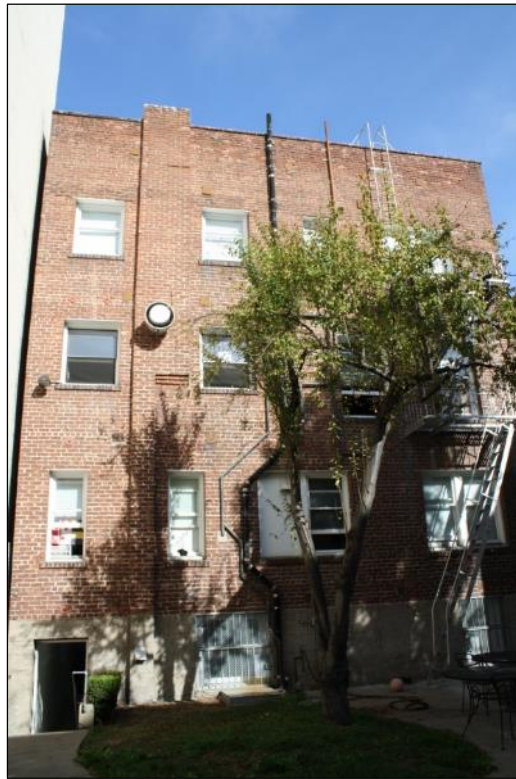
The secondary elevations feature a simplified cornice on the east and west elevations, and shallow brick copping at the eave line on the south elevation. Fenestration patterns on the side elevations mirror those of the façade, with symmetrically arranged, multi-light wood and vinyl double-hung and fixed windows. The building also exhibits stained-glass windows on the side elevation. Metal security bars have been installed over some of the basement windows.

Figure 33. 1153 Bush Street, northern perspective of the rear elevation and yard. (Source: SWCA)

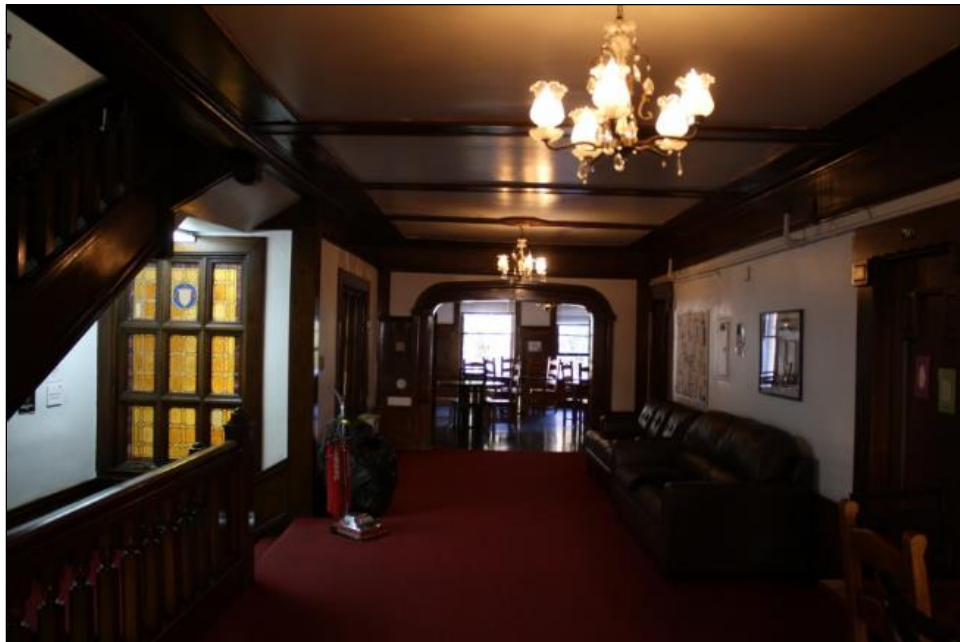
The main entry leads to a lobby, main staircase, and rooms with a number of original, character-defining features. An open dining room with an original paneled ceiling is located off the living room. Contributing interior features include wood door frames and trim, wood paneling and banister, original chandeliers, and an open wood fireplace. Carpet has been installed on the stairs and floors, and nonoriginal fluorescent lights have been added. While the room configuration appears to have been retained on the first floor, some of the upper-floor rooms have been reconfigured.

Figure 36. Interior of subject property, with contributing, character-defining interior spaces and features. (Source: SWCA)

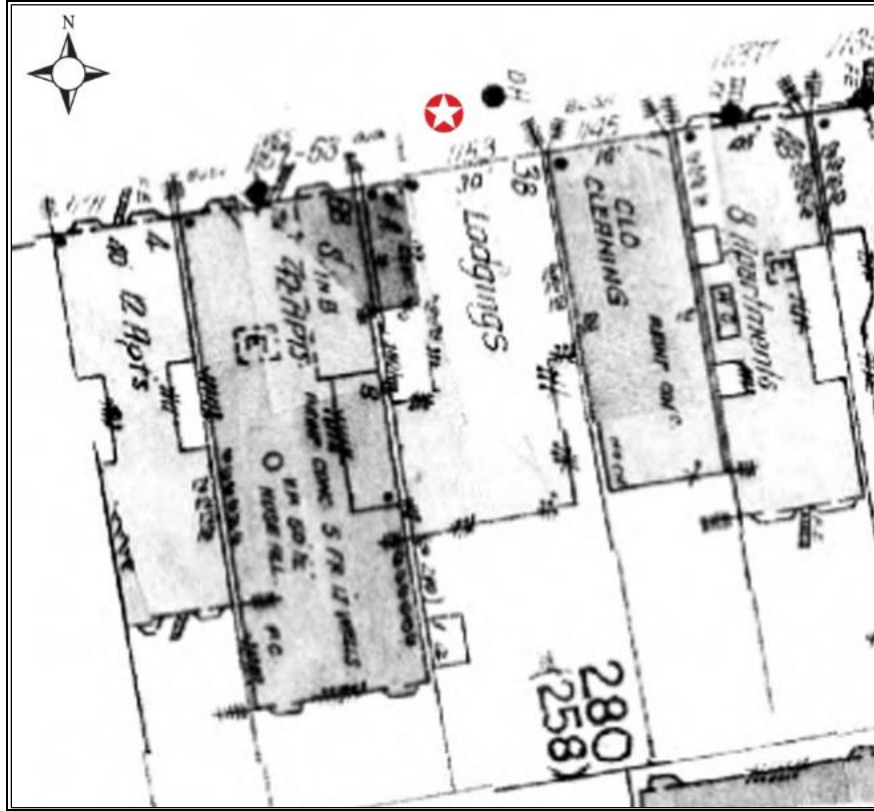
Figure 44. 1948 Sanborn Fire Insurance Map, 1153 Bush Street; by 1948, the Sanborn map indicated the building use as “lodgings.” (Source: Environmental Data Resources)

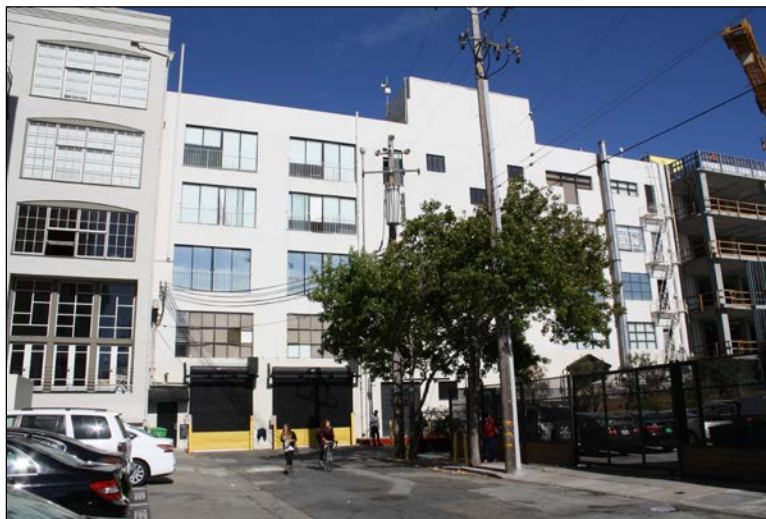
Constructed between 1910 and 1912, 58-60 Federal Street was commissioned by the Rincon Warehouse Company. The warehouse is five stories in height and rectangular in plan, with steel-reinforced concrete construction. The property is built out to fill the lot and set flush with the sidewalk.

Utilitarian in design, the building is capped with a flat roof, terminating in a shallow copping along the sixth story. Centered atop the fifth story of the property is a one-story sixth floor. The façade is characterized by an asymmetrical, purpose-driven design, with little evident or extant ornamental detailing on the exterior.

Figure 47. 58-60 Federal Street. (Source: SWCA)

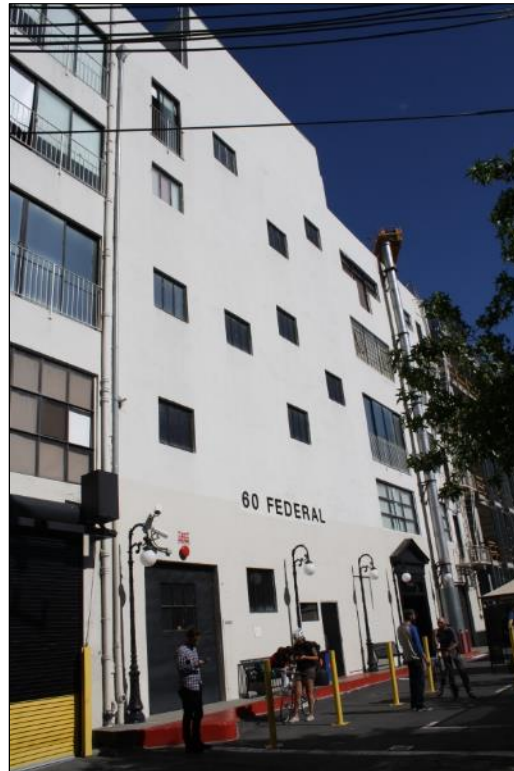
On the primary elevation, the entrance consists of paired glass doors with a single-light transom, deeply recessed within the wall plane. Framing the entrance portico is a Classical Revival-inspired pediment and door surround. (The main entrance, currently located in the north portion of the façade, was originally centered on the façade.) On the primary elevation, access is provided through a series of roll-up doors of various sizes, as well as single and paired doors with simple wood frames. Fenestration consists of a variety of window configurations and types, with multi-light, fixed, and casement steel-frame windows.

Figure 48. 58-60 Federal Street, primary elevation; the original location of the main entrance (now located further south on the façade) was below the lettering reading “60 Federal.” (Source: SWCA)

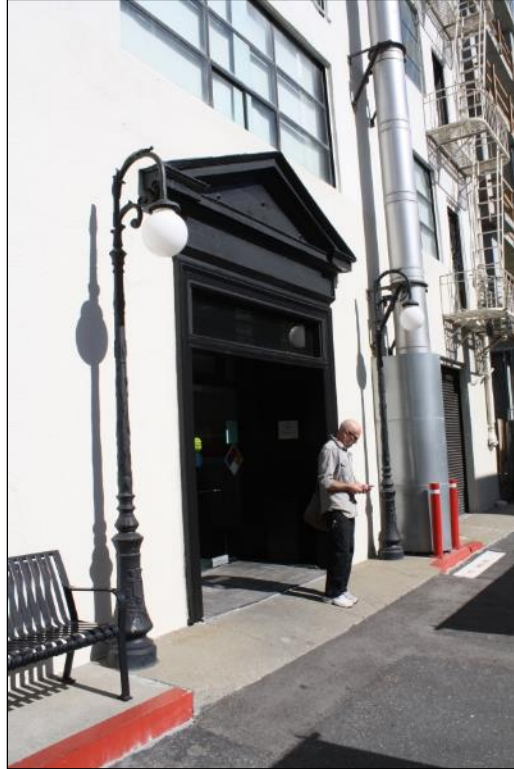
Figure 49. 58-60 Federal Street, detail, main entrance, primary elevation (Source: SWCA)

Should it be shown that AAU removed original materials at the main entry, it is recommended that extant noncontributing door be replaced with a door matching the original in size, shape, materials, and overall configuration. Design of replacement of the door shall be based on evidence (historic photos, extant historic windows) rather than conjecture.

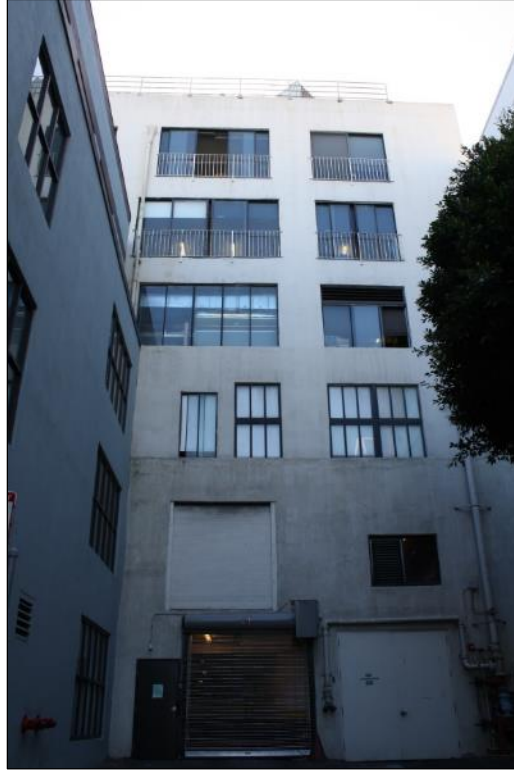
As with the primary elevation, the northeast elevation exhibits a series of roll-up doors on the first and second stories. Fenestration consists of varying window types, including steel-frame multi-light, fixed, casement, and sliding windows. On the northwest elevation, the overall pattern of window openings is asymmetrical and program-driven. Metal railings have been added in front of some of the larger sliding windows.

Figure 50. 58-60 Federal Street, southwestern perspective of the northeastern elevation. (Source: SWCA)

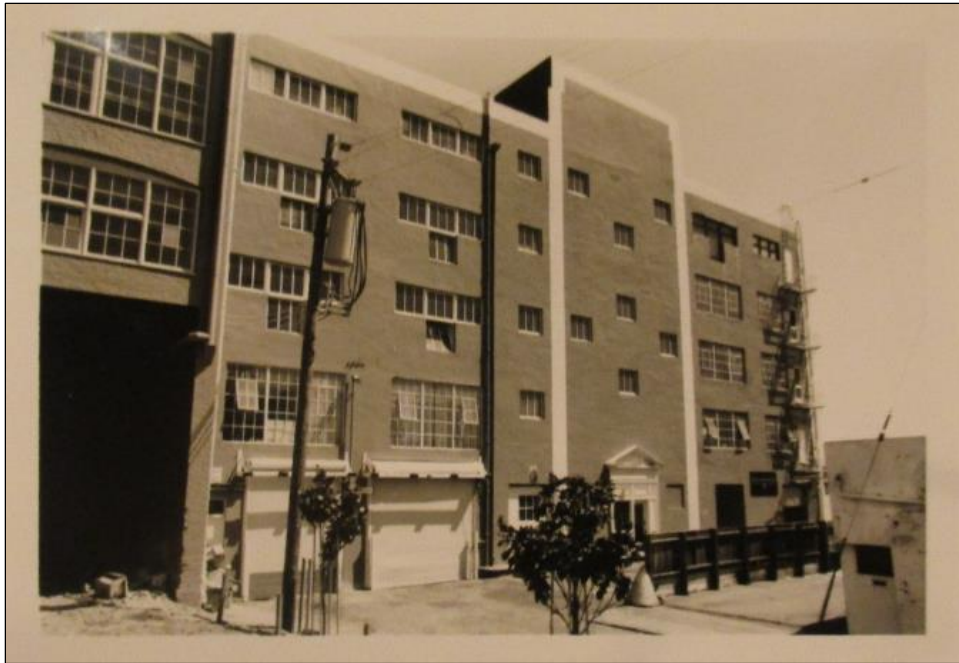
Figure 51. June 1980 field survey photo, 58-60 Federal Street. Shows the original location and configuration of entrance. (Source: San Francisco Heritage)

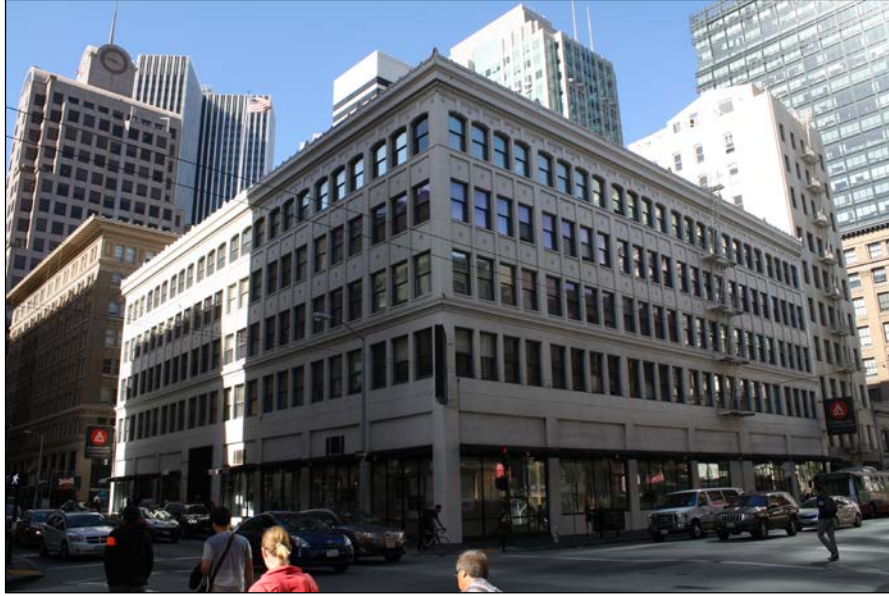
Exhibiting a Renaissance Revival-influenced style, 77-79 New Montgomery Street is a five-story commercial building in the Article 11-designated New Montgomery-Mission-Second Street Conservation District. Spanning eight bays on New Montgomery Street and six on Mission Street, the building displays a symmetrical design composition, with continuous bands of windows, separated by recessed spandrel panels accented with applied ornament. The building is nearly square in plan and set flush to the sidewalk, on a flat lot. The primary elevation faces New Montgomery Street, with secondary elevations fronting Mission Street and Jesse Street. The building is capped with a flat roof, terminating in a stepped cornice.

Figure 58. 77-79 New Montgomery Street. (Source: SWCA)

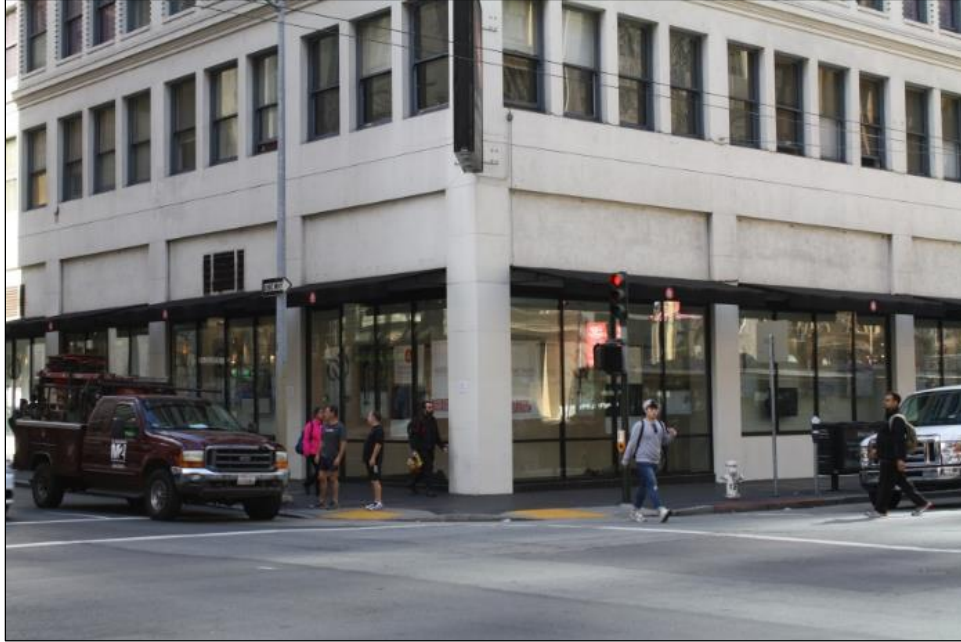
Flanking the main entry are large storefront windows, sheltered beneath slim projecting awnings. Dividing the second and third floors is a prominent belt course, which appears to mark the original 1913 construction of the first two stories, with the upper three stories added in 1920. Encircling the building are wood double-hung windows, slightly recessed in the wall plane. The fourth story windows are articulated with segmental arched openings and keystone accents. The secondary elevations are virtually identical to the primary elevation, with the exception of in-filled openings and a roll-up door installed on the eastern portion of the lot, on Jesse Street.

Figure 59. 77-79 New Montgomery Street, detail, storefronts on the first story. (Source: SWCA)

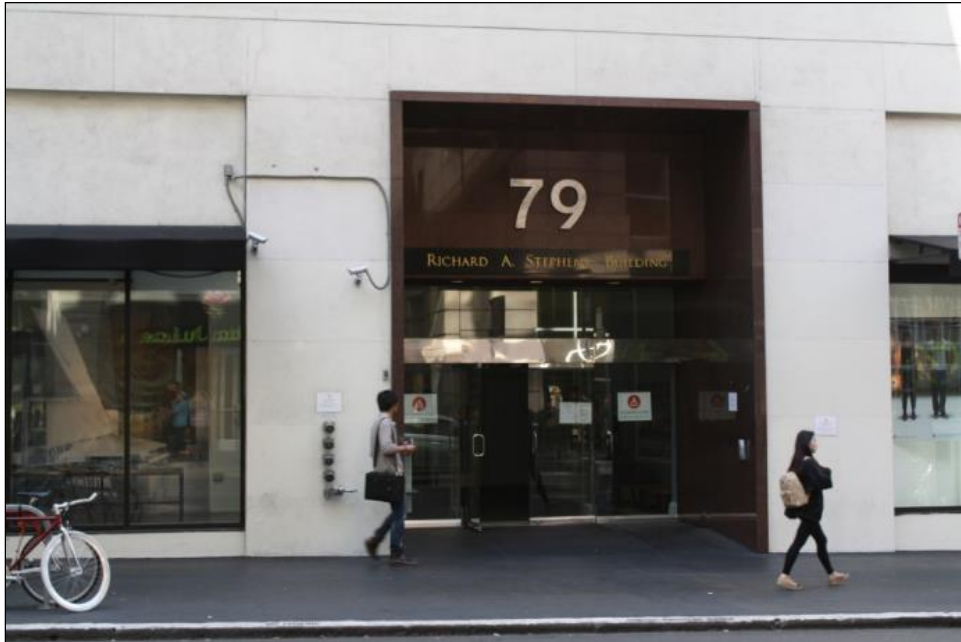
On the primary (New Montgomery Street) elevation, the first floor features a deeply recessed main entry, trimmed with marble walls and flooring and unadorned, paired glass doors and transom windows, set flush with the floor. This entrance represents a 1960 remodel carried out by renowned San Francisco architect Gardner A. Dailey for Allied Properties. (In a career spanning over 40 years, from the 1920s until his death in 1967, Dailey designed and completed numerous celebrated and award-winning commissions throughout the Bay Area.)

Figure 60. 77-79 New Montgomery Street, detail, principal entrance. This entrance represents a 1960 remodel carried out by renowned San Francisco architect Gardner A. Dailey for Allied Properties. (Source: SWCA)

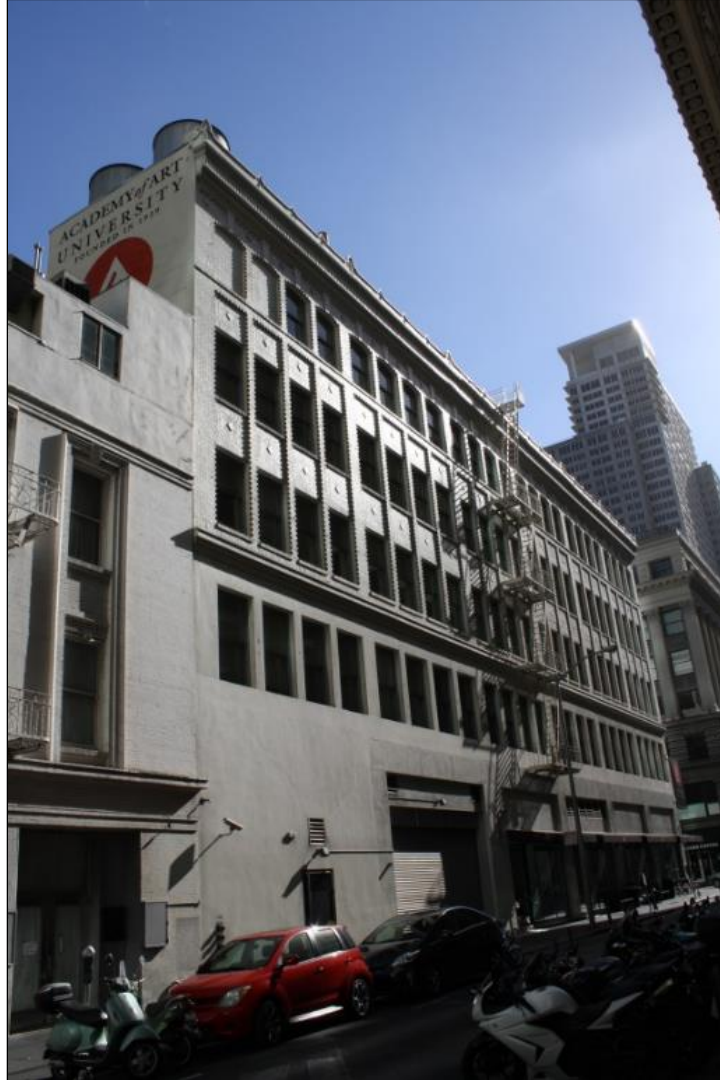
Figure 61. 77-79 New Montgomery Street, secondary elevation along Jesse Street. (Source: SWCA)

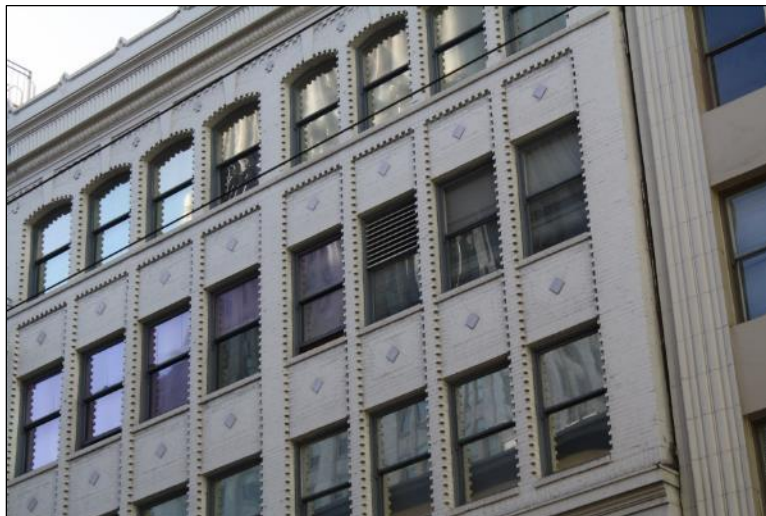
Figure 62. 77-79 New Montgomery Street, detail, window and spandrel ornament. (Source: SWCA)

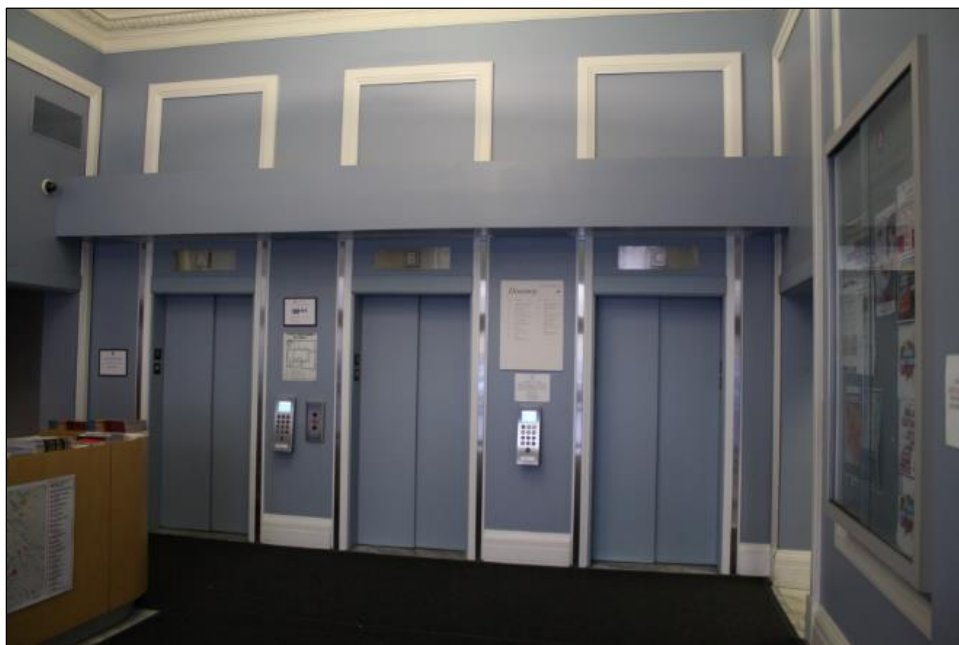
The entrance leads to a rectangular lobby with a marble floor. Three elevator bays stand opposite the main entry; the elevators appear to date to the Dailey remodel in 1960. The lobby appears to retain features from both the original interior as well as subsequent remodeling, with updated features combined with remnants of the original lobby, including a chandelier, intact crown molding, and Classic Revival-inspired decorative features.

Figure 63. Interior lobby of subject property. (Source: SWCA)

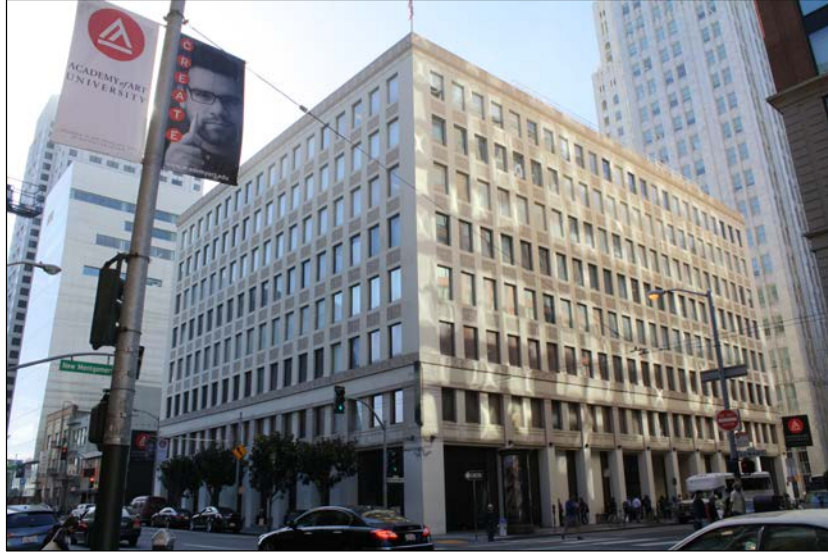
Constructed as a mid-rise office building in 1920, 180 New Montgomery is rectangular in plan and set flush to the sidewalk. The primary elevation, which spans 11 bays, faces New Montgomery Street. Secondary elevations front Howard Street (with eight bays), Natoma Street (nine bays), and a small service lot adjacent to Howard Street. The building displays a Renaissance/Classical Revival-influenced style, the building has a symmetrical design composition, with bands of windows defining the horizontal axis, and bold corner piers marking the vertical axis. The building is capped with a flat roof, terminating in a terra cotta cornice, accented with decorative panels.

Figure 73. 180 New Montgomery Street. (Source: SWCA)

On the primary elevation, the oversized ground-story displays a recessed main entry with terrazzo sheathing on the floor and walls. Former large storefront windows, separated by columns, have been in-filled or the extant glass overpainted. Above the first floor, parallel bands of rectangular fixed windows are separated by ornamental terra cotta spandrel panels.

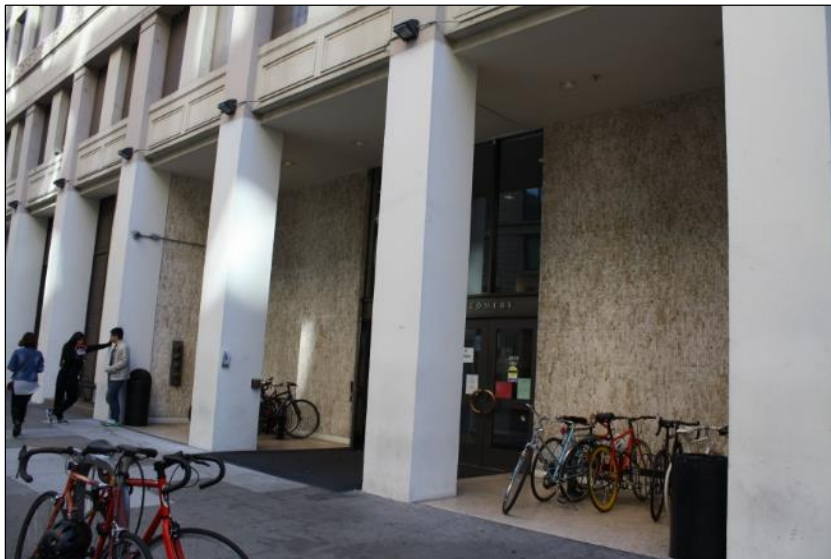
Figure 74. 180 New Montgomery Street, detail, main entry of the primary elevation. (Source: SWCA)

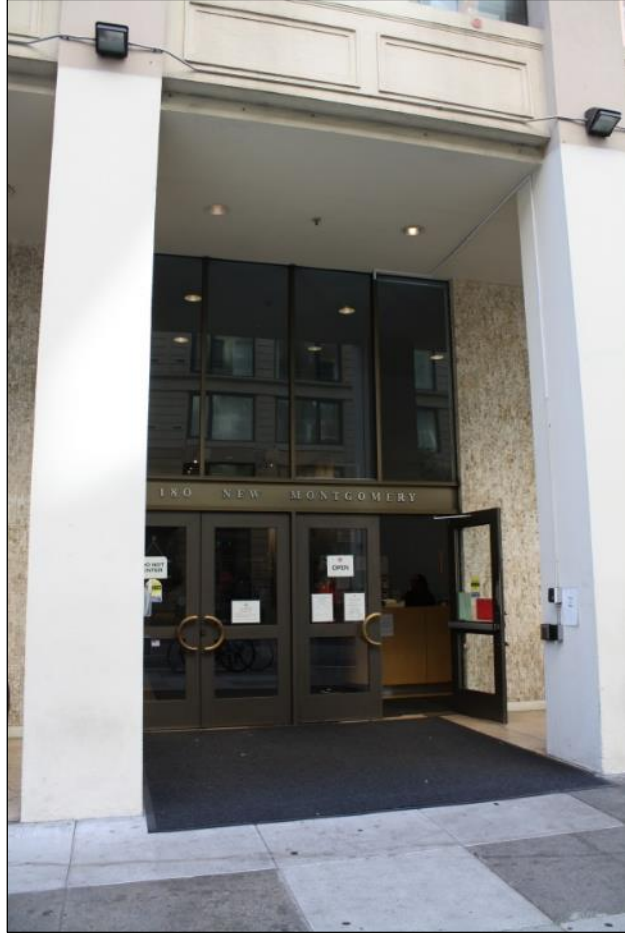
Figure 75. 180 New Montgomery Street, detail, main entry on the primary elevation. (Source: SWCA)

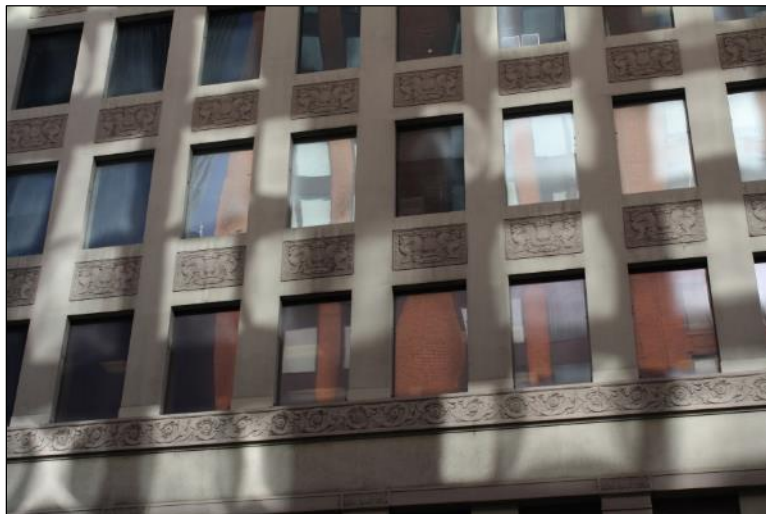
Figure 76. 180 New Montgomery Street, detail, windows and terra cotta spandrel panels. (Source: SWCA)
