APPENDIX HR:
Historic Resource Evaluations

Overview of Historical Resources Review and Findings

410 BUSH STREET (ES-26)

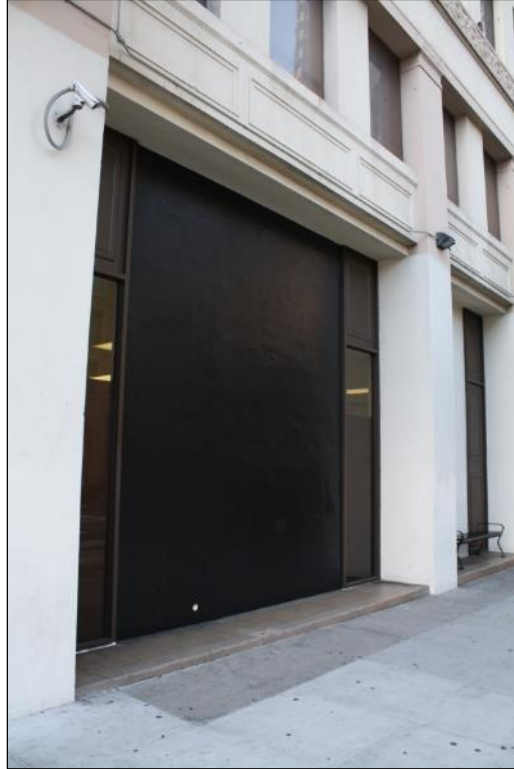
Figure 77. 180 New Montgomery Street, detail, in-filled storefronts on the primary elevation. (Source: SWCA)

On the secondary elevations, fenestration patterns match those of the primary elevation. Along Howard Street, all windows are fixed. Natoma Street elevation retains its original steel-frame casement windows. The ground-floor storefront windows along Howard and Natoma Street have either been in-filled or overpainted/covered. No fenestration is located on the southwest elevation; however a stair tower has been added.

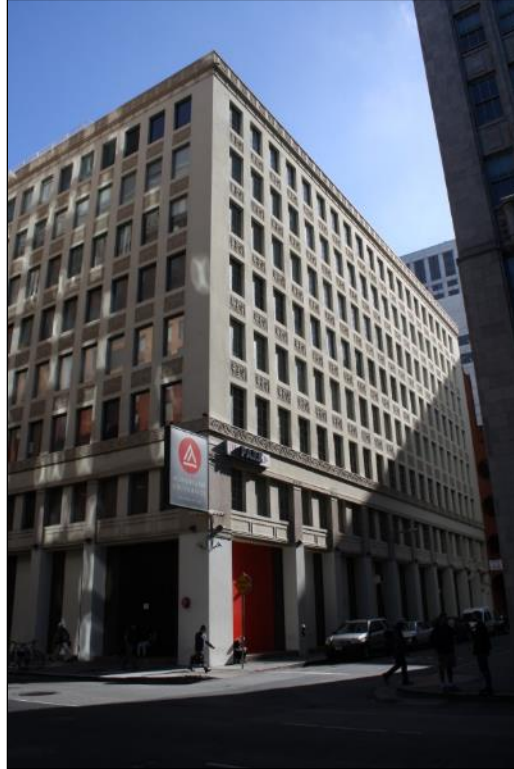
Figure 78. 180 New Montgomery Street, southeast perspective of the northwestern elevation. (Source: SWCA)

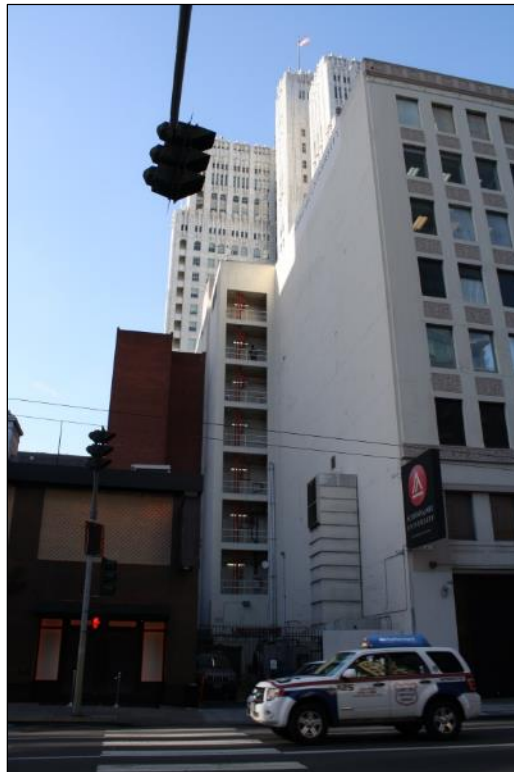
Figure 79. 180 New Montgomery Street, northwestern perspective of the southwest elevation. (Source: SWCA)

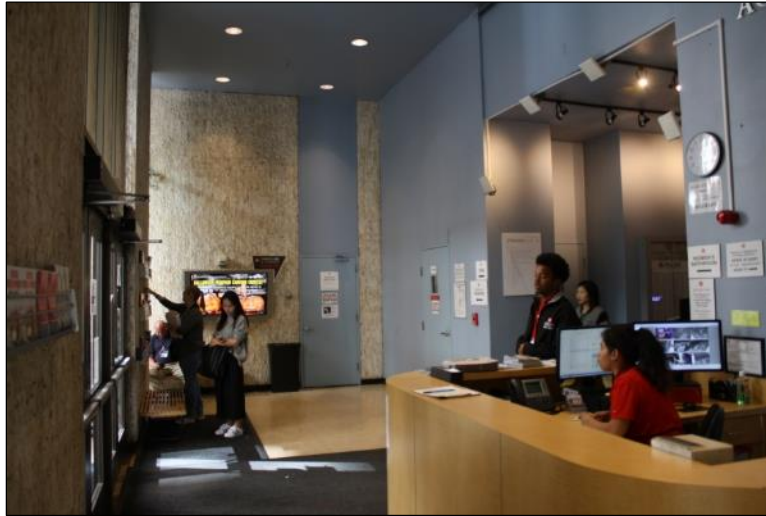
The main entry leads to a T-shaped lobby featuring Terrazzo flooring and walls. The rectangular lobby sections provide access to an enclosed main stair and a bank of elevators at the rear of the lobby.

Figure 80. Interior lobby of subject property. (Source: SWCA)

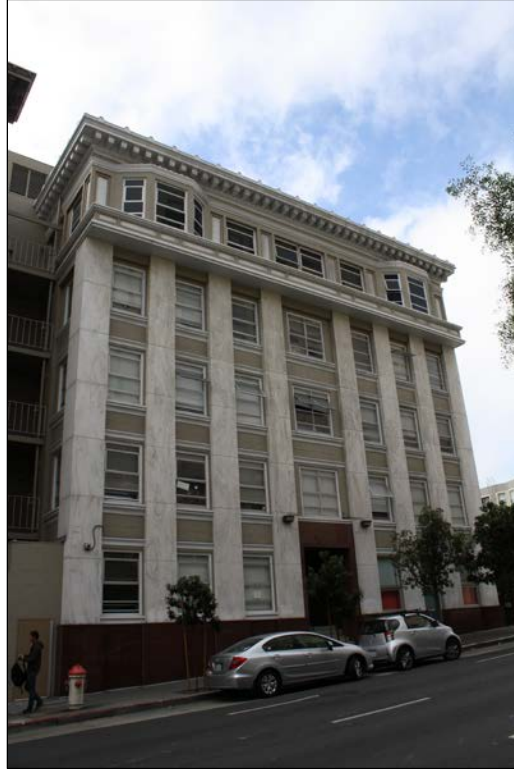
Figure 91. 1055 Pine Street. (Source: SWCA)

The first floor on the primary elevation displays a ground-level polished red granite base (a nonoriginal material) and a recessed main entry with a polished red granite surround (also nonoriginal). Fenestration consists of bands of aluminum-frame awning casement windows. Each window has a clearly defined sill and lintel. The fifth story is delineated by a decorative projecting band below and cornice above. A series of aluminum-frame awning-casements, flanked by two bay windows, extend across the fifth story. A fire stair has been added to the eastern corner of the elevation with two personnel doors leading to the sidewalk. A rolling metal gate has been installed in front of the driveway on the western side of the lot.

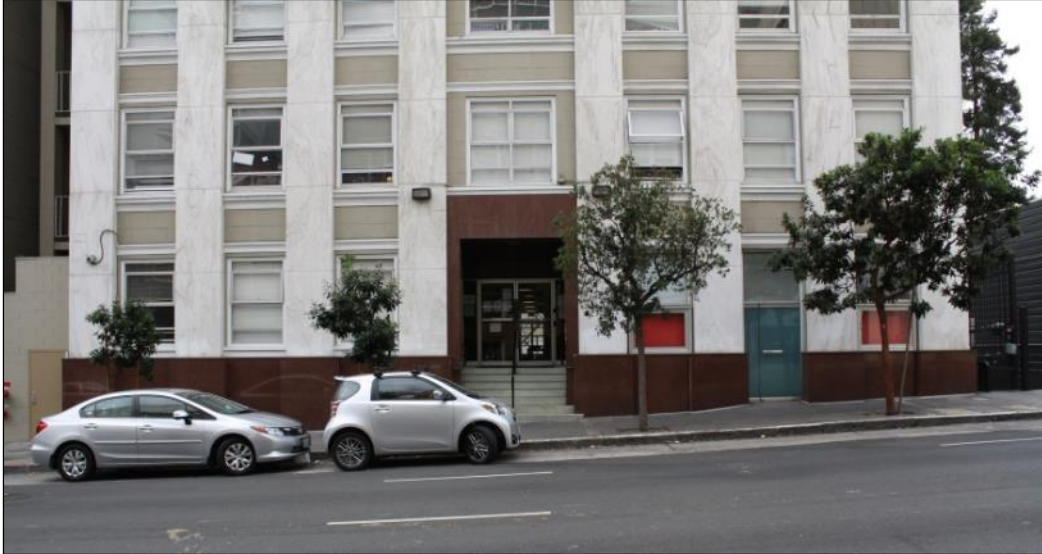
The full-length marble piers spanning the building, as well as the red polished granite and marble at the building foundation and entrance, represent alterations to the original design. In addition, the original wood windows were removed and replaced in 1966, in work overseen by San Francisco architect George Adrian Applegarth. (A Bay Area native born in Oakland in 1875, Applegarth was a long-time resident and practitioner in San Francisco. He designed numerous commissions throughout San Francisco during his long career, including residential, commercial, and institutional designs.)

Figure 92. 1055 Pine Street, detail, first and second floors of the primary elevation. The full-length marble piers spanning the building, as well as the red polished granite and marble at the building foundation and entrance, represent alterations to the original design. (Source: SWCA)

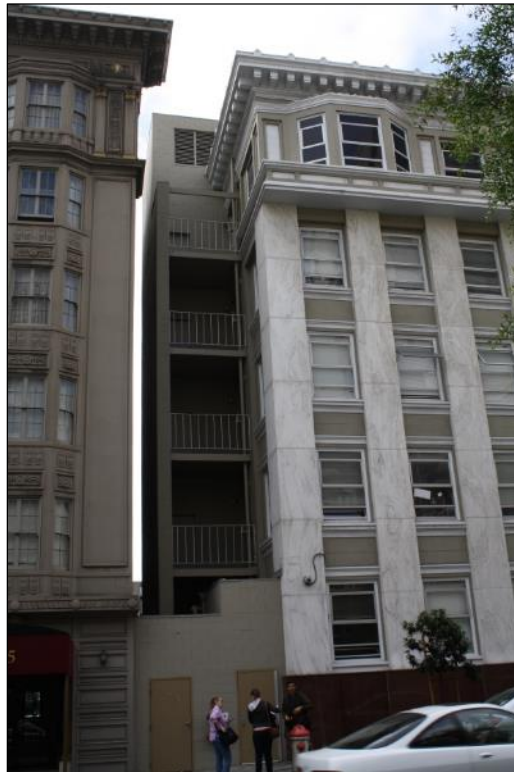
Figure 93. 1055 Pine Street, detail, fire stair case addition on the primary elevation. (Source: SWCA)

| DATE | PERMIT NUMBER | OWNER | ARCHITECT | COST | DESCRIPTION |
|---|---|---|---|---|--|
| Mar. 5, 1982 | 8201667 (492861) | St. Anthony Foundation | John G. Minton | \$350,000 | Alterations to 1 st and 5 th floors to add sleeping rooms. Install new smoke-proof tower stairway. |

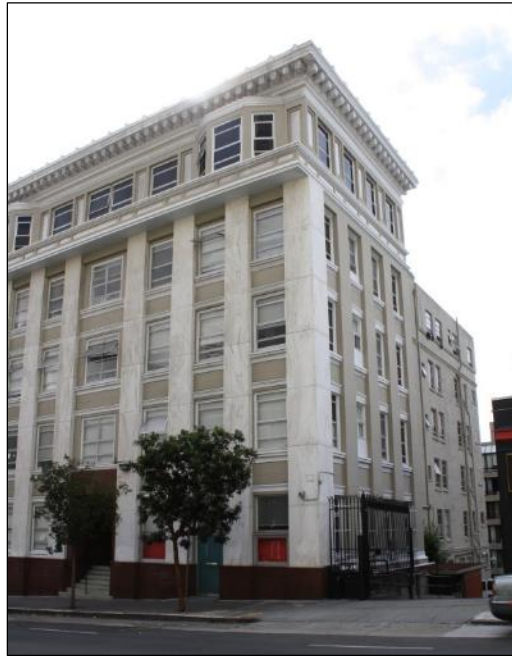
The treatment of the façade is mirrored on the east and west elevations, in terms of materials and fenestration patterns. Toward the south, the building extends in a stepped-in wing with aluminum-framed awning casements. Side elevations reveal areas with board-form concrete, covered in stucco. The south and rear elevations have two sets of stacked bay windows with a central door on each floor, connected by a fire

Figure 94. 1055 Pine Street, view of the primary and stepped-in western elevations. (Source: SWCA)

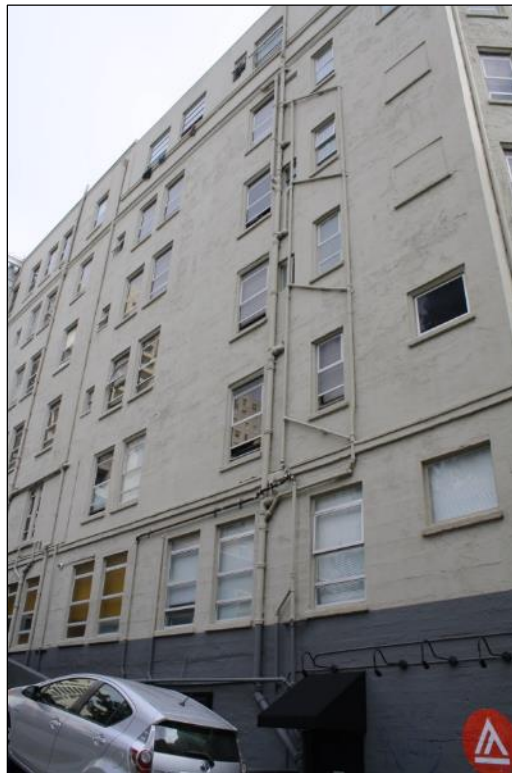
Figure 95. 1055 Pine Street, northeast perspective, west elevation. (Source: SWCA)

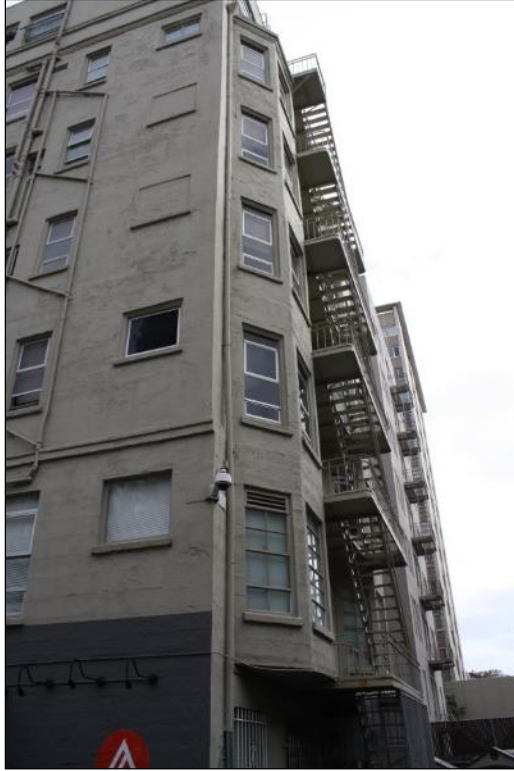
Figure 96. 1055 Pine Street, northeastern perspective, southwest corner. (Source: SWCA)

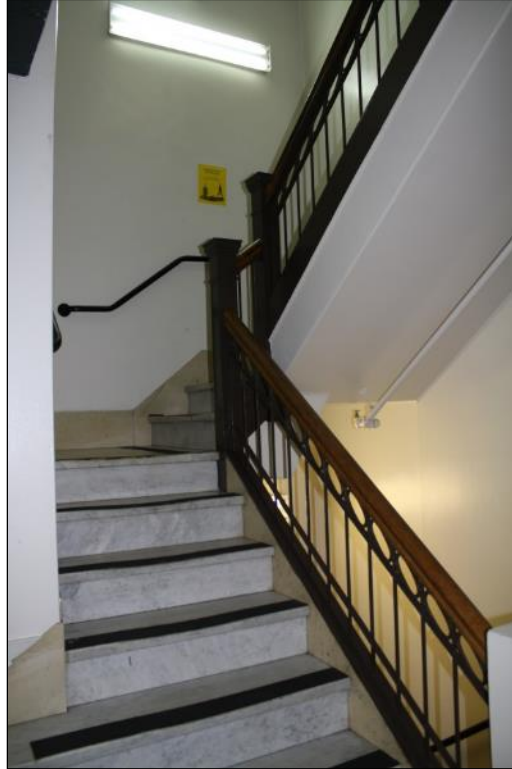
Numerous alterations have occurred throughout the interior of the building. Original features remaining on the interior include the marble staircase with metal banister and wood hand rail. On the upper floors, fluorescent lights, tile floors, and new doors have been installed.

Figure 97. Interior view of the stair of subject property. (Source: SWCA)

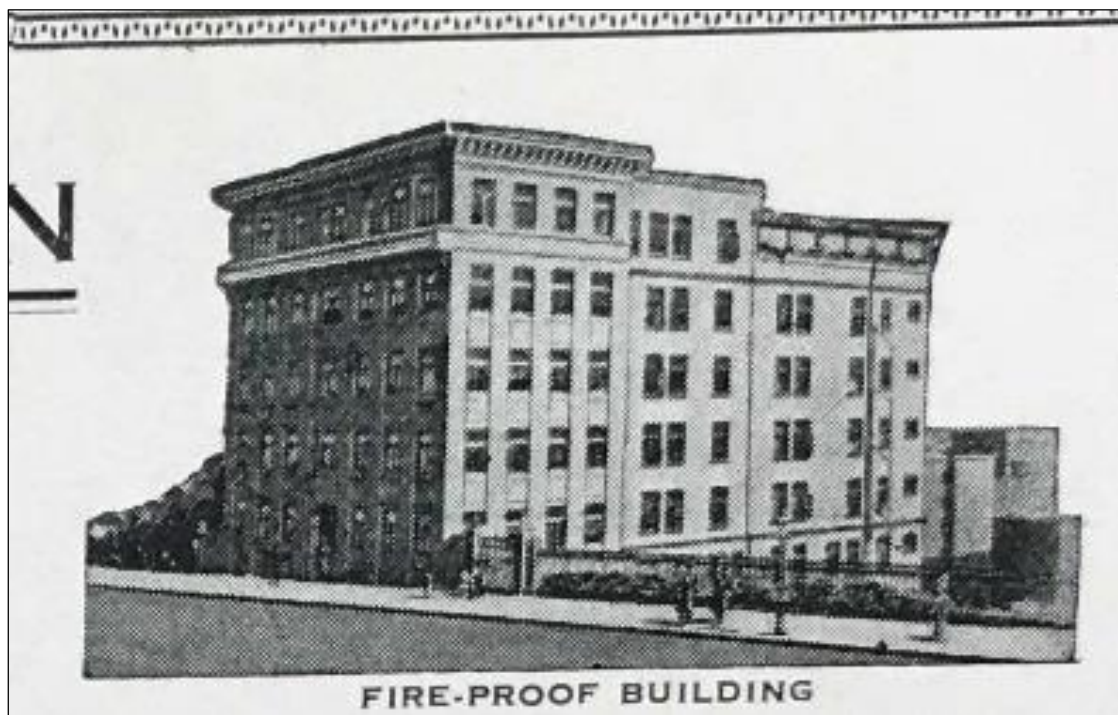
Figure 100. This close-up shows the general character (including a clearly articulated two-part vertical design) of the original building, as compared with the extant façade. Source: *Polk’s Crocker-Langley San Francisco City Directory*, 1925 (San Francisco, CA: R.L. Polk and Company).

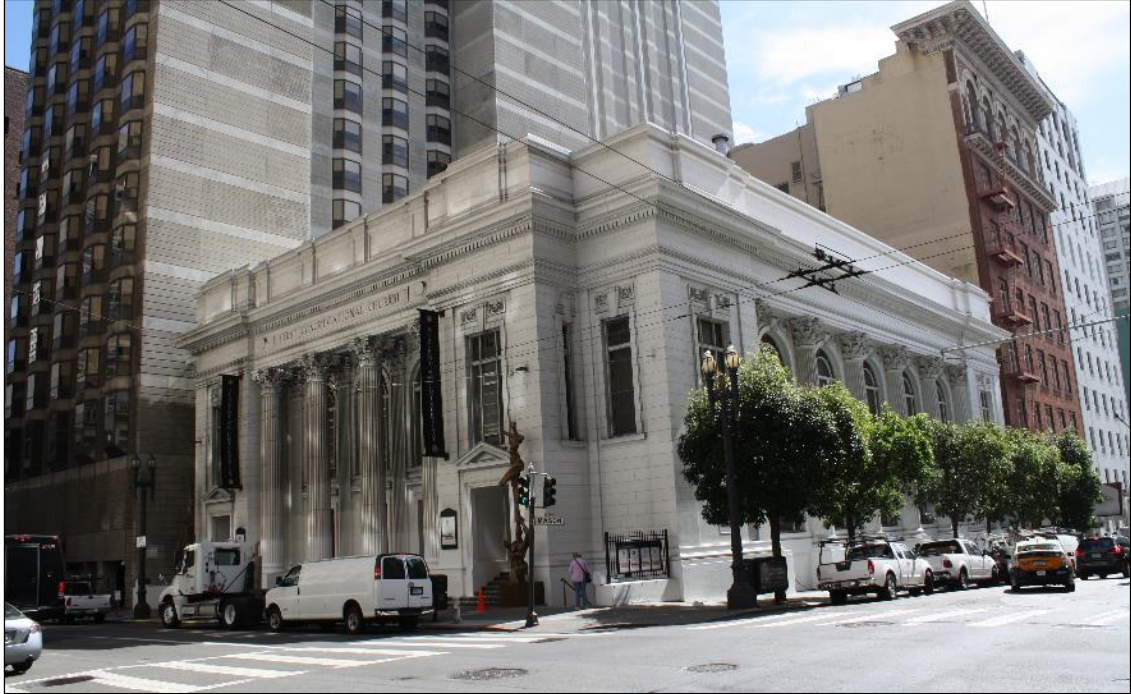
Made of steel-reinforced concrete with terra cotta ornament, the building displays a monumental scale and symmetrical design composition. The primary entrance faces Post Street, with the secondary elevation extending southward along Mason Street. The focal point of the design is a series of giant order Corinthian columns on the facade, fluted and clad in terra cotta. The Mason Street elevation is defined by arched, deeply recessed window openings, separated by giant order attached Corinthian columns. Along the roof line, a bold, stepped cornice line defines the horizontal axis and balances the overall design.

Figure 107. 491 Post Street, northwest perspective. (Source: SWCA)

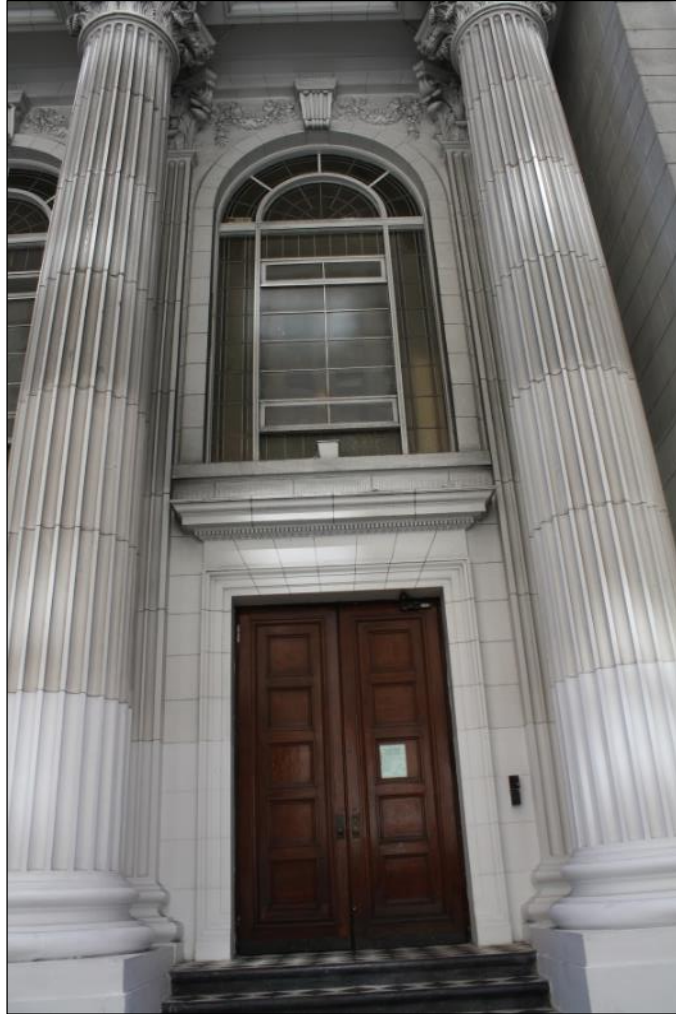
On Post Street, the main entrance consists of a recessed entry portico, accessed via a broad stairway. Five bays span the façade, with paired, wood-paneled doors on the ground floor and large multi-light windows recessed within arched, decorative openings on the second floor. Two entrances are sheltered beneath triangular pediments, and the other three are framed beneath lintels. In addition to the giant order Corinthian columns, ornament on the façade includes attached, fluted pilasters, keystones, and other applied ornament. Windows are generally multi-light stained glass windows with aluminum awning inserts. The congregation name appears in scored concrete above the three center doors. On either side of the primary elevation, paired metal doors lead to the basement level.

Figure 109. 491 Post Street, detail, main entrance. (Source: SWCA)

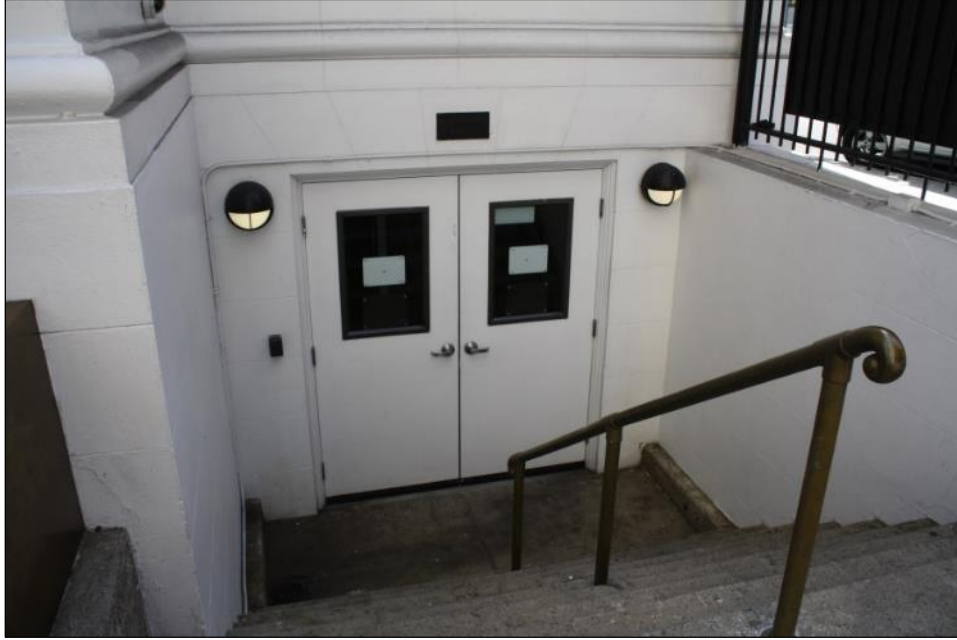
Figure 111. 491 Post Street, detail, doors to the basement on the primary elevation. (Source: SWCA)

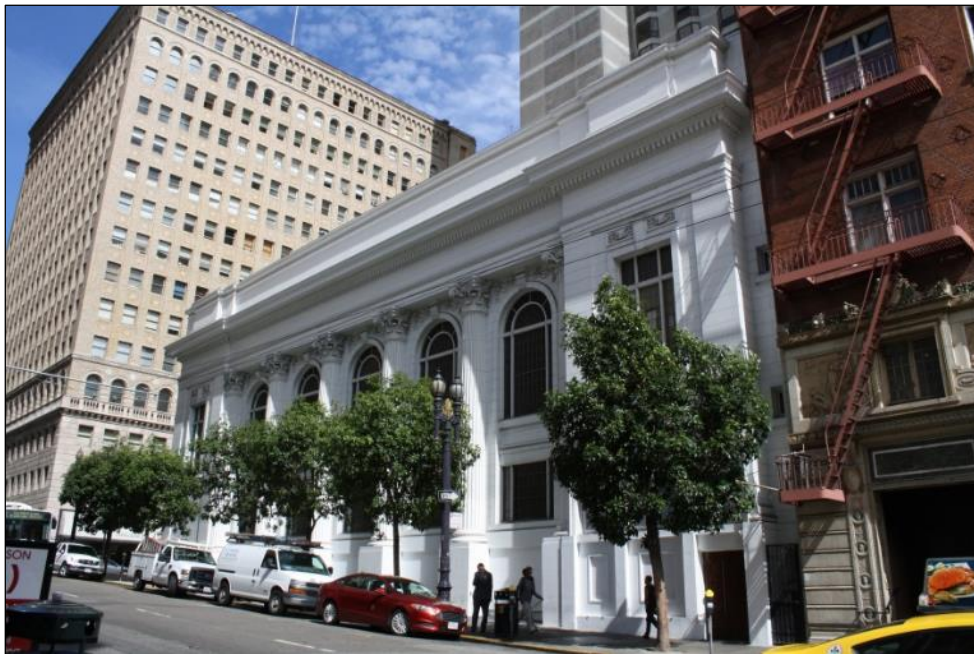
The secondary elevation along Mason Street mirrors the design of the primary elevation, including the use of rectangular and Palladian-style windows accented with decorative keystones. Paired wood doors with a hopper casement transom are located at the southernmost corner of the Mason Street elevation.

Figure 112. 491 Post Street, northeast perspective of the western elevation. (Source: SWCA)

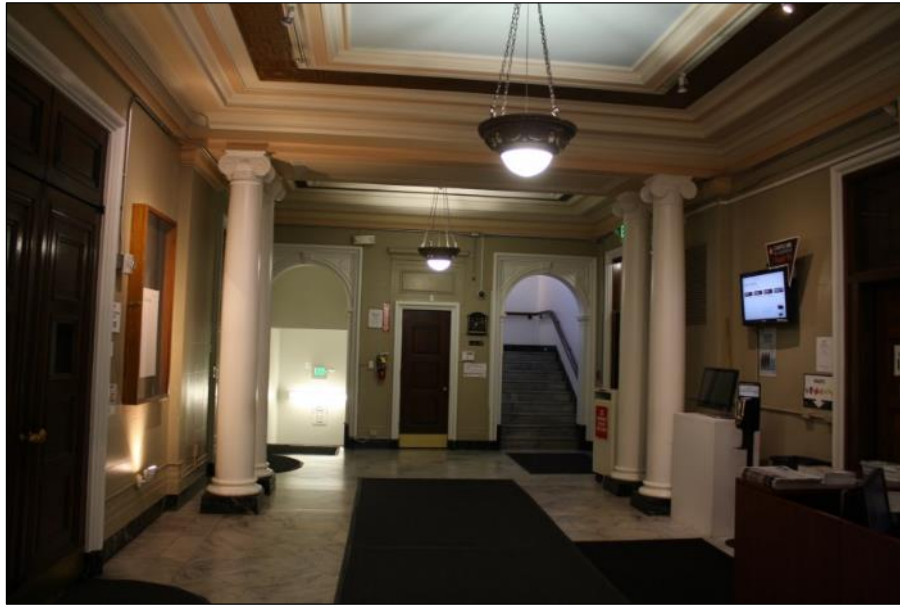
The main entrance leads to a rectangular narthex. Marble stairs at the western and eastern end of the narthex lead to the basement and to the second floor balcony. Large wood double-doors lead to the nave, which remains intact with the exception of the stage area. The interiors of the narthex and nave are highly intact.

Figure 113. Interior narthex of subject property. (Source: SWCA)

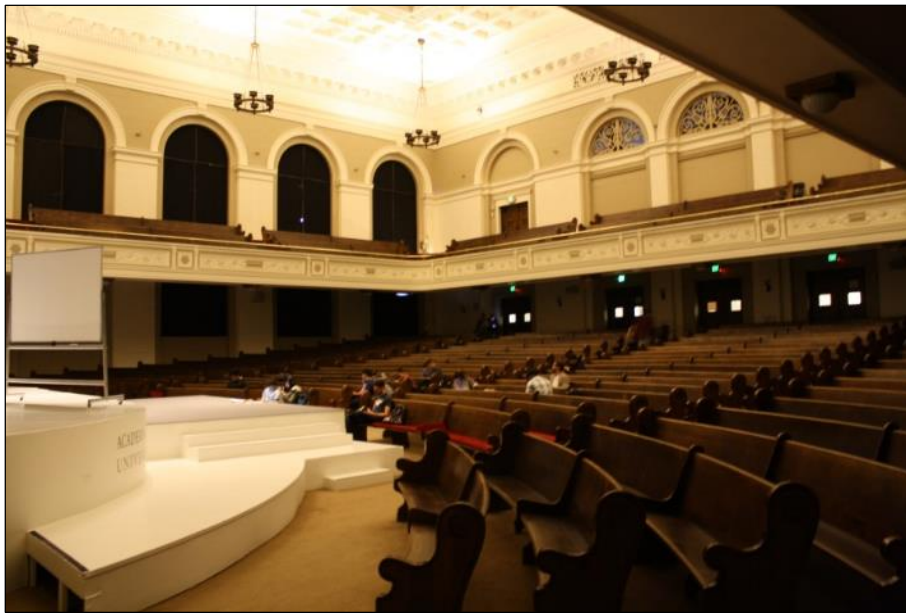
Original character-defining features include wood doors and trim, marble floors, coffered ceilings, crown molding, wooden pews, a second story balcony, and original light fixtures.

Figure 114. Interior nave of subject property. (Source: SWCA)

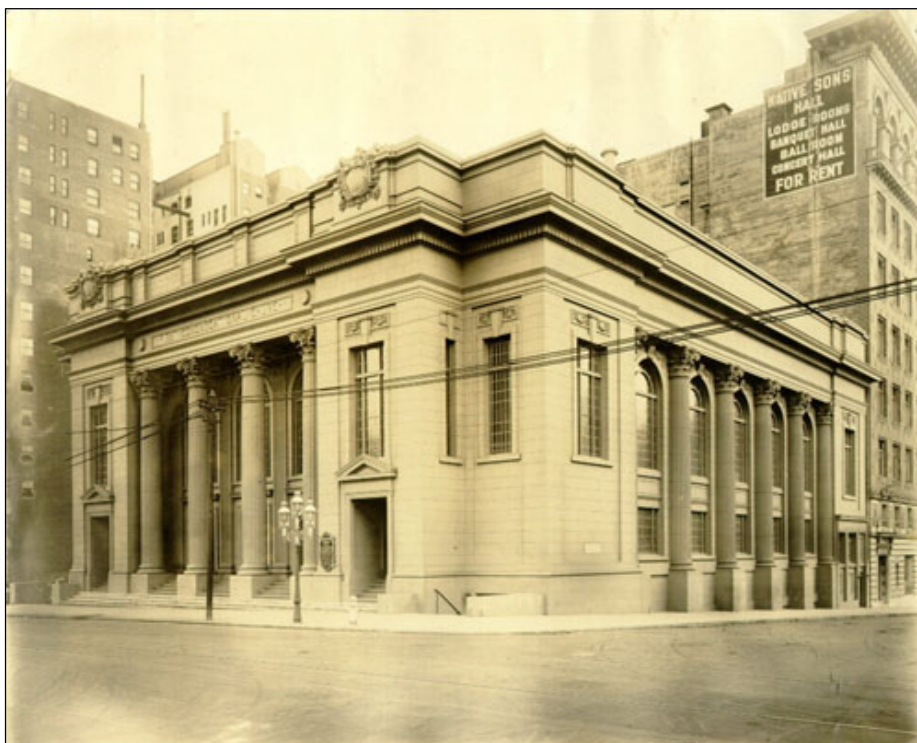
Figure 115. 1932 photograph of 491 Post Street; at this time, crest ornaments accented each side of the cornice. (Source: San Francisco Public Library History Center)

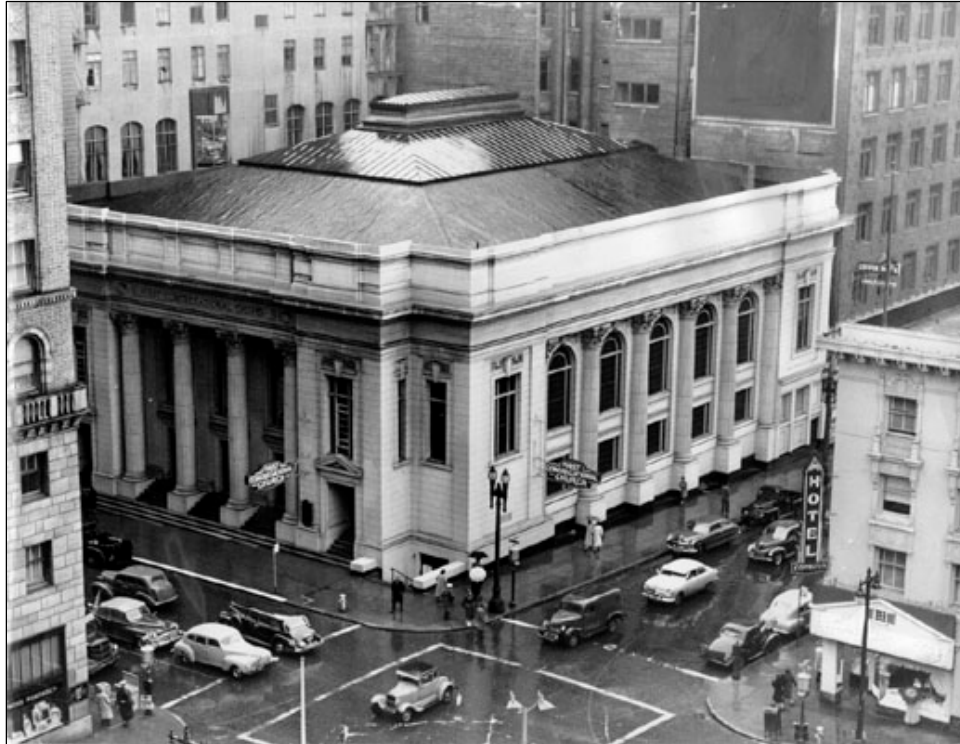
Figure 116. 1949 photograph of 491 Post Street; crest ornaments removed by this date. (Source: San Francisco Public Library History Center)

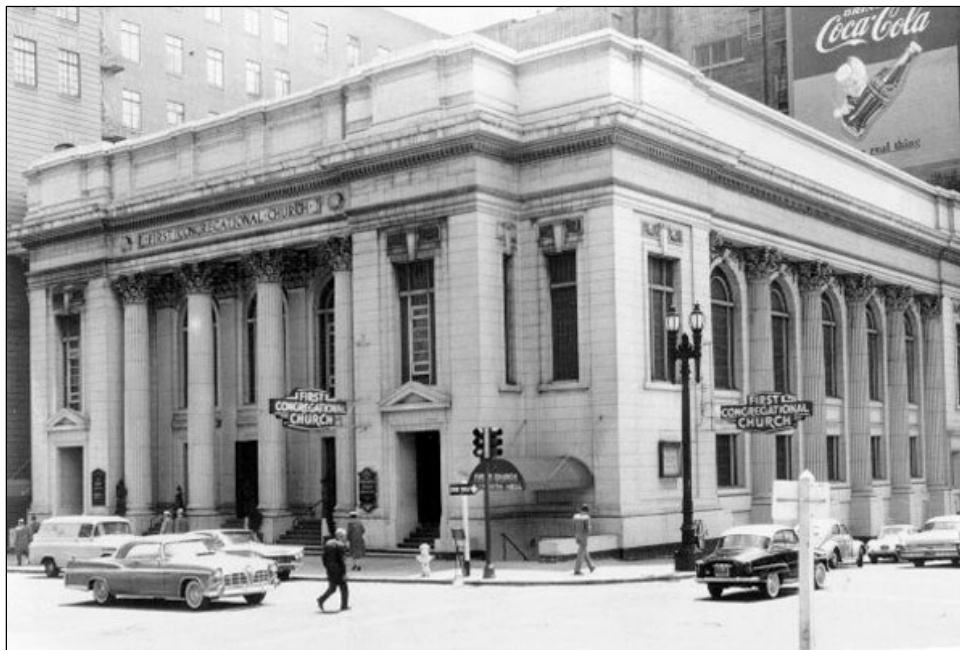
Figure 117. 1959 photograph of 491 Post Street; by this time, projecting signs were present on the façade and Mason Street elevation. (Source: San Francisco Public Library History Center)

Signage: The project does not comply with Rehabilitation Standard No. 5. The project resulted in the installation of large mounting brackets directly into historic wall materials. The project is likely to have resulted in damage to wall materials that characterize the property through their removal or destruction as part of the installation of the projecting signs.

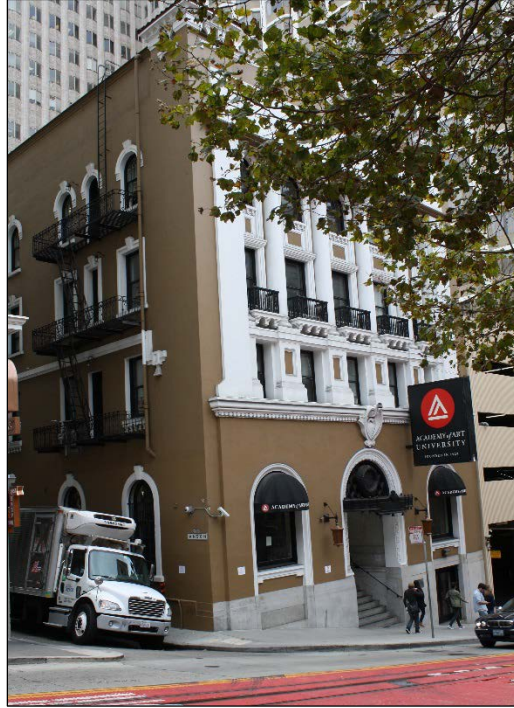
The ground story generally consists of broad, unadorned expanses of smooth stucco-clad walls, punctuated with three large arched openings. A granite-clad base provides the foundation of the building the level of the sidewalk. The focal point of the ground story is the centered entry portico, flanked by two arched window openings. The center stories are characterized by a progression of attached columns and rows of double-hung windows, with ornamental detailing varying on each floor.

The building is capped with a flat roof and stepped parapet, accented with scroll work and centered medallion, facing Powell Street.

Figure 126. 540 Powell Street.

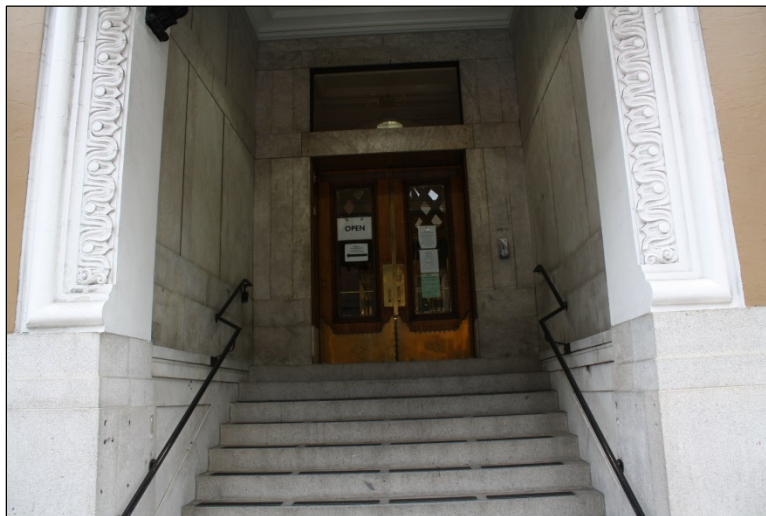
The tall first story features a centered, recessed main entry adorned with marble. The main entrance appears to retain its original wood double-doors; the doors have beveled vertical windows, stylized metal sheeting at the bottom, and transom windows above. Arched windows trimmed with molded frames are located on either side of the main entry, which are partially covered by dome window awnings. A cornice line above the first story has a central large medallion. Second, third, and fourth story windows are accented with recessed spandrel panels, engaged Corinthian columns, and ornamental detailing. The windows are nonoriginal vinyl, with original wood-framed double-hung windows on the upper stories, and original fixed and hopper wood-framed windows on the first story. A nonoriginal glass and metal door in the southernmost corner of the facade leads to the basement.

Figure 127. 540 Powell Street, close up of one of the main entry of the primary elevation.

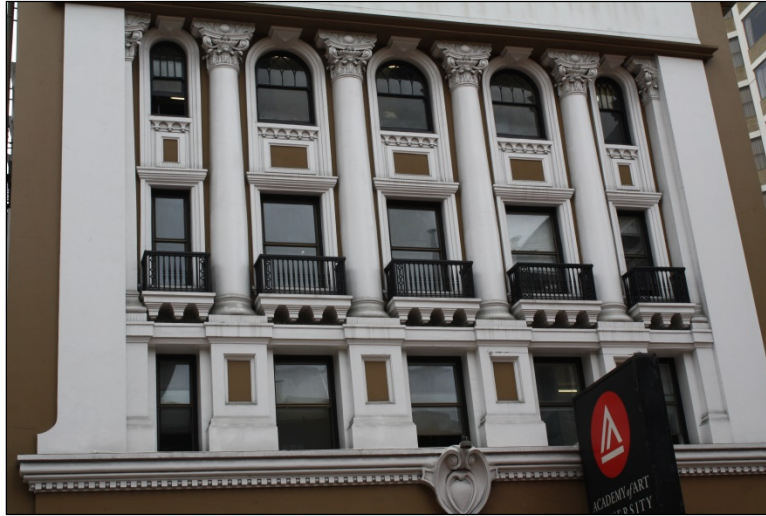
Figure 128. 540 Powell Street, close up of windows and details on the primary elevation.

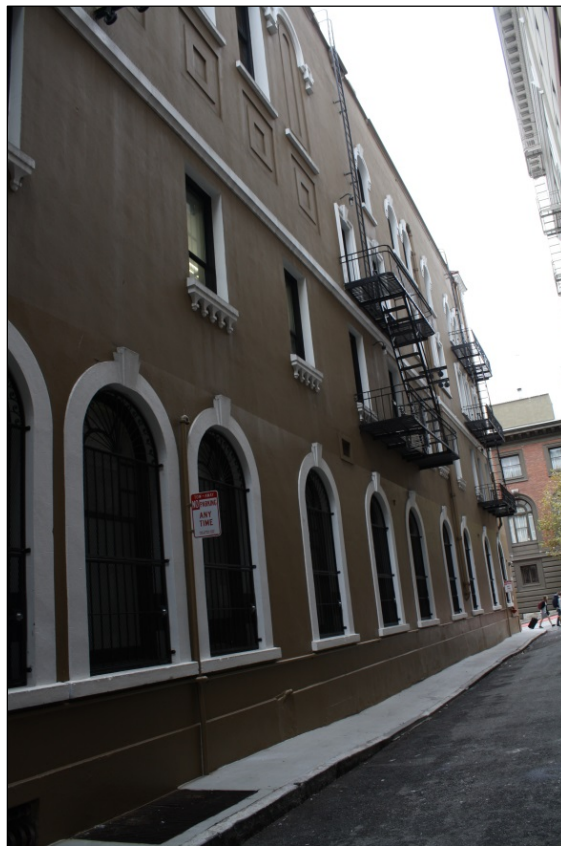
Along Anson Street, the secondary elevation has a fire escape at the eastern end with various types of personnel doors and a wheelchair ramp on the first story. Windows on this elevation feature decorative sills, hood molds with keystones, and frames with keystones. Other decorative features include recessed panels and trim above the second floor. Rectangular and arched double-hung windows in a variety of configurations are displayed on the elevation. Similar to the façade, the windows on the second and third floors have been replaced with vinyl. Metal security bars have been added over the first story windows.

Figure 129. 540 Powell Street, southwest perspective of the north elevation.

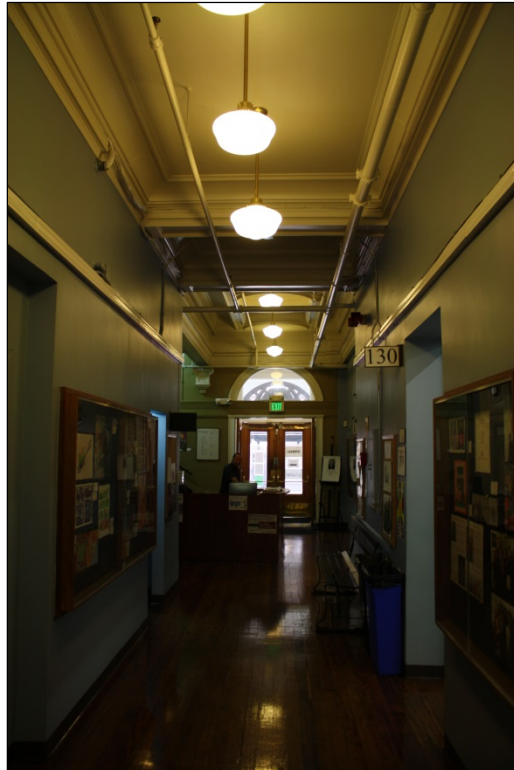
The main entry leads to a small lobby, with a hallway extending towards the rear (east) of the building. Each of the upper floors features a similar floorplan consisting of a narrow hallway bordered by classrooms on either side. Each floor is accessed via a curved wooden staircase or an original Otis elevator. The basement level has been altered through early partitions, which have divided what was originally an open floor plan. Character-defining features found within the interior spaces include original wood elements and accents such as doors, framing, and floors, as well as original wainscot, fireplaces with paneled chimneys, transom windows, light fixtures, coffered ceilings, and paneled walls.

Figure 130. Interior lobby of subject property.

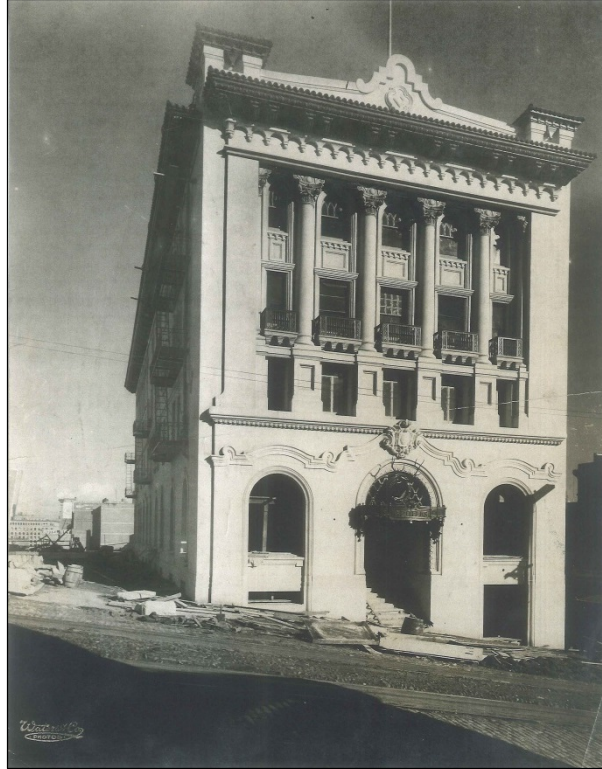
Figure 133. Circa 1908 photograph of 540 Powell Street under construction. (Source: University of Berkeley, College of Environmental Design Archives)

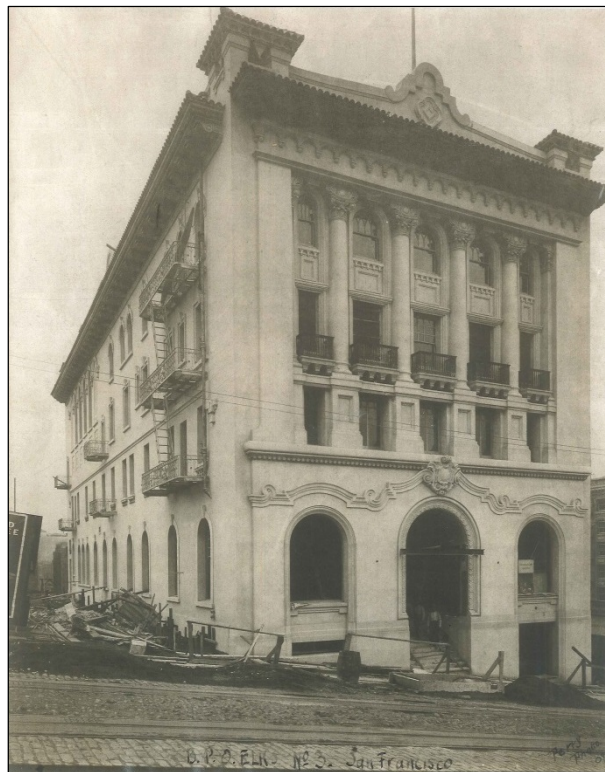
Figure 134. Circa 1908 photograph of 540 Powell Street under construction. (Source: University of Berkeley, College of Environmental Design Archives)

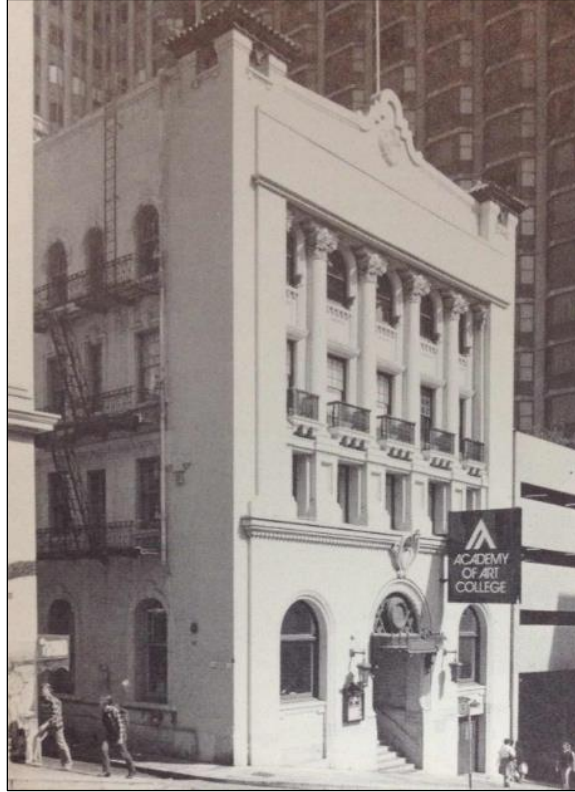
Figure 139. 1978/1979 photograph. (Source: San Francisco Architectural Heritage Survey)

- Original second- and third-story windows on the Powell Street elevation removed and replaced with double-hung vinyl windows; original windows visible on 1979 photograph included with Charles Page Hall & Associates Survey (see below)
- Parapet stabilization repair work completed in 2001 (Permit 201106067509)
- The first signage was approved in 1976 (Permit 456488); later signage was approved in 2008 (Permit 200804018449)
- Two dome window awnings added to ground story in 1992 (Permit 9214035)
- Hole cut into the top of the south arched window (window intact and visible on the 1979 photograph included with Charles Page Hall & Associates Survey)
- Security cameras added

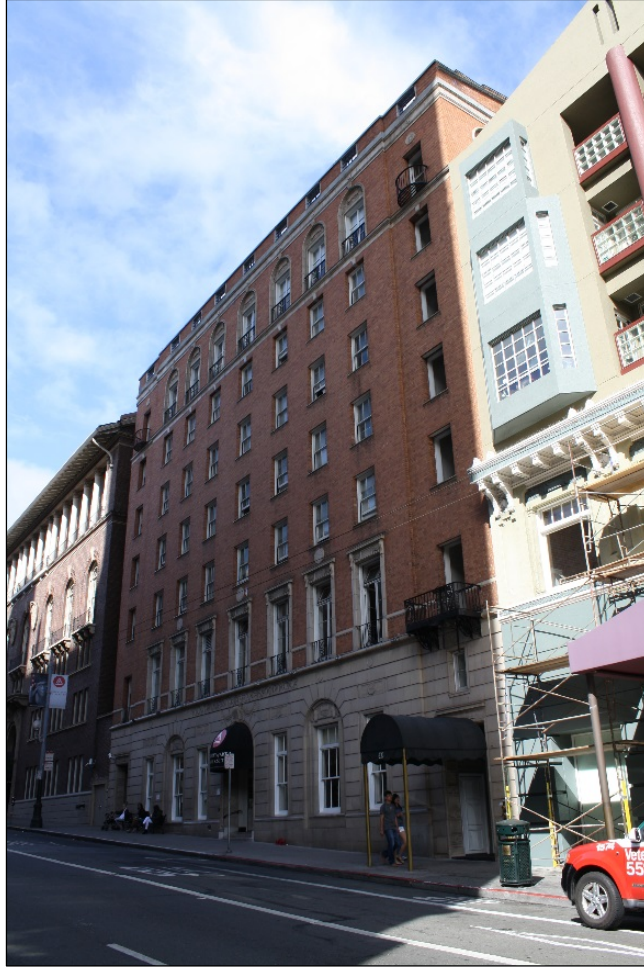
The former YWCA at 620 Sutter Street is a mid-rise, Georgian Revival style building constructed in 1918. It features rectilinear massing and is set to flush to the sidewalk on a rectangular, sloped lot. Constructed of stone and brick, it is nine bays wide and has a tripartite design composition that is articulated by bolder ornamentation and forms on the lower and upper stories. The building has a flat roof and a parapet, which terminates in a shallow coping.

Figure 148. 620 Sutter Street.

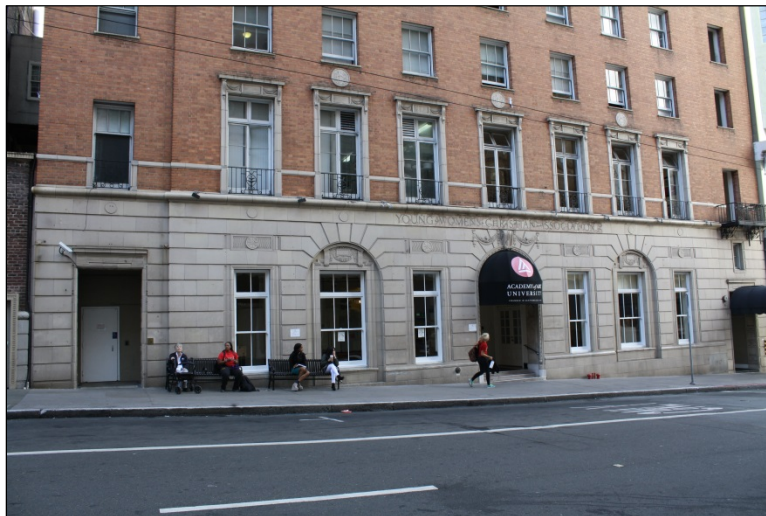
The primary elevation's tall first story is covered in stone and has a centered, recessed main entry. Rectangular multi-light casement and double-hung windows are arranged symmetrically on the elevation. The windows on the first, second, and seventh stories are bordered by detailed arched and rectangular stone surrounds. While there are window openings on the second through seventh stories of the eastern bay of the elevation, there are no window frames installed in the openings, which appears to be original to the building's construction. Stone medallions are located above windows on the second and seventh story. Decorative metal railings are located in front of the seventh story windows. Awnings have been added over the main entry and the eastern personnel door on the first story.

Figure 149. 620 Sutter Street, first and second story of the primary elevation.

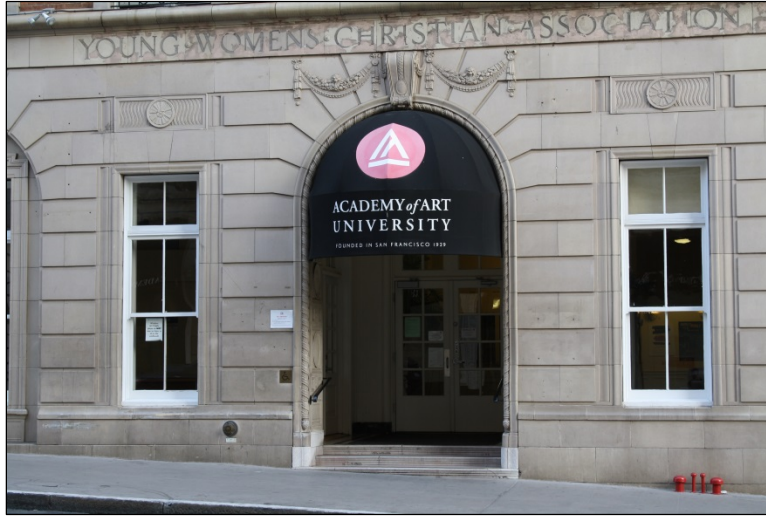
Figure 150. 620 Sutter Street, close up of the main entry on the primary elevation.

- Awning over main entry added in 1975 by the YWCA (Permit 444568)
- Main entry doors replaced in 1988 by Pat & Bill Ferdon (Permit 8808865)
- Reroofing was completed in 1996 by William Ferdon (Permit 9601944)
- Awning at central entryway installed in 1994 (Permit 9418743)
- Extending barrel canopy installed in 1997 (Permit 9721964)
- Windows on the 2nd through 7th floors on the eastern edge of the main elevation are open voids. Although drawings and renderings from the original architect show planned windows in these locations, it appears that, by 1930 (historic photographs), the window and frames had already been removed, if they had ever been installed
- Removal of cornice (AAU, Memo to SWCA, 2/2/2016)
- Ground-level side doors replaced with solid metal personnel doors (AAU, Memo to SWCA, 2/2/2016)

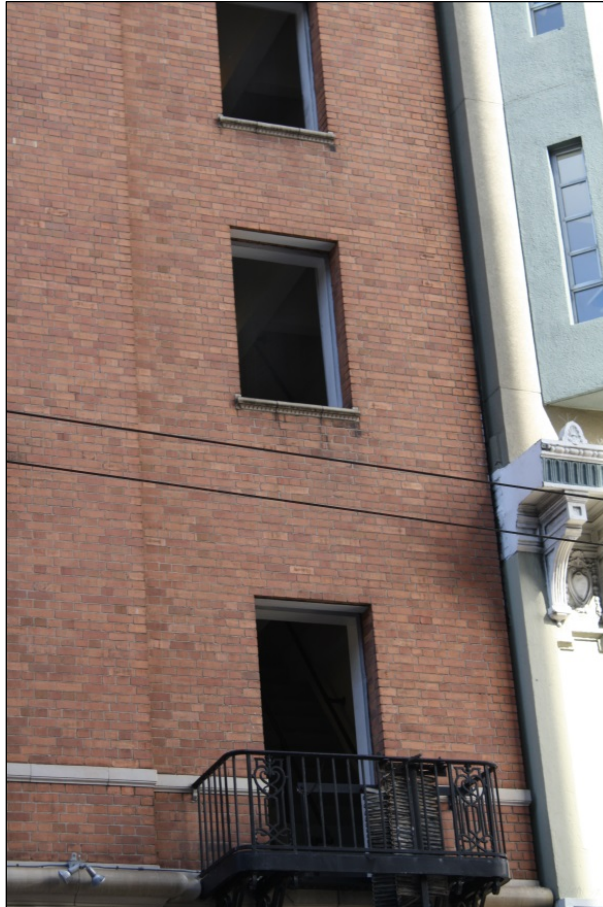
Figure 151. 620 Sutter Street, close up of the eastern window openings without window frames on the primary elevation.

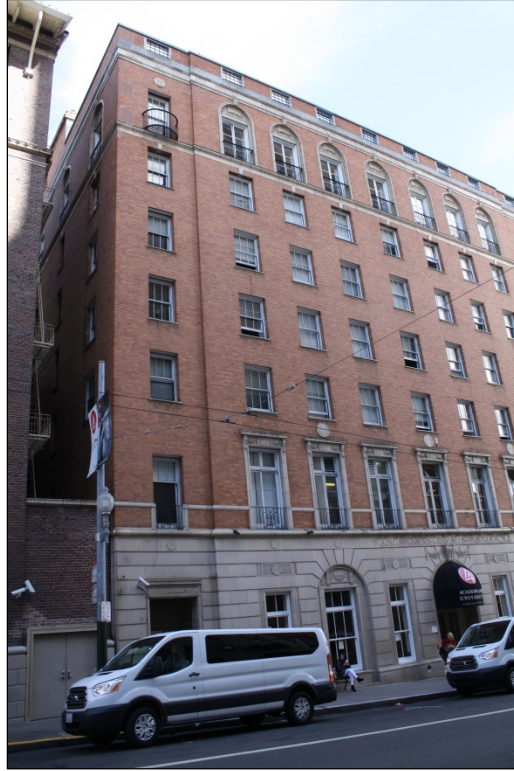
A portion of the eastern elevation is visible from the second story to the seventh story. The patterns in fenestration and materials usage established on the primary elevation have been retained on all visible portions of the secondary elevation.

Figure 152. 620 Sutter Street, northern perspective of the south and west elevations.

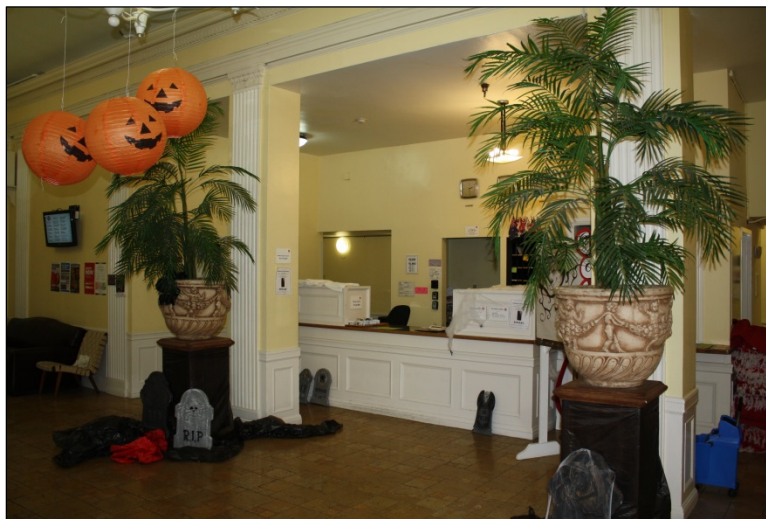
Through the main entry is a large rectangular lobby that has been largely altered with modern materials. It is bordered by open rooms, which previously housed a nonoriginal bar and hair salon. Other communal spaces located off the lobby include an indoor pool and a performance theater. Although the theater has been altered, the pool appears largely intact both in materials and design. With the exception of the second and seventh floors, which feature dining accommodations and a dance studio respectively, the upper floors are residential and have identical floor plans. Character-defining features found throughout the interior include decorative molding, and original doors, transoms, frames, and wainscot.

Figure 153. Interior lobby of subject property.

The lobby appears to have been largely altered and reconfigured since the property was initially constructed. The lobby was divided into smaller spaces at various times to provide for a tea room and later a hair salon. Additional changes include the addition of ADA ramp, newer lighting fixtures, and removal of floor and wall materials. The upper floors appear largely intact featuring original doors, trim, wainscot, and light fixtures, with some have been replaced. The pool is also largely intact, although the light fixtures have been replaced and vinyl mesh pool mats have been placed around the pool perimeter. In addition, AAU obtained a permit for inspection of the fire alarm system and patched holes in a telephone closet (Permits 201002247104 and 201104063562).

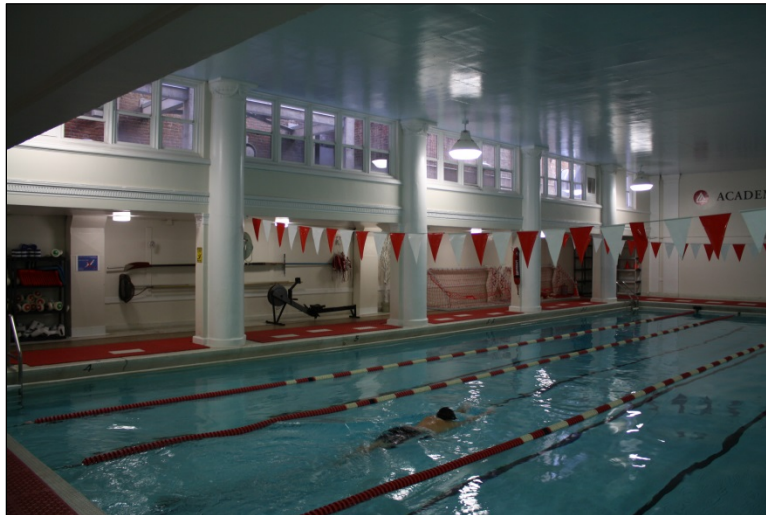
Figure 155. Interior pool of subject property.
