APPENDIX HR:
Historic Resource Evaluations

Overview of Historical Resources Review and Findings

410 BUSH STREET (ES-26)

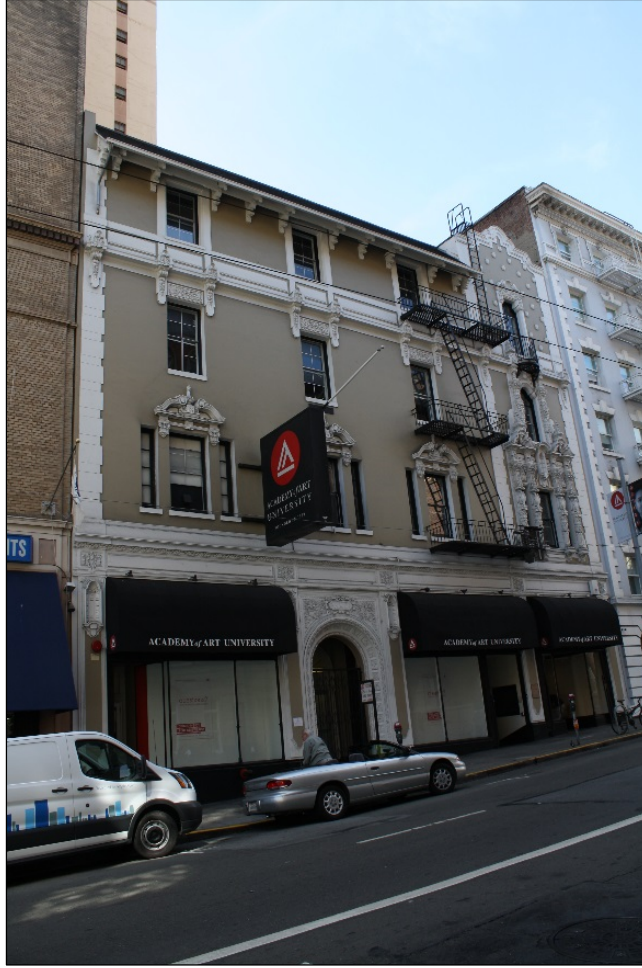
The primary elevation features an elaborated, centered recessed main entry centered in the eastern portion of the building and surrounded by Churrigueresque detailing. On either side of the main entry is a storefront with a recessed entry and transom windows above that are currently boarded with plywood. A third storefront is located on the first story of the western bay. A cornice line divides the commercial first story from the upper stories. Four rectangular windows are spaced evenly across each story, one in the western bay and the other three spaced throughout the eastern portion. The windows on the eastern bay feature pediments and sidelights on the second story and surrounds on the fourth story. On the western bay, Churrigueresque ornamentation surrounds the second and third story windows, and a decorative surround and sea shell details are featured on the fourth story. A wide band with Churrigueresque details and recessed panels separate the third and fourth story.

Figure 163. 625-629 Sutter Street.

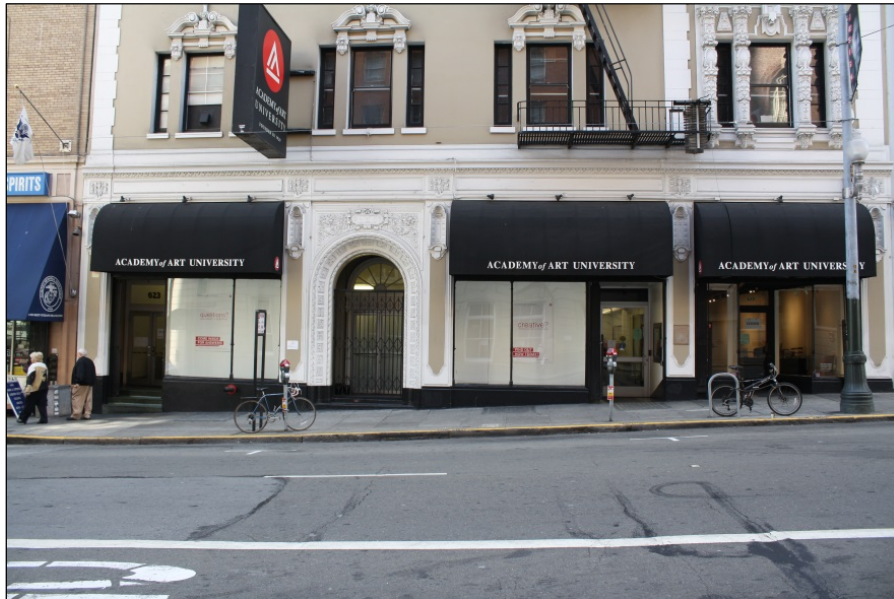
Window types utilized on the primary elevation include original wood and nonoriginal aluminum double-hung, multi-light, large fixed storefront windows, and fixed transom windows. Noncontributing awnings have been added over the storefronts.

Figure 164. 625-629 Sutter Street, first story of the primary elevation.

- Three awnings were installed by AAU in 1975 (Permit 449072). Although there is no permit, the current awnings most likely have had the fabric replaced with the AAU logo.

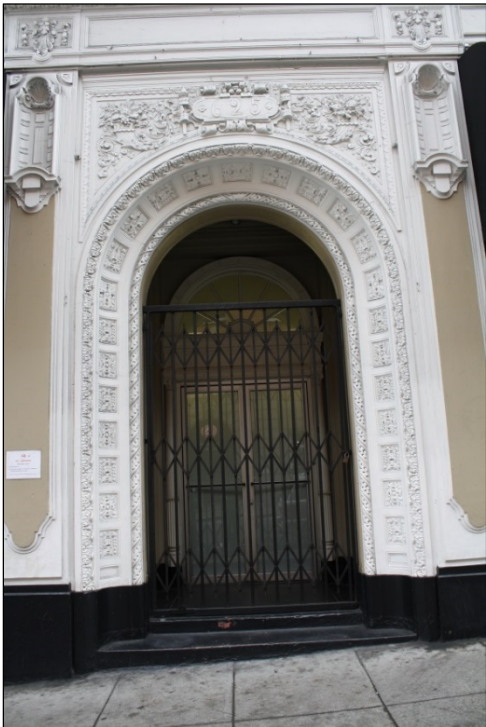
Figure 165. 625-629 Sutter Street, close up of the main entry on the primary elevation.

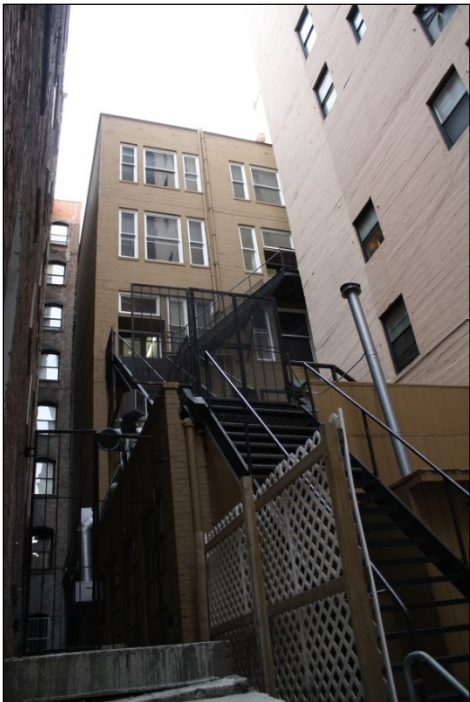
A secondary elevation is visible from the alley. A metal stair provides access to the upper floors over the early one-story addition. Brick and board form concrete are visible on the elevation. Windows used in a variety of configurations include rectangular vinyl double-hung and casement windows.

Figure 166. 625-629 Sutter Street, western perspective of the south and rear eastern elevations.

- Metal stairway with metal gate stretches over the rear one-story addition constructed in 1929, meets the building at the 3rd floor, turns the corner and climbs alongside the building to the 4th floor (AAU, Memo to SWCA, 2/2/2016)
- Glass metal doors added at landing from the 3rd floor to the metal stair (AAU, Memo to SWCA, 2/2/2016)
- Wood lattice fence (AAU, Memo to SWCA, 2/2/2016)
- Replacement doors (metal double-doors) on one-story addition (AAU, Memo to SWCA, 2/2/2016)

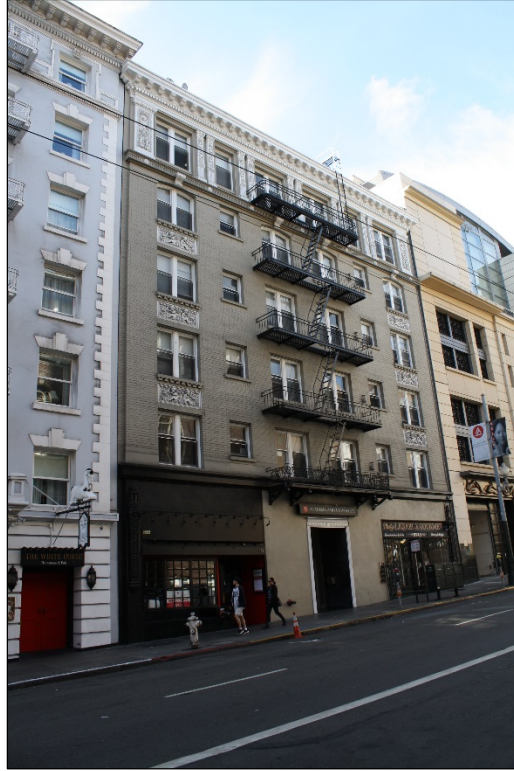
Designed by Frederick Herman Meyer, 655 Sutter Street was constructed in 1912, originally as apartments. By 1933, according to city directory research, the building had been at least partially converted to commercial/office space. With a T-shaped building plan, the six-story property is set flush to the sidewalk on a rectangular, sloped lot, with its primary elevation facing Sutter Street. 655 Sutter Street exhibits a symmetrical, Renaissance Revival design, with a relatively spare ornamental program on the ground story, finer detailing through the middle stories, and elaborate ornamentation on the top story. The building is sheathed in brick and smooth stucco and capped with a flat roof, terminating in an ornamental cornice accented with modillions and dentils.

Figure 174. 655 Sutter Street.

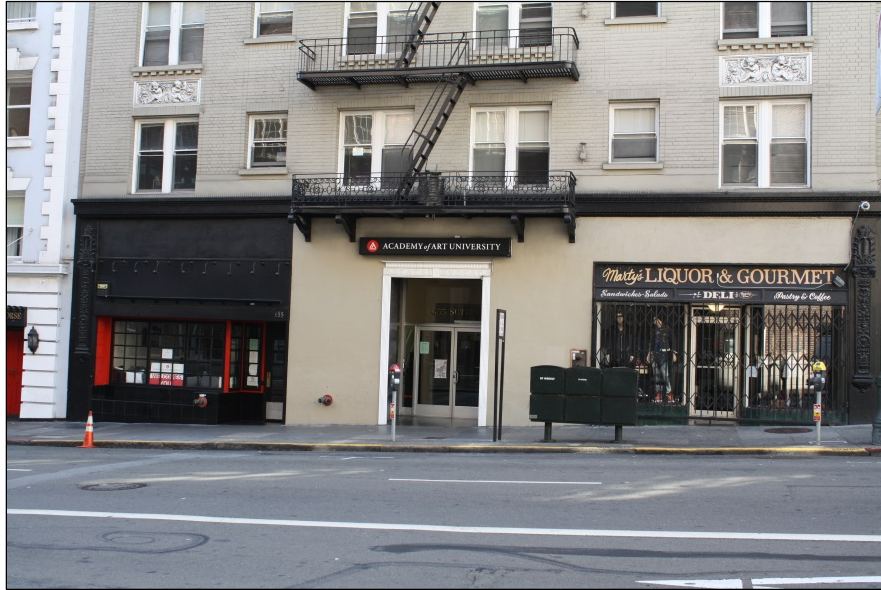
Among the storefronts, the westernmost segment appears to retain the highest degree of integrity to the circa 1933 conversion (and the character-defining features of this storefront are considered to have gained significance in their own right). The western storefront exhibits centered glass entry doors, with single-pane glazing and signage above. Minimal ornamentation on the first story includes scrolled brackets adjacent to the storefronts. A simple cornice line divides the first story from the upper stories.

Figure 175. 655 Sutter Street, first story of the primary elevation.

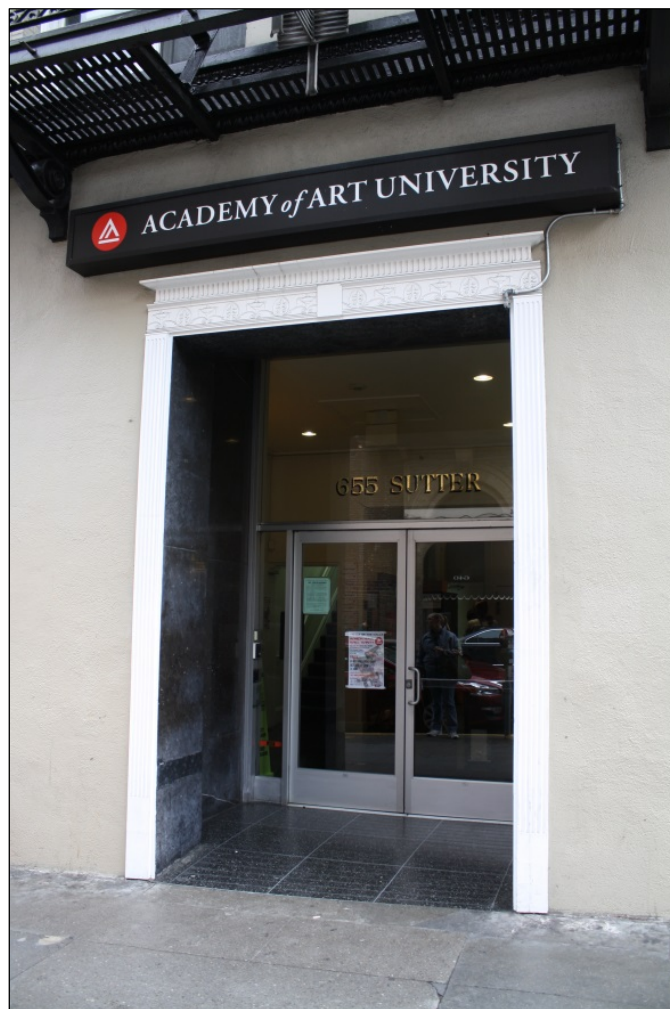
The primary elevation's tall first story features a centered, recessed main entry with storefronts on either side. The main entry is composed of paired aluminum doors with side lights and a large transom window, which appears to date to 1962. The walls of the recessed entry are sheathed in marble and framed on the exterior by thin aluminum surrounds. Each storefront features large windows and a recessed entrance. The eastern storefront was extensively altered in 1986 through the installation of the multi-light fixed window, and more recently with the addition of a black-tiled bench and lighting fixture.

Figure 176. 655 Sutter Street, close up of the main entry on the primary elevation.

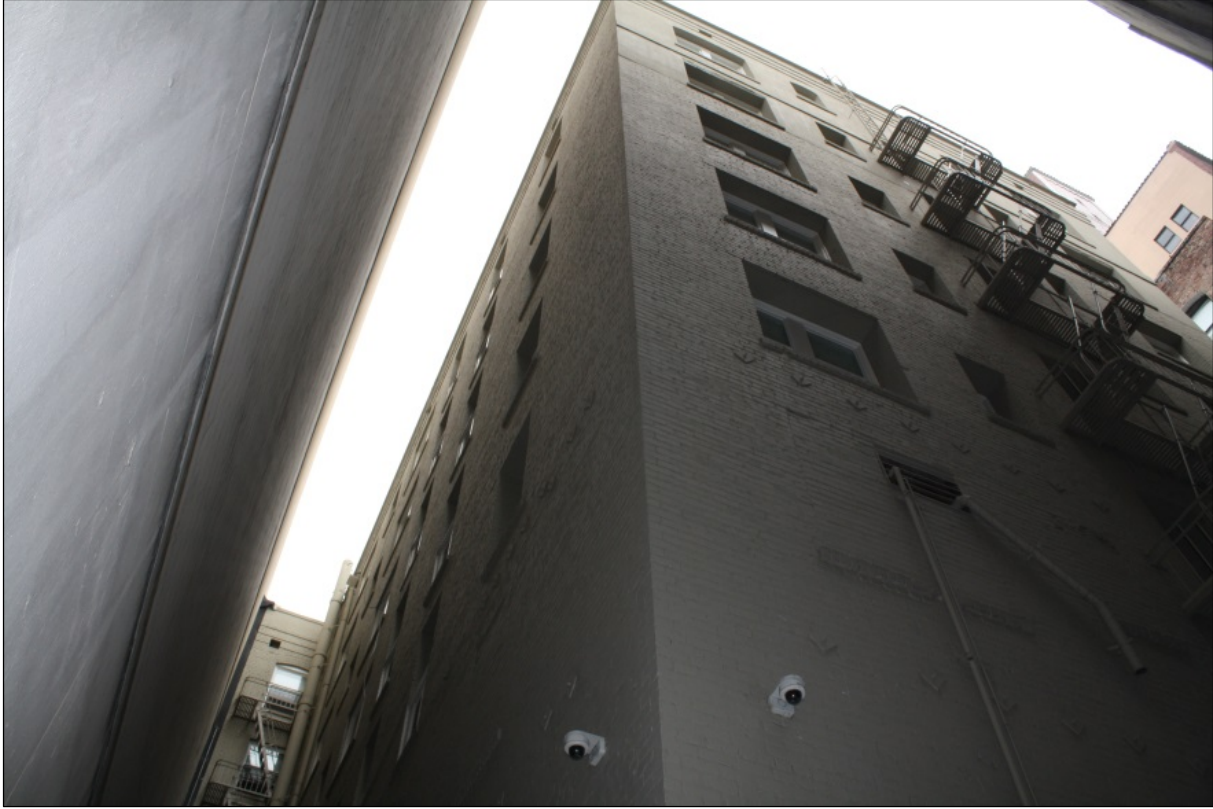
Figure 177. 655 Sutter Street, northern perspective of the south and west elevations.

Secondary elevations are visible from the alley behind the structure. The rear section of the T-shape is constructed of brick with recessed windows. The flat roof is capped in a shallow copping at the eave line. The window types utilized include single-hung windows in a variety of configurations. A metal fire escape is located on the southern elevation.

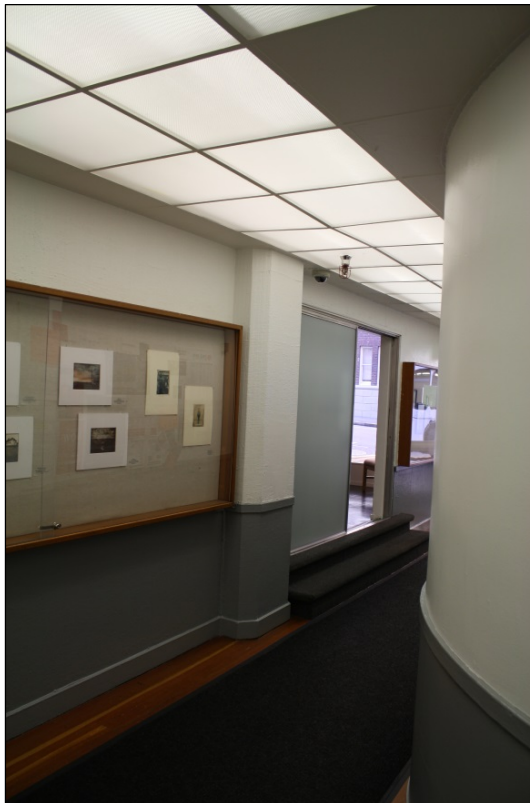
The main entry leads to a small lobby, which features terrazzo floor tiles, mirrored walls, elevators, and staircase. The original design appears to have included a lobby; since its original construction, however, the lobby has been configured several times, to include ground-floor commercial spaces. The double-loaded corridor spatial arrangement of the upper stories appears to be intact, however, the original materials appear to have been largely replaced with drywall, metal doors, and carpeting.

Figure 179. Interior lobby of subject property.

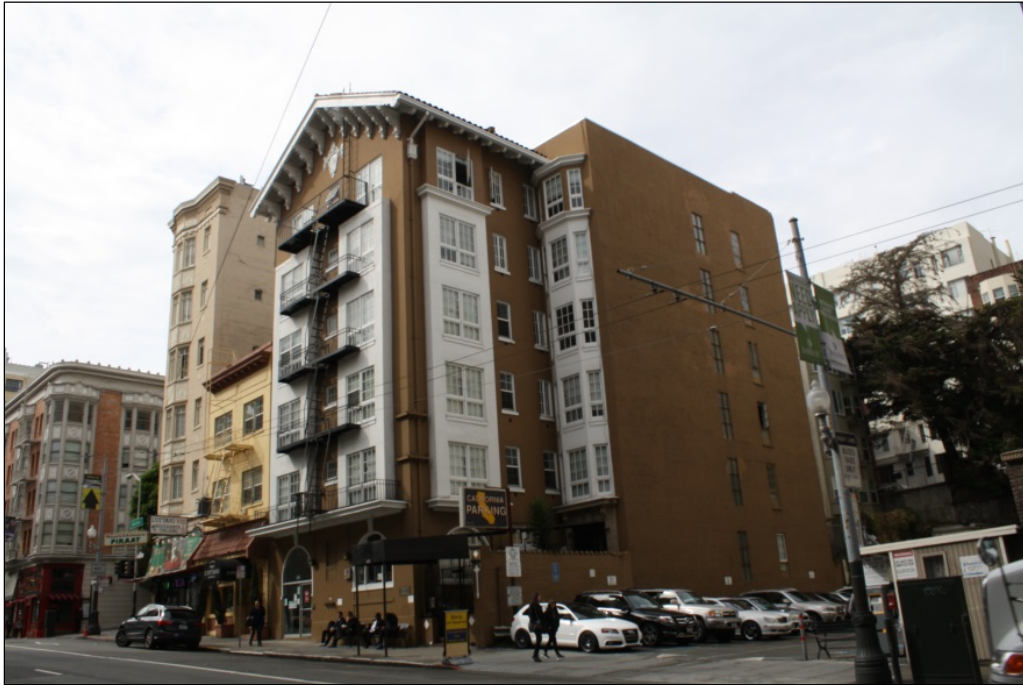
The first story on the primary wing features a nonoriginal main entry with an arched transom and an arched window to the left, both accented with decorative keystones. A prominent projecting cornice line separates the ground floor from upper stories. Projecting bays with paired rectangular windows are located above the cornice on the second through fifth stories. As was typical for multifamily properties of this era, a fire escape is prominently positioned on the center of the building's primary elevation. On the recessed eastern bay of the primary elevation is a large wood door with glass lights and an ornate stone surround providing access to the residential units upstairs. A brick wall separates the entry way from the neighboring parking lot. The entry has been modified with the addition of a security gate and long awning, making the residential entry less visible from the street. Stacked above the residential entry are bay windows with a defining cornice line above and below the sixth story bay window. Windows types visible on this elevation are

Figure 187. 680 Sutter Street.

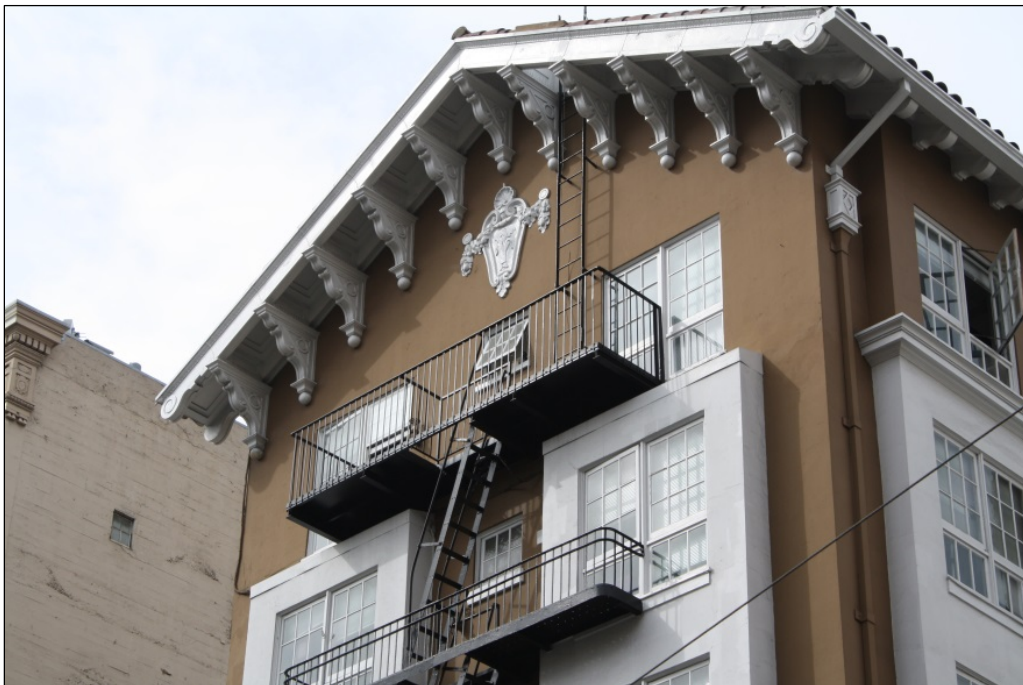
Figure 188. 680 Sutter Street, close up of the decorative brackets and rafter ends on the primary elevation.

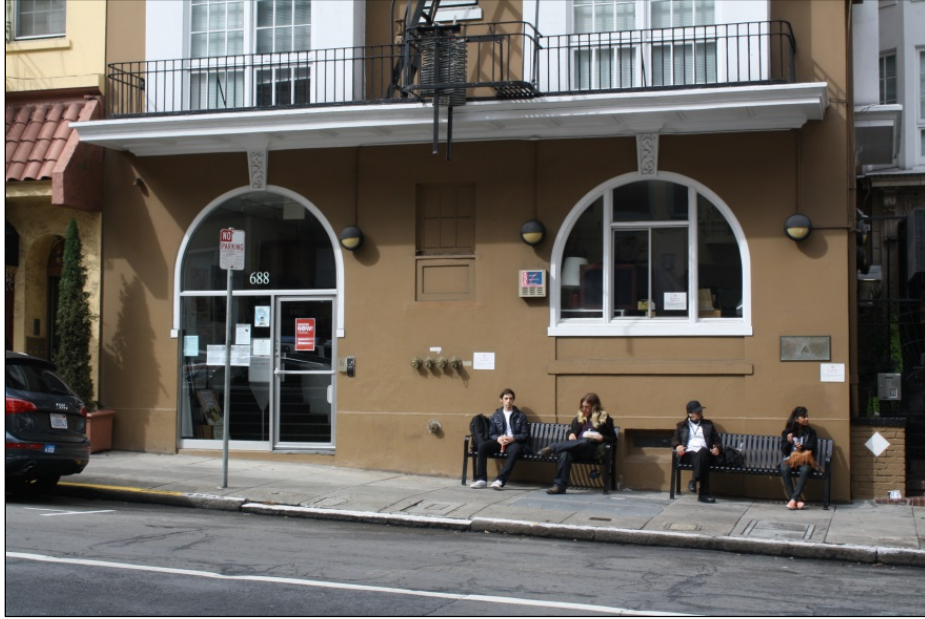
Figure 189. 680 Sutter Street, close up of the main entry on the primary elevation.

- Original, western arched window on ground-level was converted into a doorway prior to 1934 (SF Chronicle)
- New entrance awning, 1960 (Permit 24049)
- Ground-level storefront was widened to accommodate the current aluminum door and the upper transom window was replaced in 1962 (Permit 2715328)
- Original ground-floor window painted over (AAU, Memo to SWCA, 2/2/2016)

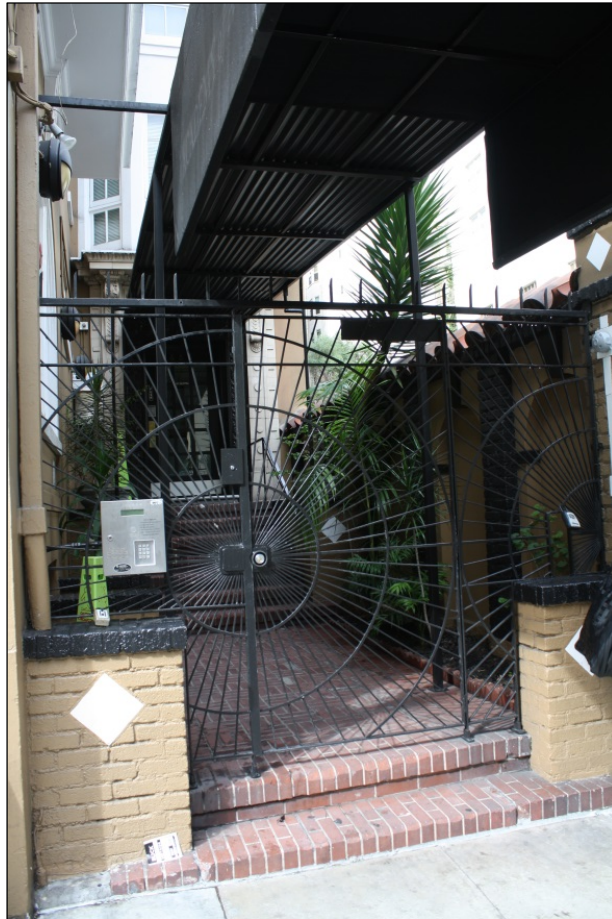
Figure 190. 680 Sutter Street, close up of the residential entry on the recessed eastern wing of the primary elevation.

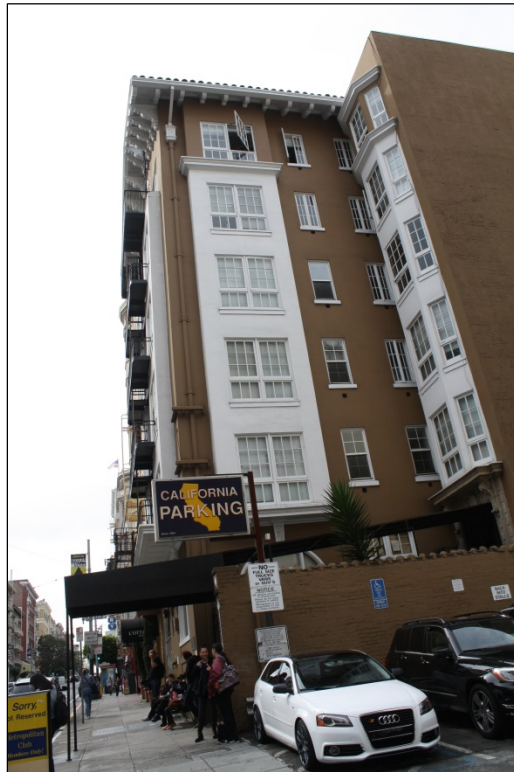
Secondary elevations are visible on the north, east, and west elevations. The east elevation is comprised of two sections. The southern section has a column of the same projecting paired rectangular windows seen on the primary elevation. Adjacent to the projecting windows are two columns of single, rectangular windows, a design element that is replicated on the northern section of the east elevation. A smooth stucco finish on the southern section is present, while on the northern section board-formed concrete is visible underneath the stucco. The north elevation is divided into three bays with horizontal bands separating each story. The west and east bays have pairs of windows while the center bay has a single window. The west elevation is only visible from the street where it extends above the adjoining property. Board-formed concrete is visible as is one small window. Utilized throughout the secondary elevations are vinyl single-hung, wood multi-light casement, and fixed windows used in a variety of configurations.

Figure 191. 680 Sutter Street, western perspective of the southern portion of the eastern elevation.

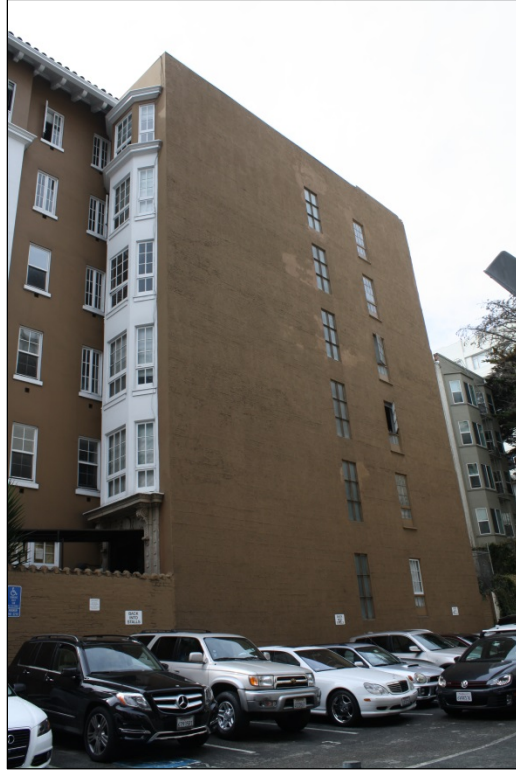
Figure 192. 680 Sutter Street, northwestern perspective of the northern portion of the eastern elevation.

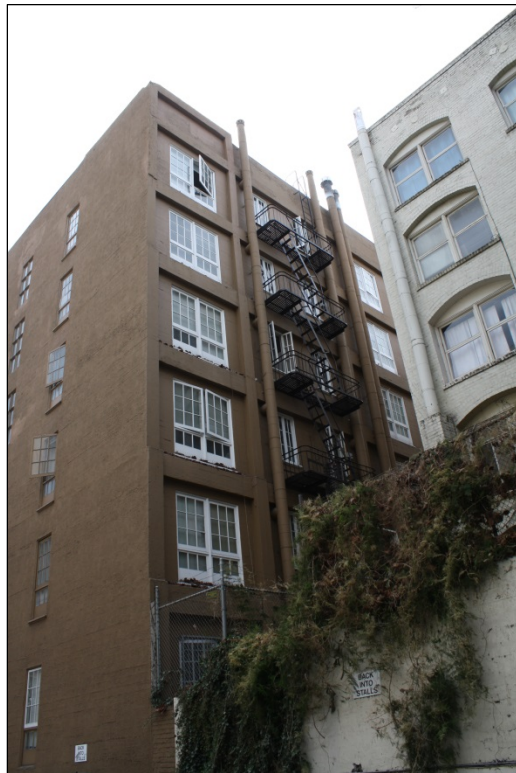
Figure 193. 680 Sutter Street, southwestern perspective of the northern elevation.

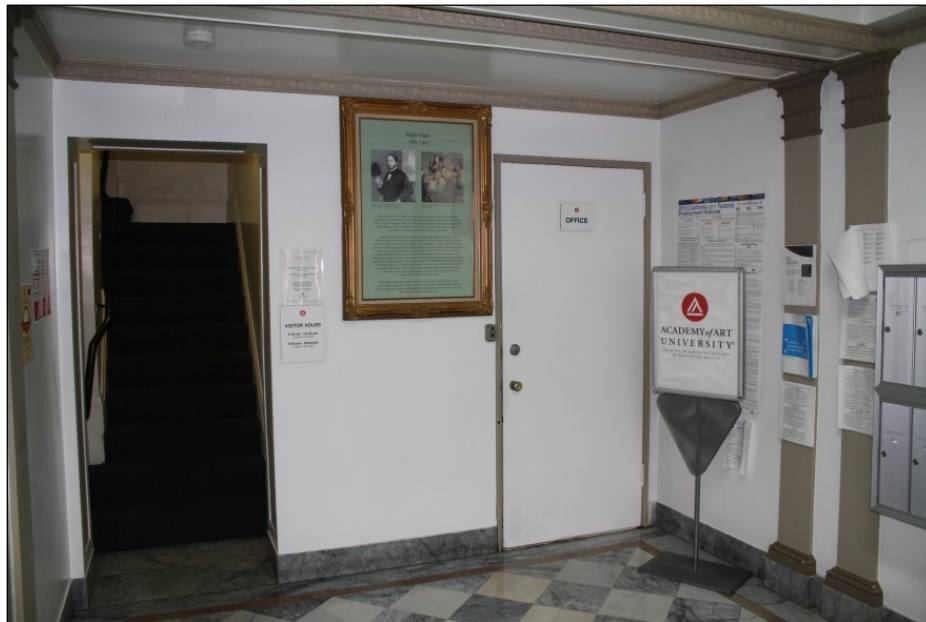
The residential entry leads to a small lobby featuring decorative pilasters, marble floors, and a vaulted ceiling with decorative molding. A decorative railing and a marble fireplace are also present on the first floor. The building's upper floors have short hallways along an open, central courtyard. Original doors, frames, decorative picture rails, and base moldings are extant through the upper floors. The nonoriginal commercial entry off Sutter Street, leads to a small office space that features a short interior stairway and open space bordered by individual rooms.

Figure 195. Interior lobby of subject property.

Although the first floor has been converted into a retail space since the property's initial construction, the small lobby appears to be largely intact. Changes include the addition of lighting, the replacement of some interior doors, and removal of materials outside of the lobby.

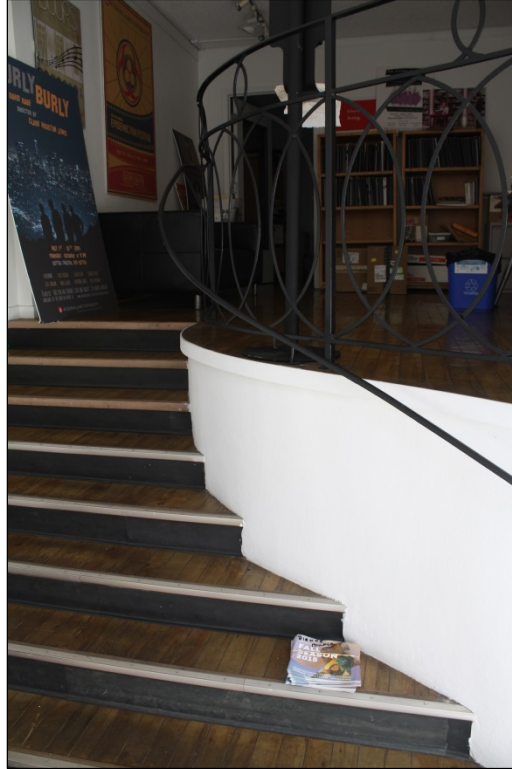
Figure 196. Interior decorative railing in small office space.

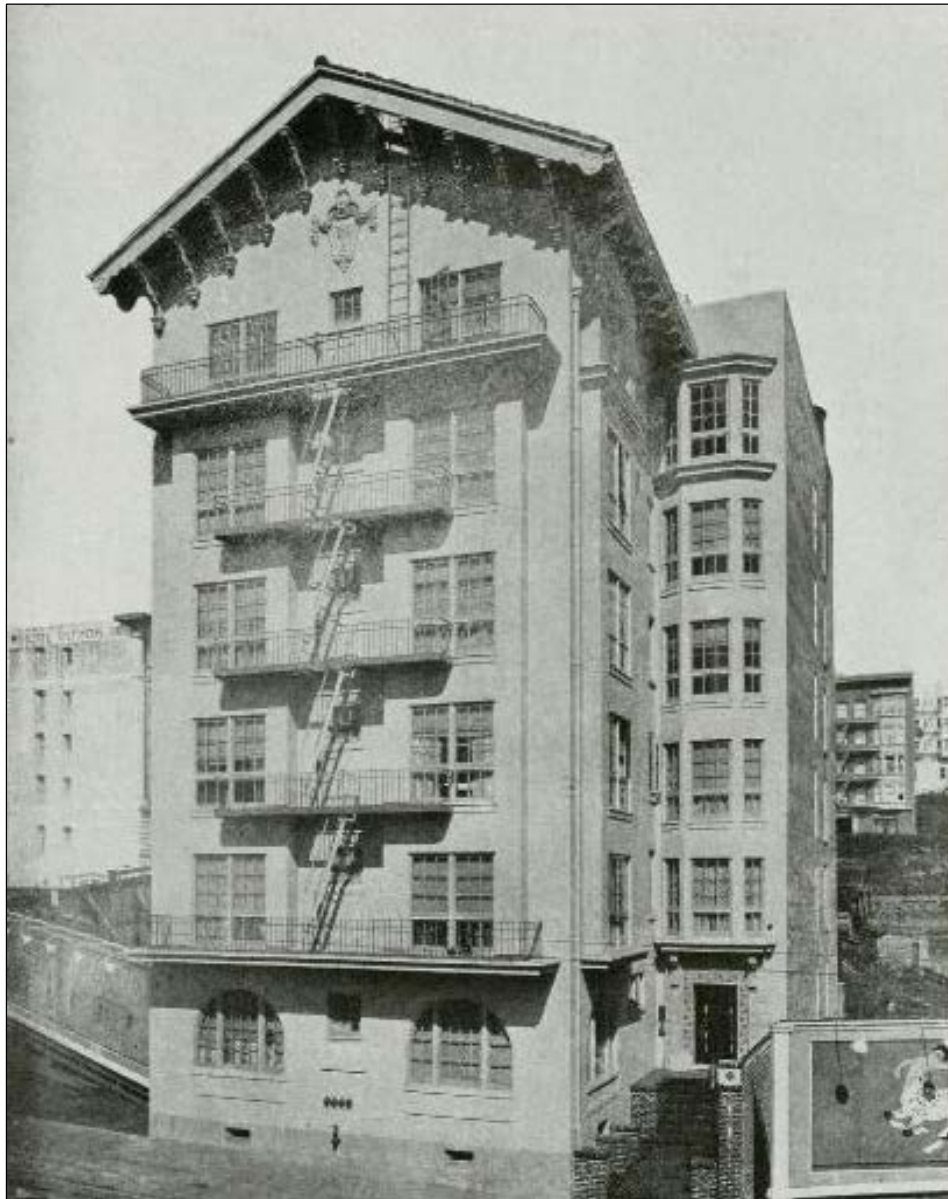
Figure 197. 1919 photo of 680 Sutter Street. This photo shows the original character and brickwork/detailing of the recessed side entrance (lower right of photograph). (Source: *Architect and Engineer*, September 1919)

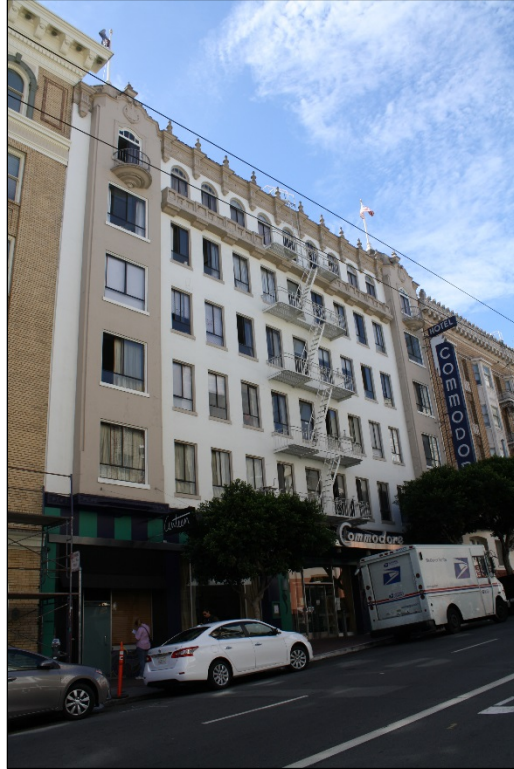
The mid-rise building at 817-831 Sutter Street was constructed in 1924 as a residential and commercial hotel. The building has a T-shape plan and is set flush to the sidewalk on a rectangular, sloped lot with the primary elevation facing north on Sutter Street. With Spanish Colonial details, the building features a symmetrical design with a stucco façade, and is capped with a flat roof with a short parapet sheathed in red clay tile and topped by pinnacles.

Figure 206. 817-831 Sutter Street.

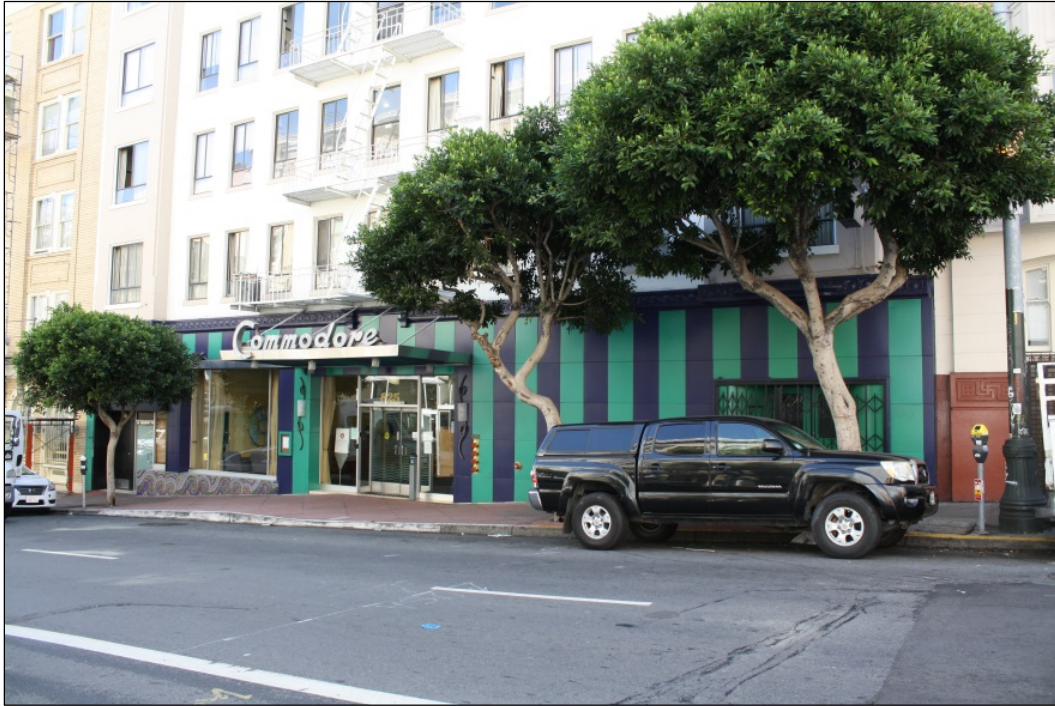
The primary elevation has a delineated commercial storefront on the first story covered in green and purple panels. The main entry is centered on the elevation and is composed of a nonoriginal, recessed aluminum framed, glass double-door with large sidelights and transom. Above the main entry is a metal canopy with sign that reads “Commodore.” To the west of the main entry is a curved entry with a set of paneled double-doors with a metal security gate, which formerly led to a bar. East of the main entry is a former restaurant space (now vacant) that is delineated by a large fixed window and two single doors; one glass with a transom window and an adjacent metal personnel door.

Figure 207. 817-831 Sutter Street, close up of the first story on the primary elevation.

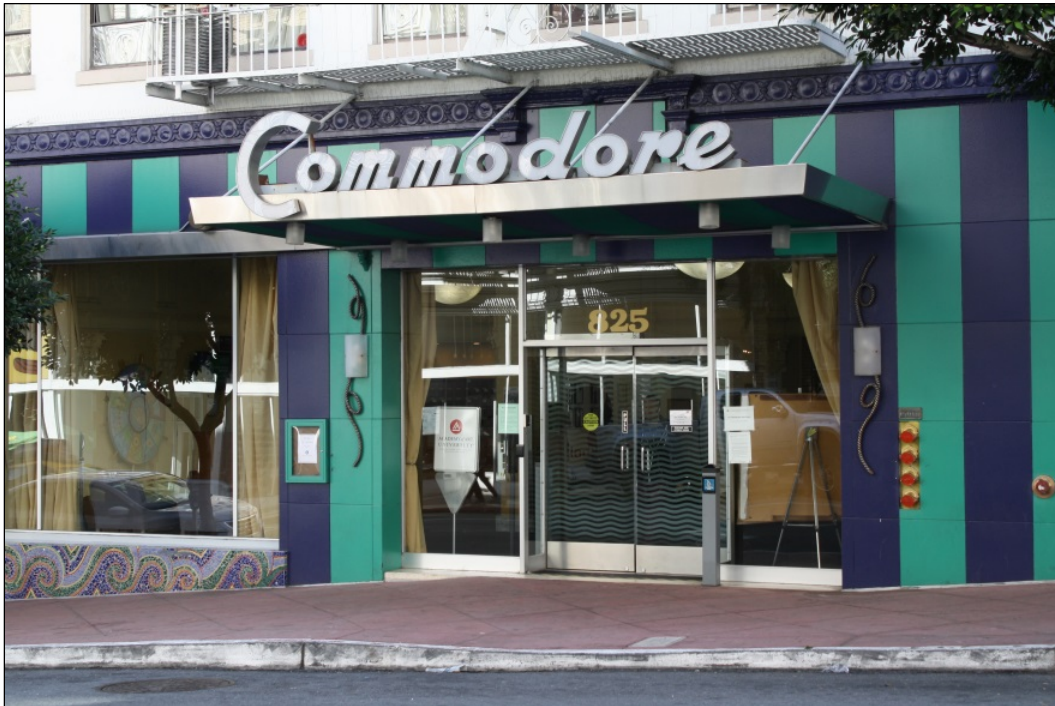
Figure 208. 817-831 Sutter Street, close up of the main entry on the primary elevation.

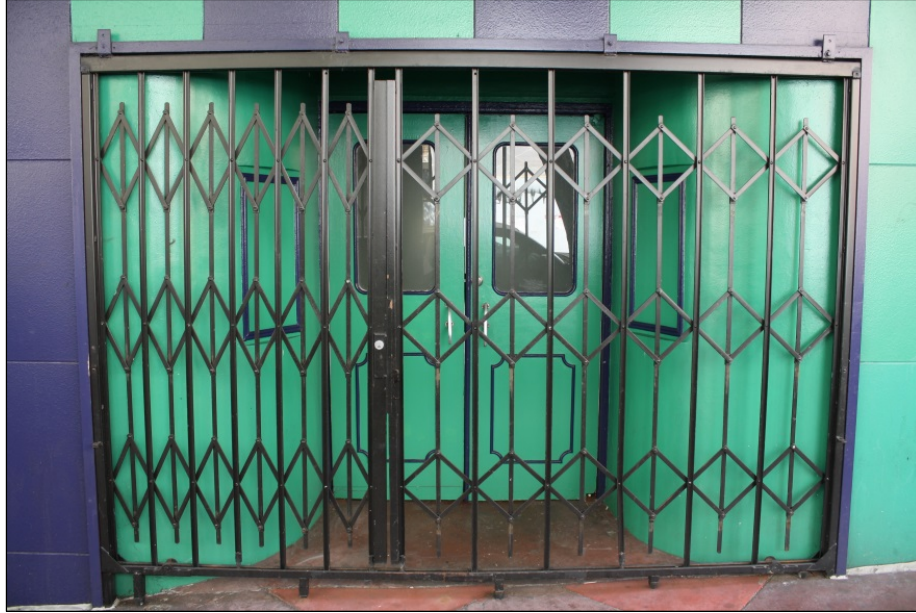
Figure 209. 817-831 Sutter Street, close up of the entry to the yoga room on the primary elevation.

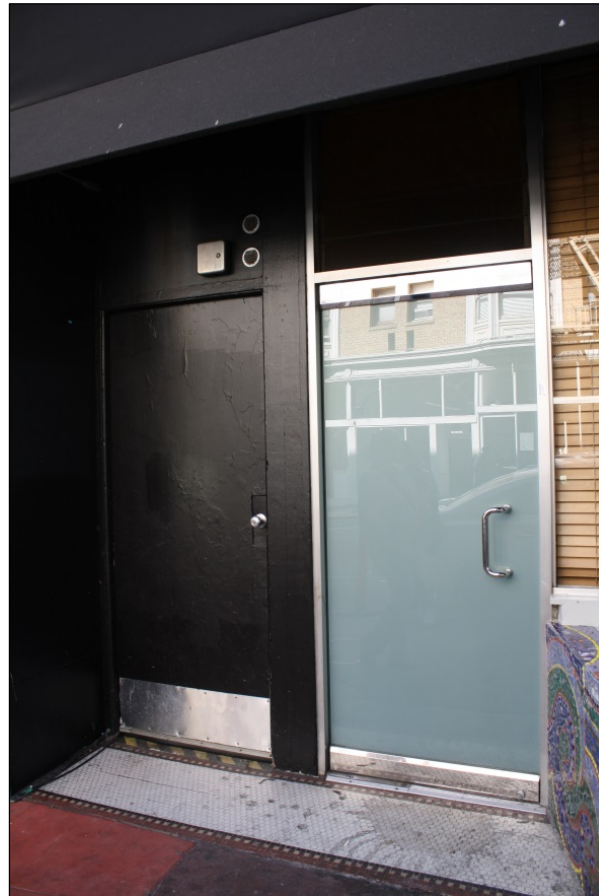
Figure 210. 817-831 Sutter Street, close up of the entry to the former café and basement on the primary elevation.

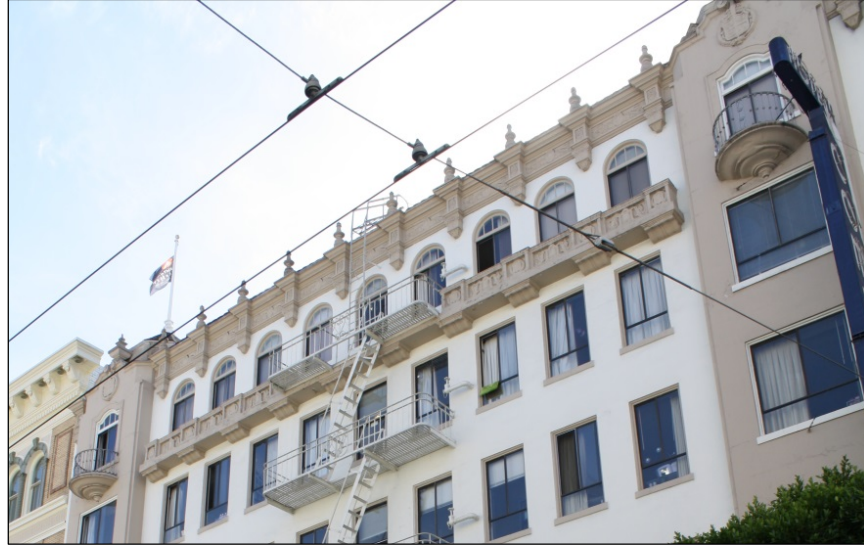
Above the first floor, projecting window bays on the second through the sixth stories form defined vertical elements on the east and west side of the building. Between the projecting window bays, rectangular windows are symmetrically spaced on the second through the fifth stories, while the sixth story windows are arched. Rounded balconies with decorative entablature and brackets are located in front of the eastern and western most sixth story windows. A detailed frieze separates the fifth and sixth stories and the decorative parapet features escutcheon on the projecting bays. Vinyl sliding windows have replaced the original windows on the upper stories.

Figure 211. 817-831 Sutter Street, close up of the upper story details.

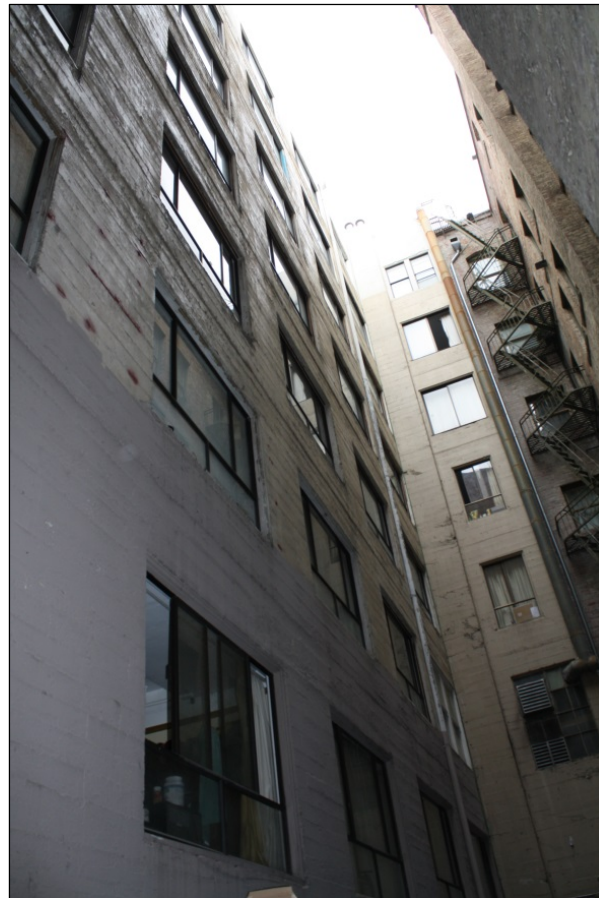
Secondary elevations are visible from a small courtyard on the east and a walkway on the west, both of which are accessed via a personnel door from the basement. The secondary elevations are comprised of horizontal bands of windows comprised of nonoriginal vinyl and aluminum sliders, double-hung, and casement windows.

Figure 212. 817-831 Sutter Street, northern perspective of the western elevation.

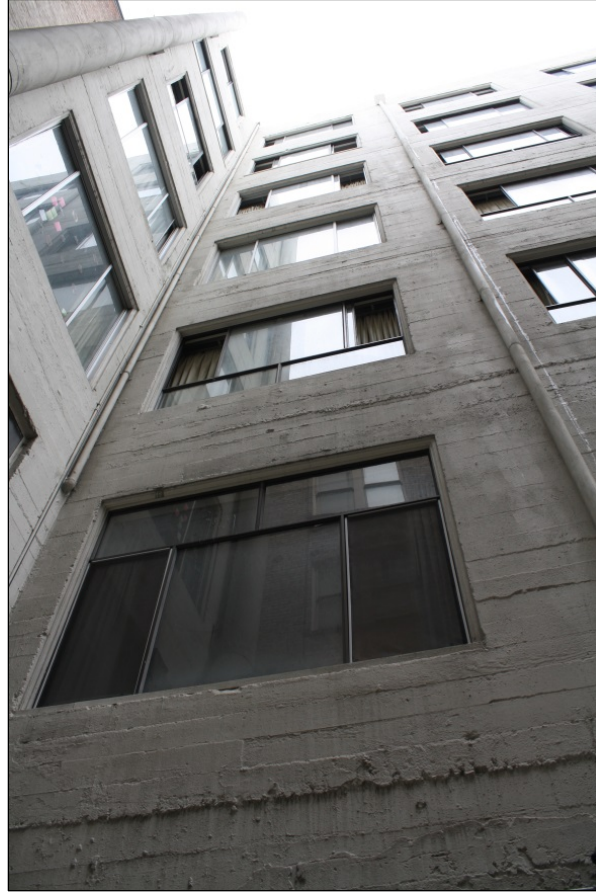
Figure 213. 817-831 Sutter Street, northeastern perspective of the western elevation.

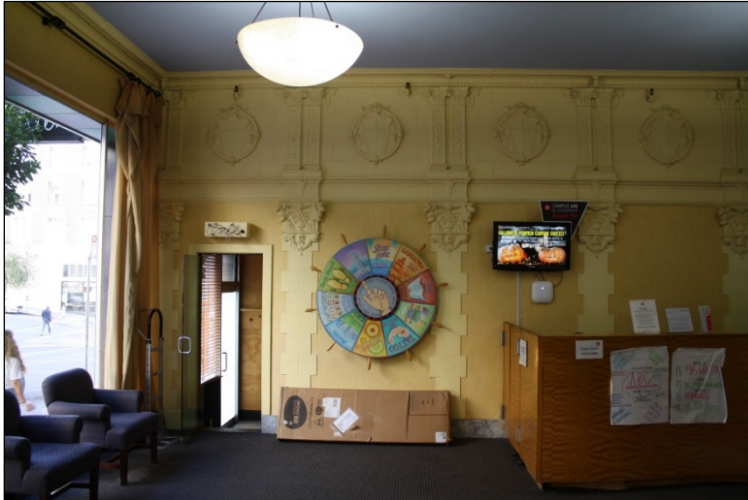
The main entry leads to a large open lobby, which features decorative molding, columns, and pilasters. When the lobby was reconfigured in 1956, the elevator doors and other interior features were removed, and more recently a glass door leading to a room behind the lobby has been added. A door on the east side of the room provides access to the yoga room, which recently replaced a former bar located in the western, ground-level commercial space. The room is now an open space with modern materials typical of its function. A glass door on the west side of the lobby, also accessed through the glass door on the primary elevation, is a former coffee shop that appears to date to the 1990s or 2000s. The materials, including seating and kitchen equipment, have been left in place although the space remains vacant. Marble stairs from the lobby lead to the residential floors with double-loaded corridors. Original rounded ceilings and wainscoting are extant throughout the upper stories.

Figure 214. Interior lobby of subject property.

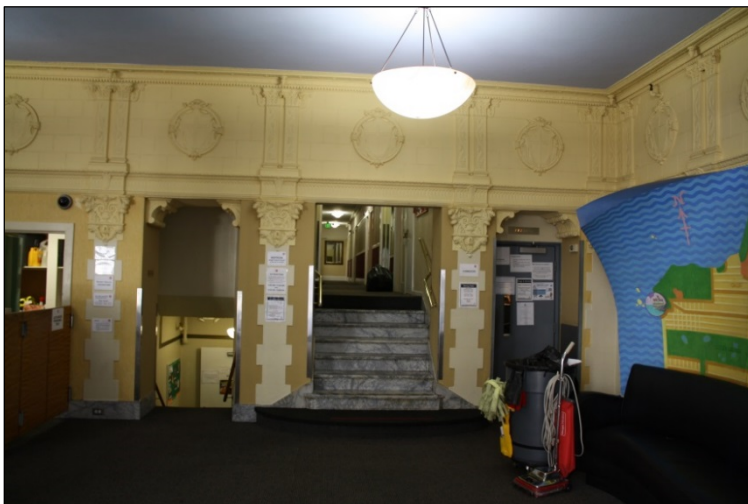
Figure 215. Interior lobby of the subject property.

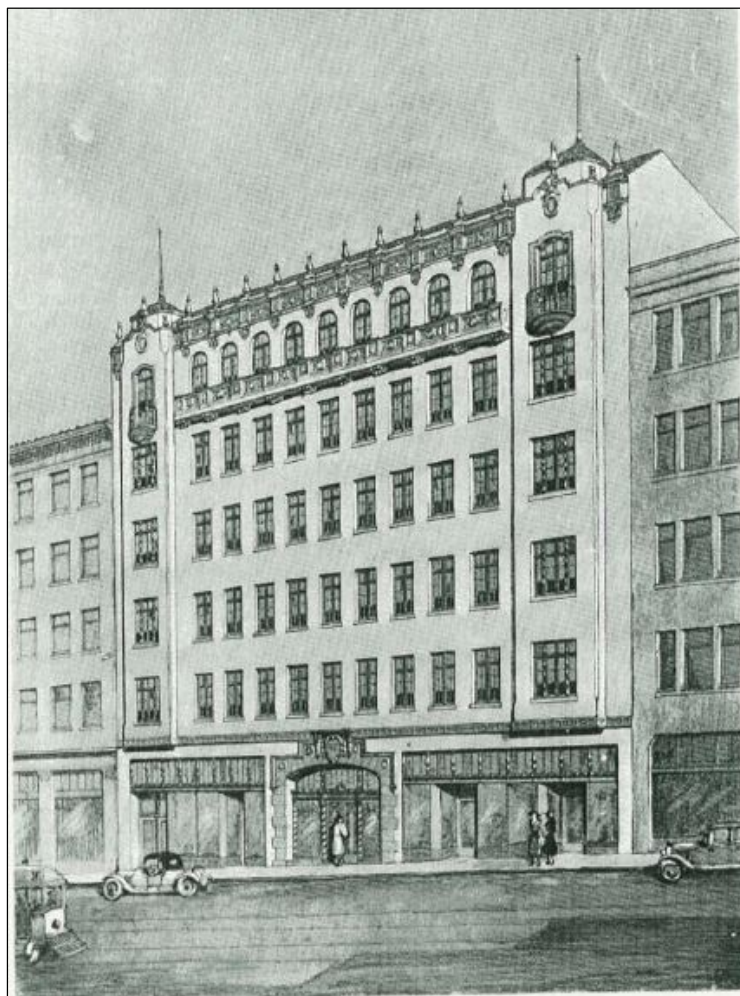
Figure 218. 1924 rendering of 817-831 Sutter Street. (Source: Architect and Engineer, January 1924)

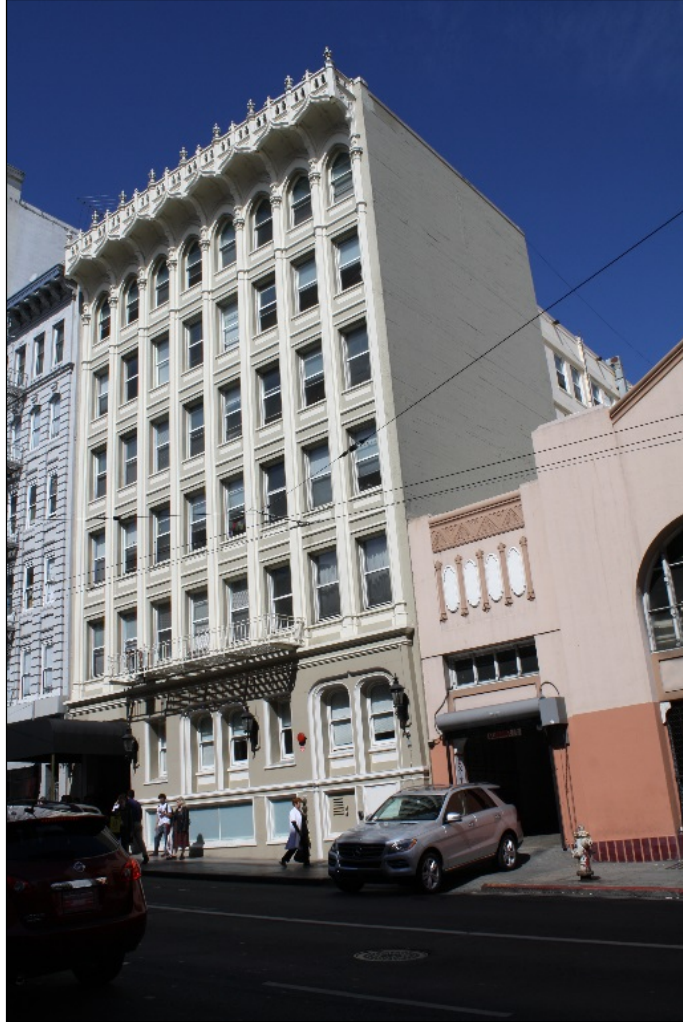
Recessed in the western corner of the façade, the main entrance is accessed via marble stairs. The doors display horse-shoe arches and tracery-like glazing. Rectangular and rounded windows with articulated ornamental surrounds are located on the first story with recessed square and rectangular windows below providing light to the basement. A short, secondary door is located on the eastern side of the elevation and leads to a walkway along the eastern side of the lot.

Figure 226. 860 Sutter Street.

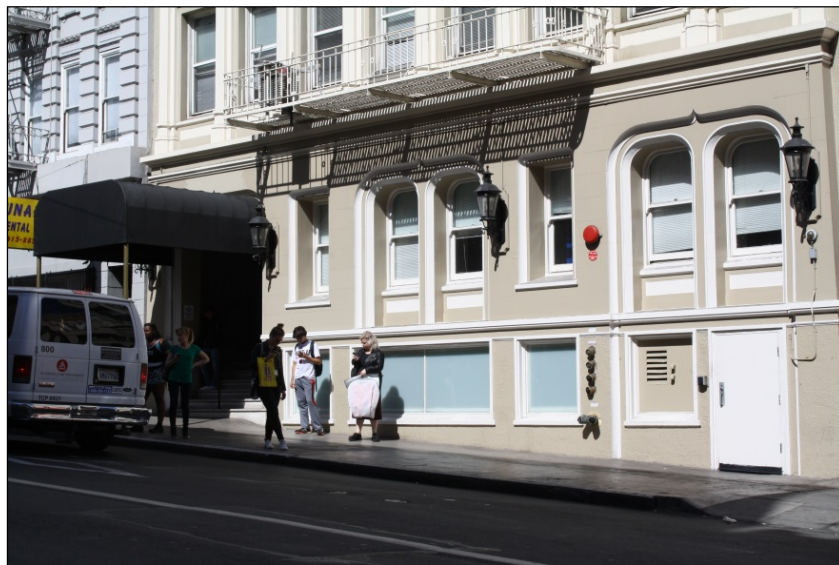
Figure 227. 860 Sutter Street, close up of the first story on the primary elevation.

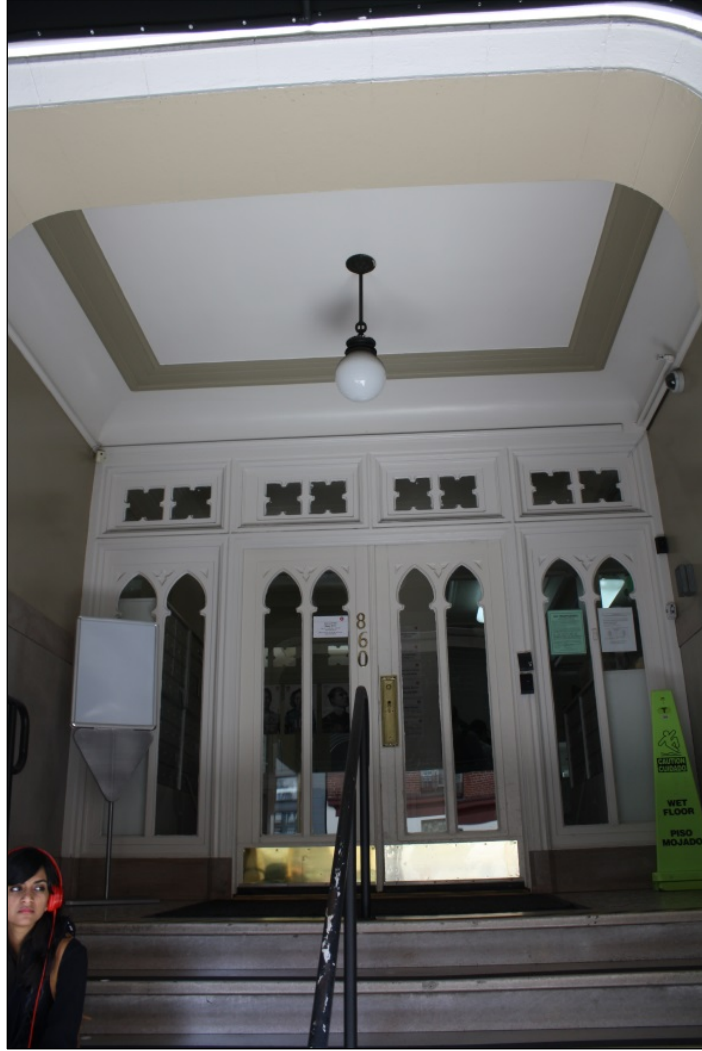
Figure 228. 860 Sutter Street, close up of the main entry on the primary elevation.
