APPENDIX HR:
Historic Resource Evaluations

Overview of Historical Resources Review and Findings

410 BUSH STREET (ES-26)

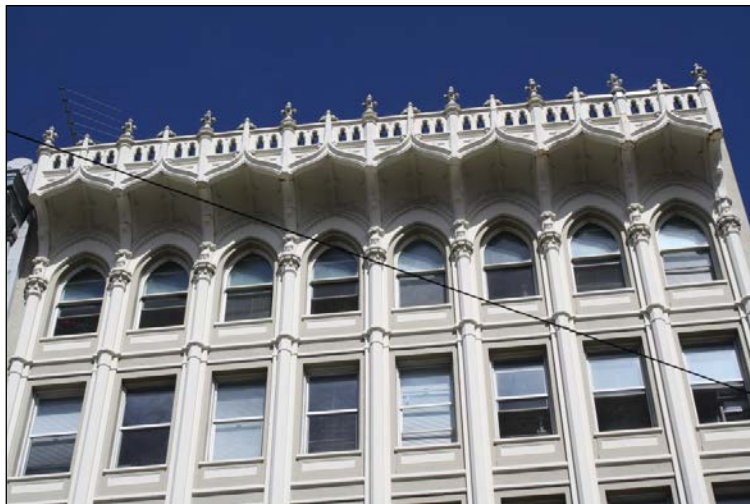
Above the first floor the fenestration pattern consists of narrow vertical bays with rectangular and arched upper windows recessed in the wall plane and paneled spandrels. Vertical piers separate the rows of upper-level windows with window types including wood and replacement vinyl double-hung windows and fixed glass windows. A central fire escape is located on the primary elevation.

Figure 229. 860 Sutter Street, close up of the upper story windows and projecting parapet on the primary elevation.

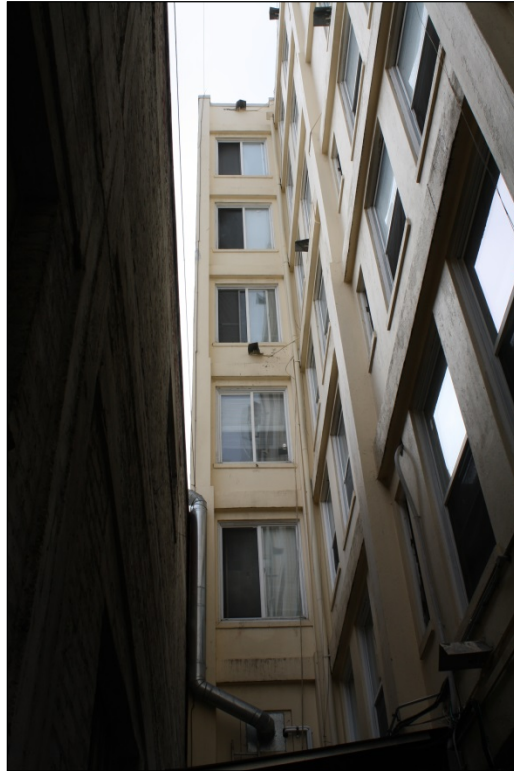
Secondary elevations are visible on the east from a narrow walkway and on the north from a small open area located between the adjacent buildings. On the ground floor of the eastern elevation is the kitchen, visible through large rectangular windows and accessed through multiple single doors. Above the ground floor, the fenestration pattern established on the primary elevation continues on the eastern elevation. On the north elevation, horizontal bands of evenly spaced windows are located on the upper stories. A second fire escape is centered on the north elevation. Horizontal seismic bracing supports join the north elevation of the structure to the rear wall on the property. Board form concrete is visible on the north elevation. There are awning windows on the first floor of the eastern elevation and horizontal bands of vinyl double-hung windows on upper stories of the east and north elevations.

Figure 230. 860 Sutter Street, southern perspective of the upper stories on the eastern elevation.

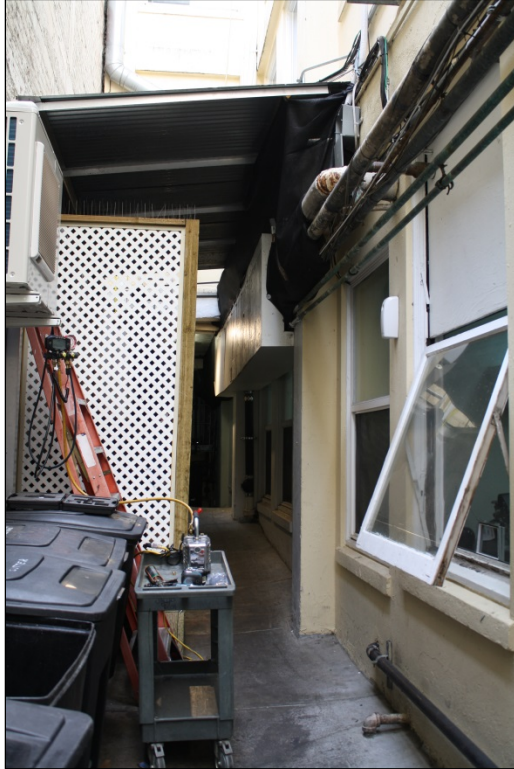
Figure 231. 860 Sutter Street, southern perspective of the first floor on the eastern elevation.

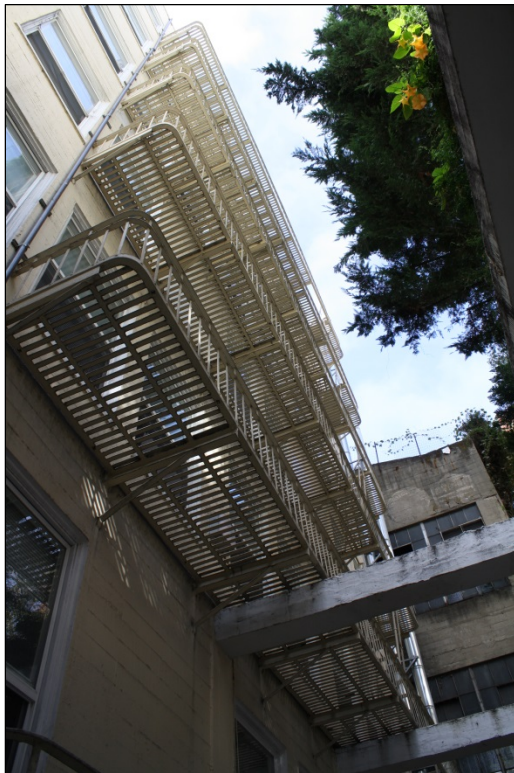
Figure 232. 860 Sutter Street, southwestern perspective of the north elevation.

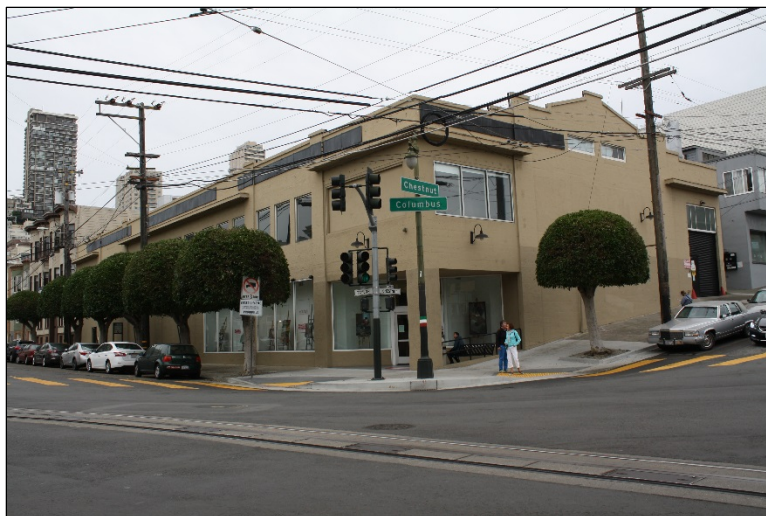
The building has minimal Mission Revival details and is two-story building is capped with a flat roof and a parapet with a shallow copping at the eaveline. Constructed of reinforced concrete, board-formed concrete is visible around the building.

Figure 243. 2295 Taylor Street.

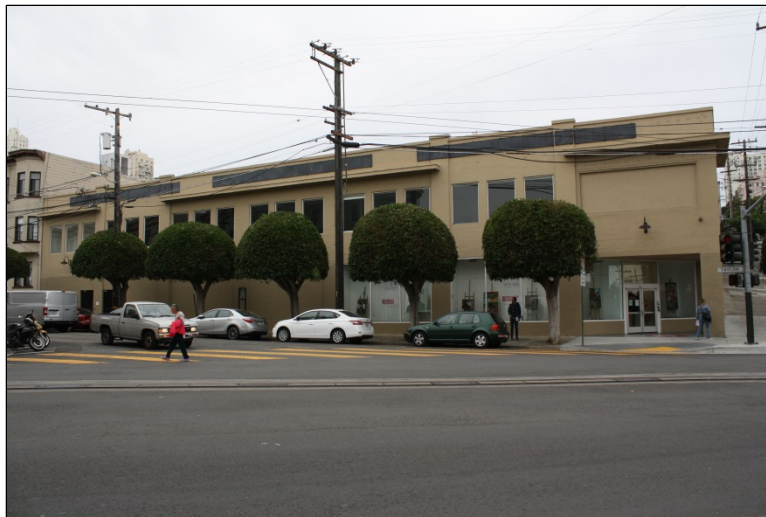
Located at the northeast corner of the building is a recessed entryway with non-original aluminum glass double-doors that is flanked by a transom and large storefront windows, and set at a 45 degree angle to face the corner of the block. The east elevation is divided into five bays by columns with a larger center bay. The columns rise just above the parapet and are capped with a shallow coping. Two sets of nonoriginal large three-part storefront windows are located immediately east of the main entry. To single metal personnel doors are located on the southern bays of the elevation. The second floor features a vertical band rectangular fixed-glass windows; three in the smaller bays and nine in the center bay. The northern most bay has an in-filled recessed panel instead of windows. A projecting cornice is featured on the northern, southern, and center bay above the second story windows.

Figure 244. 2295 Taylor Street, the primary elevation.

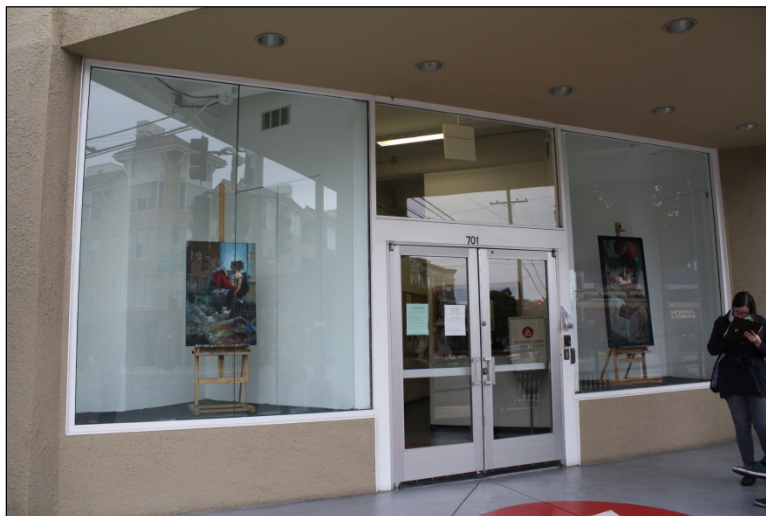
Figure 245. 2295 Taylor Street, close up of the main entry on the primary elevation.

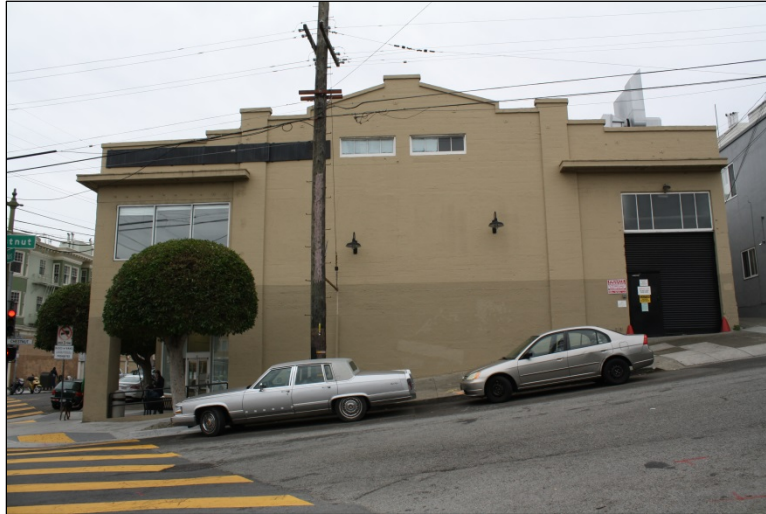
Secondary elevations are visible on the north and west elevations. The north elevation features three bays, divided by the same columns as seen on the primary elevation. The eastern bay contains the recessed main entry on the ground floor with three fixed-glass windows above. The projecting cornice turns the corner

from the primary elevation and continues on the eastern by of the north elevation. The larger central bay features a stepped parapet and two small, original rectangular multi-light windows above the second story. The western bay has a large roll-up door with an inset personnel door and a multi-light transom window. Above the door is the projecting cornice line. The western elevation facing the alley space has no fenestration or openings.

Figure 246. 2295 Taylor Street, southern perspective of the northern elevation.

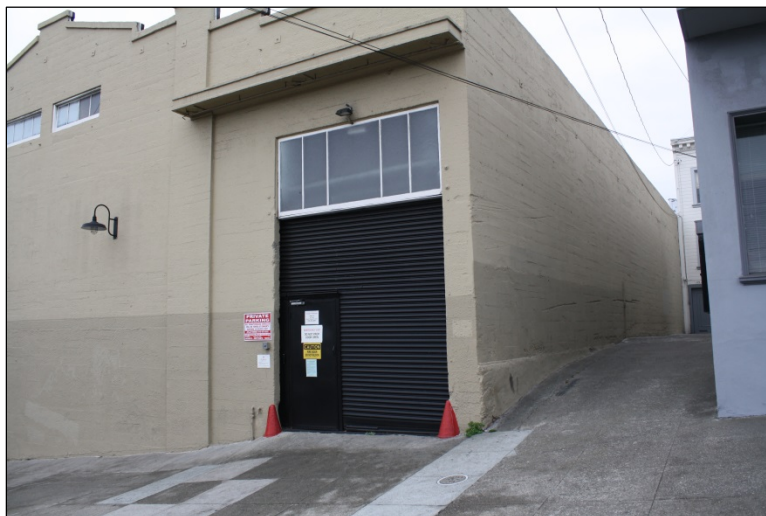
Figure 247. 2295 Taylor Street, southwestern perspective of the western elevation.

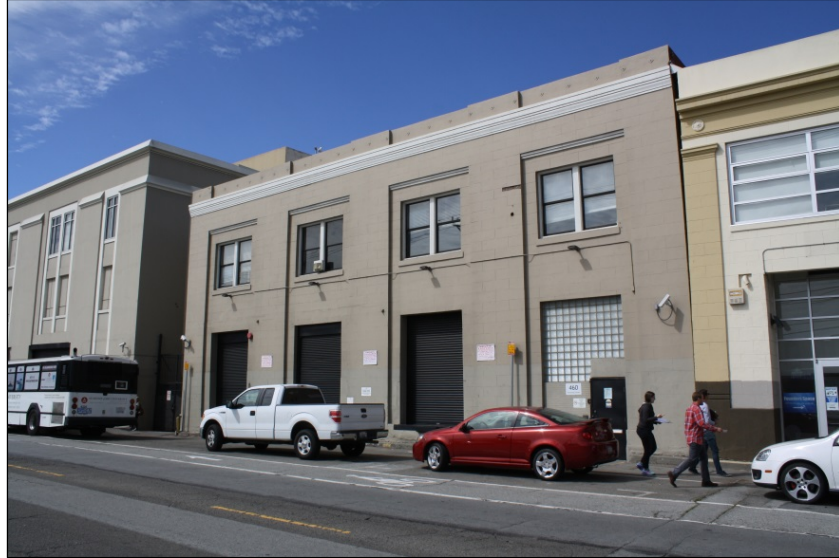
The symmetrical primary elevation is composed of four defined structural bays with a large rectangular opening on the ground floor and a pair of vinyl double-hung windows recessed in the wall plane above. Three of the large ground floor openings are filled with roll-up doors and the fourth has been in-filled with a single personnel door, concrete, and glass block. Above the second floor, a cornice line spans the length of the facade.

Figure 258. 460 Townsend Street.

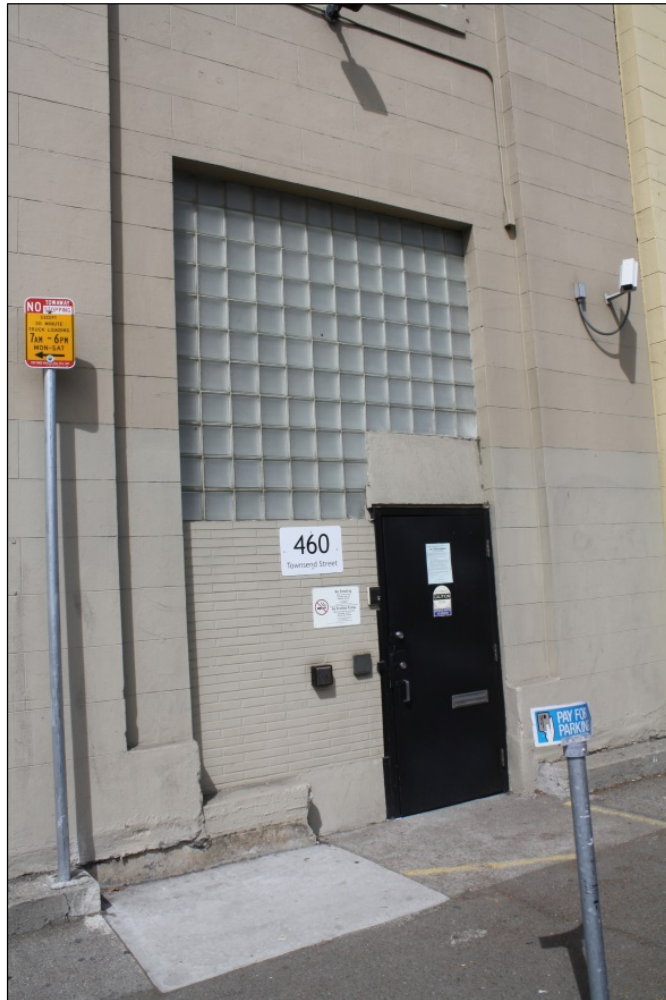
Figure 259. 460 Townsend Street, close up of the entry on the primary elevation.

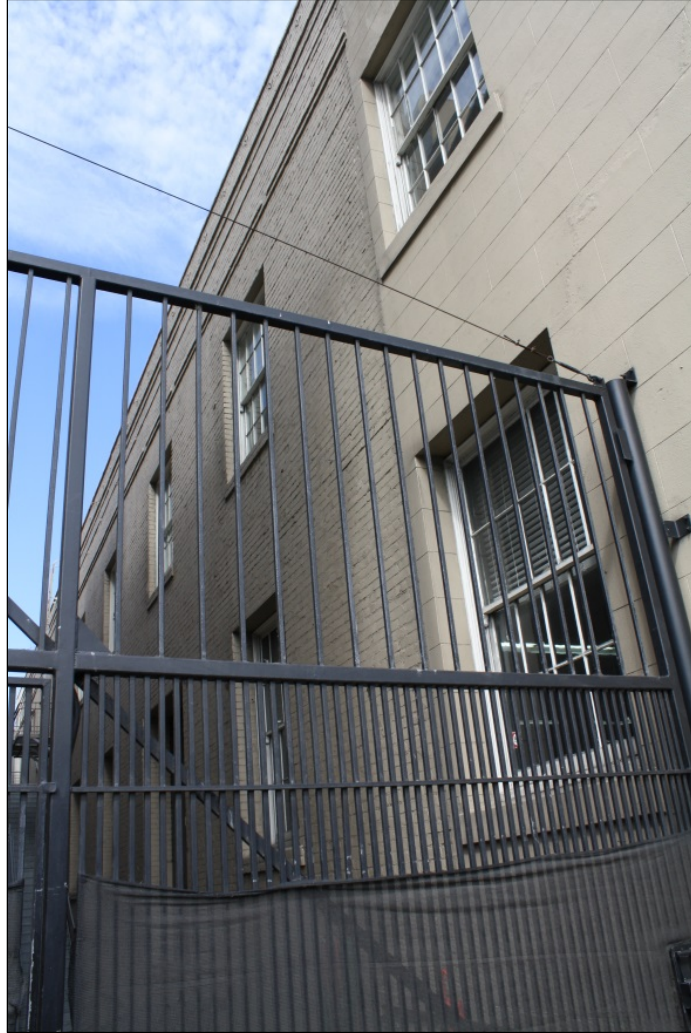
A secondary elevation is visible on the southwest facing the adjacent alley. There is a large original, wood double-door on the first floor and a metal stair case leads to the second story at the northern end of the elevation. The brick construction is visible on the elevation, although it has been painted to match the primary elevation. Original multi-pane, double-hung wood windows are evenly spaced horizontally along first and second story of the elevation.

Figure 260. 460 Townsend Street, northern perspective of the southwestern elevation.

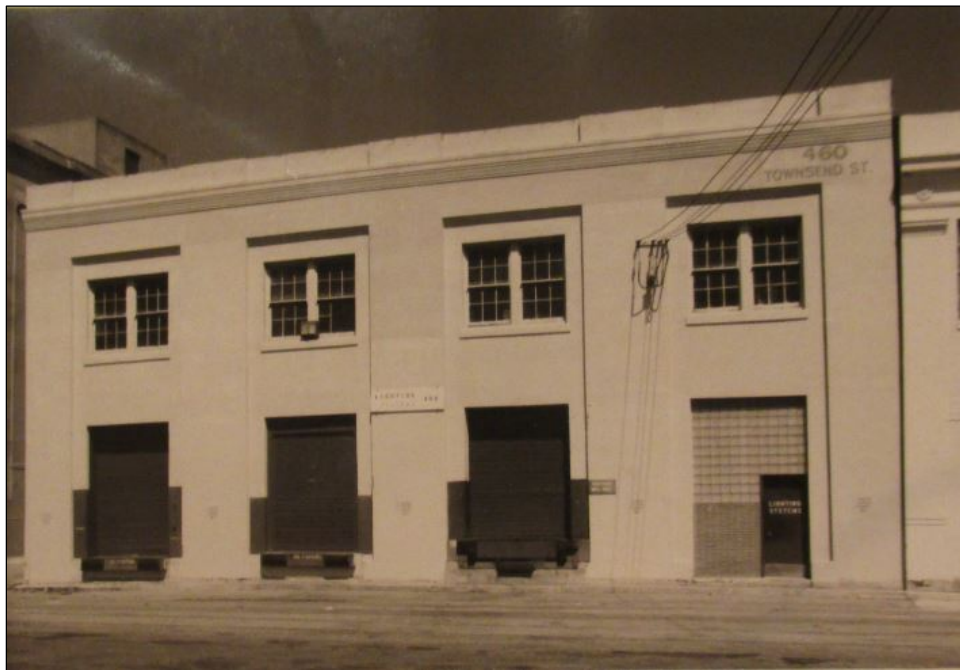
Figure 262. 1981 photo of 460 Townsend Street. (Source: San Francisco Heritage)

460 Townsend Street has been altered though the replacement and infill of original doors and windows on the main (south) elevation, however it still exhibits many of the features that convey the significance of the district, including scale, massing, and fenestration pattern. As such the building, and the district as a whole, retains sufficient historic integrity. The property has therefore been assigned a CHR Status Code of 5D3 and is considered a historical resource for the purposes of CEQA.

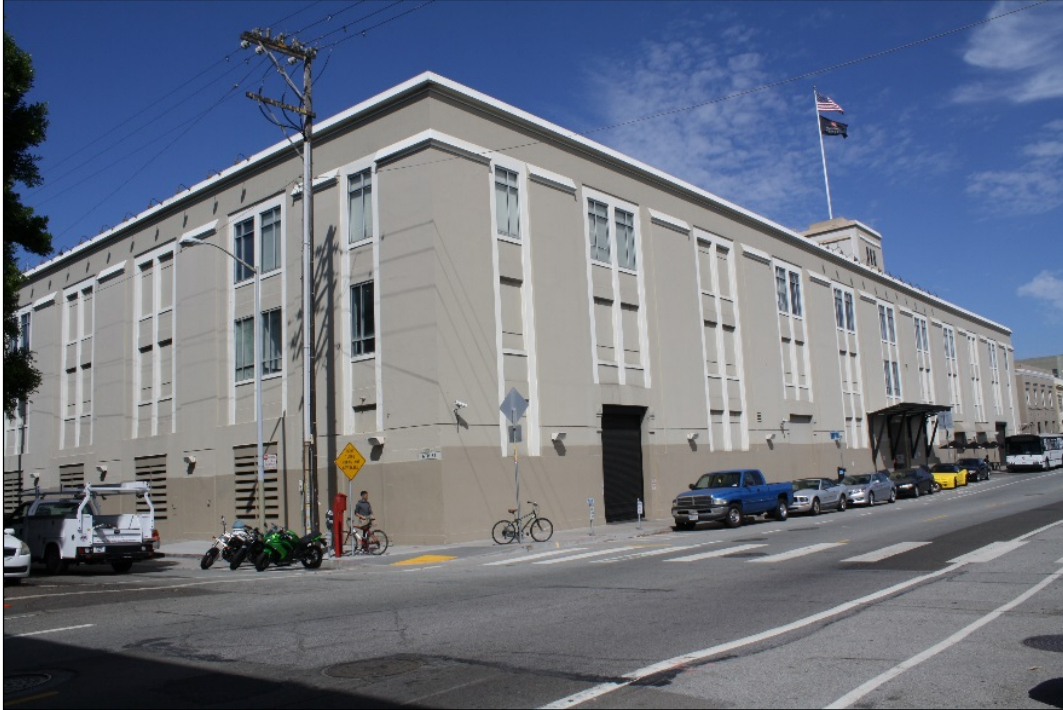
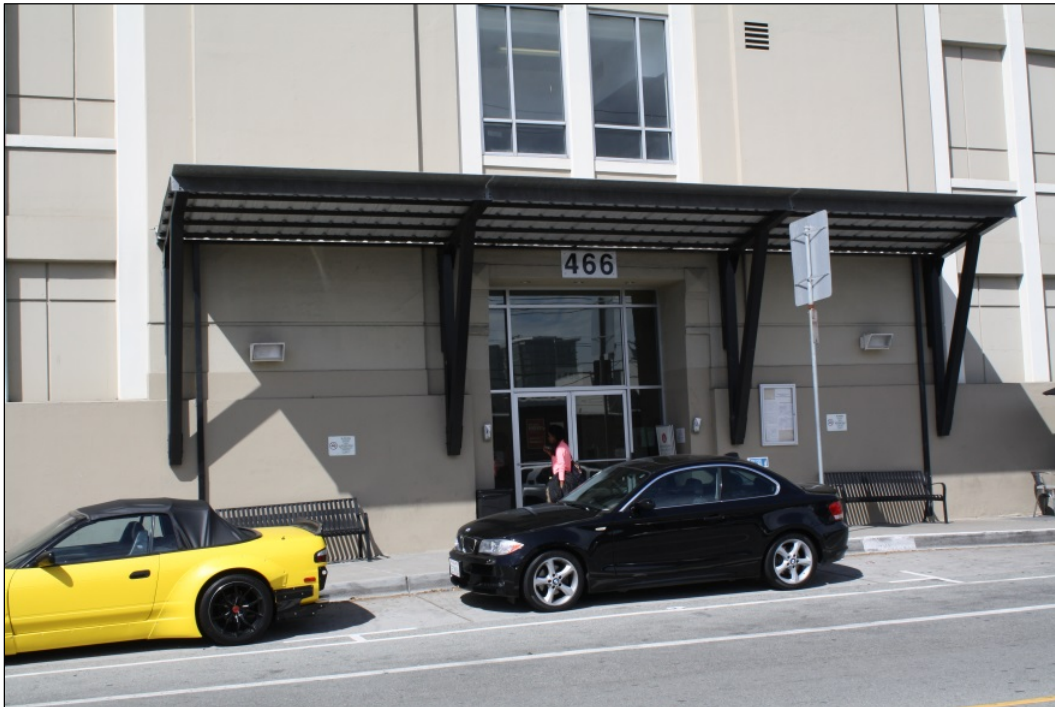
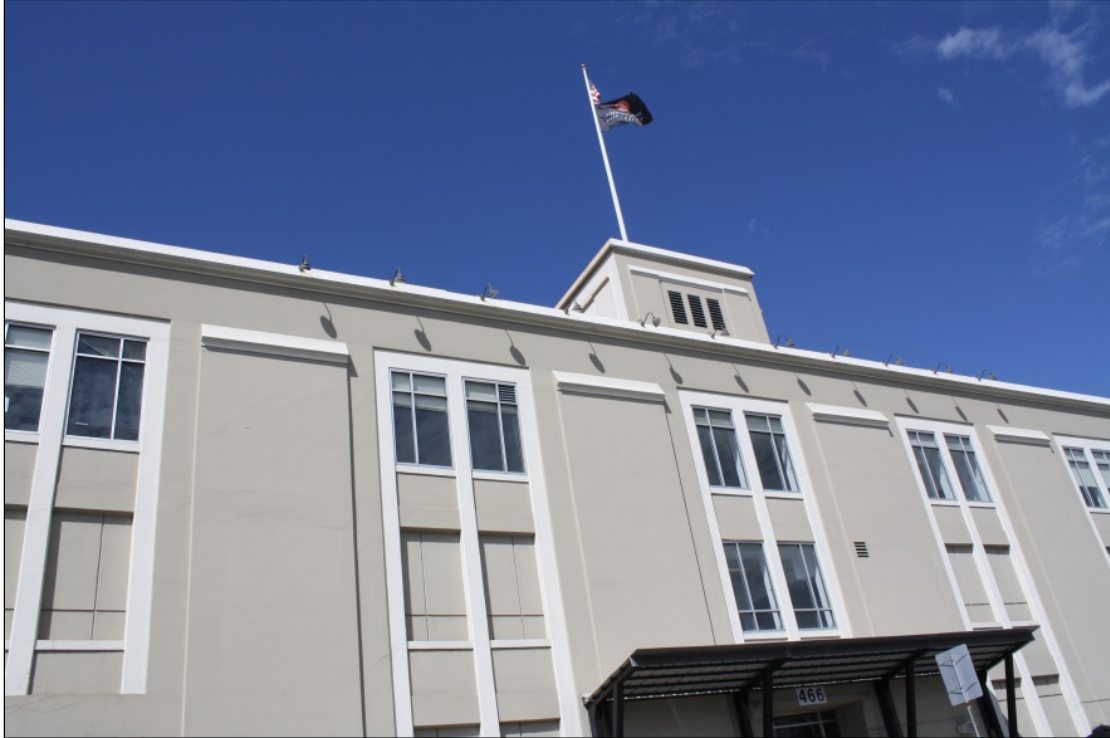
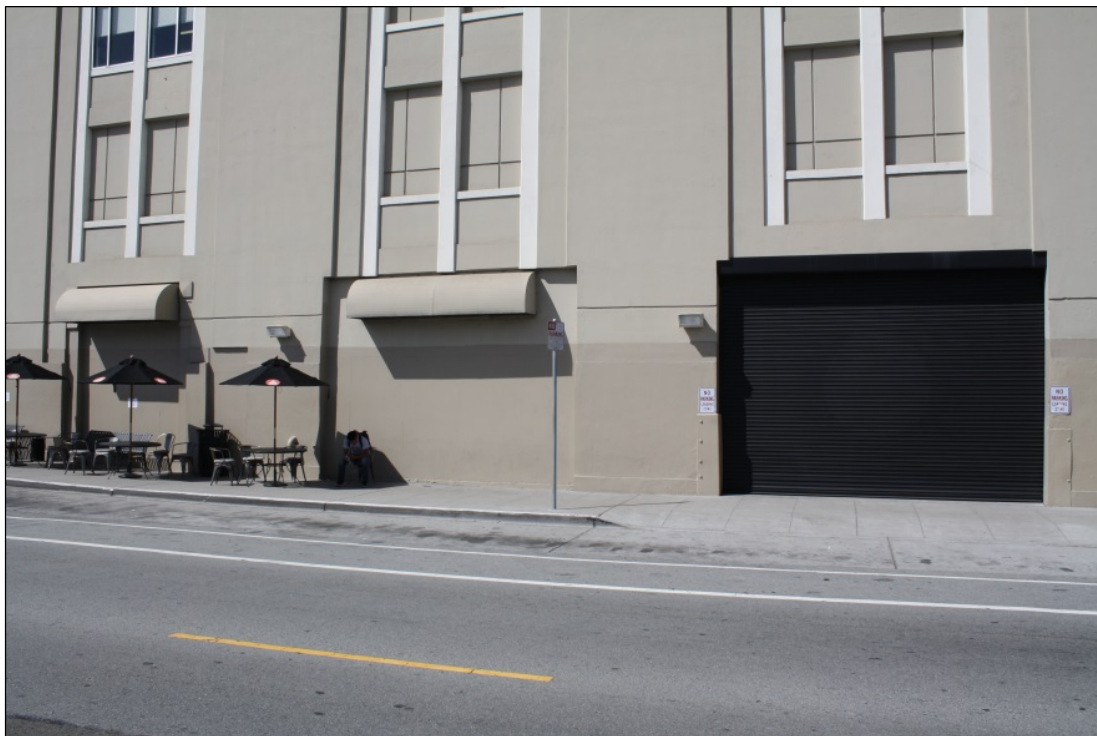
Figure 270. 466 Townsend Street.

Figure 271. 466 Townsend Street, close up of the main entry on the primary elevation.

Figure 272. 466 Townsend Street, close up of the windows and fenestration pattern on the primary elevation.

Figure 273. 466 Townsend Street, close up of the roll-doors and in fill on the northern half of the primary elevation.

The overall character, massing, and reinforced concrete construction of the property are characteristic of post-1906 earthquake and fire industrial reconstruction in the South of Market. The building displays a symmetrical design composition, with design details provided in horizontal and vertical banding. Smooth stucco sheathes the exterior walls. The building is capped with a flat roof with a parapet and a shallow, unadorned overhanging eaves.

Centered on the façade, the main entry consists of aluminum glass doors with sidelights and a transom, sheltered beneath a metal canopy supported on knee-braces. Large roll-up doors are located on eastern and western end of the elevation. Former large openings on the northern end of the elevation have been in-filled. Vertical and horizontal bands frame the stacked windows, creating bays and a distinctive fenestration pattern within the bays. Original windows have been replaced with multi-light fixed windows or in-filled with concrete and scored to replicate the multi-light window pattern. Centered above the main entry on the roof is an extending tower with a flag pole.

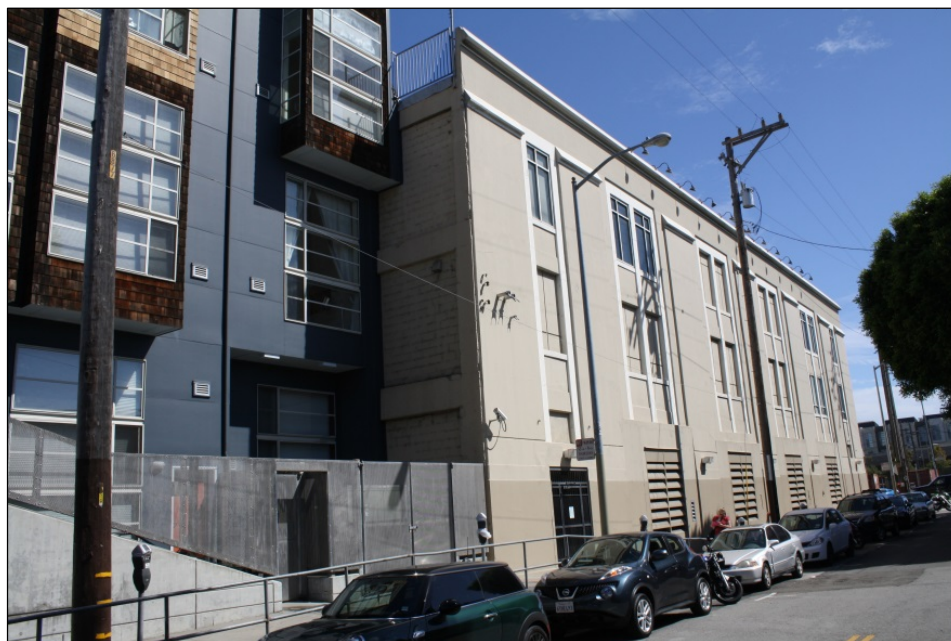
Figure 274. 466 Townsend Street, southeastern perspective of the southwestern and northwestern elevations.

The secondary elevations continue the fenestration and bay pattern and use of windows and scored concrete of the facade. Along the southwest elevation, on the first story of each bay, are large rectangular vents and a roll-up door. A small portion of the northwestern elevation is visible along Sixth Street. Although there is no fenestration, the masonry construction is visible. On the northeastern elevation, the windows have been in-filled.

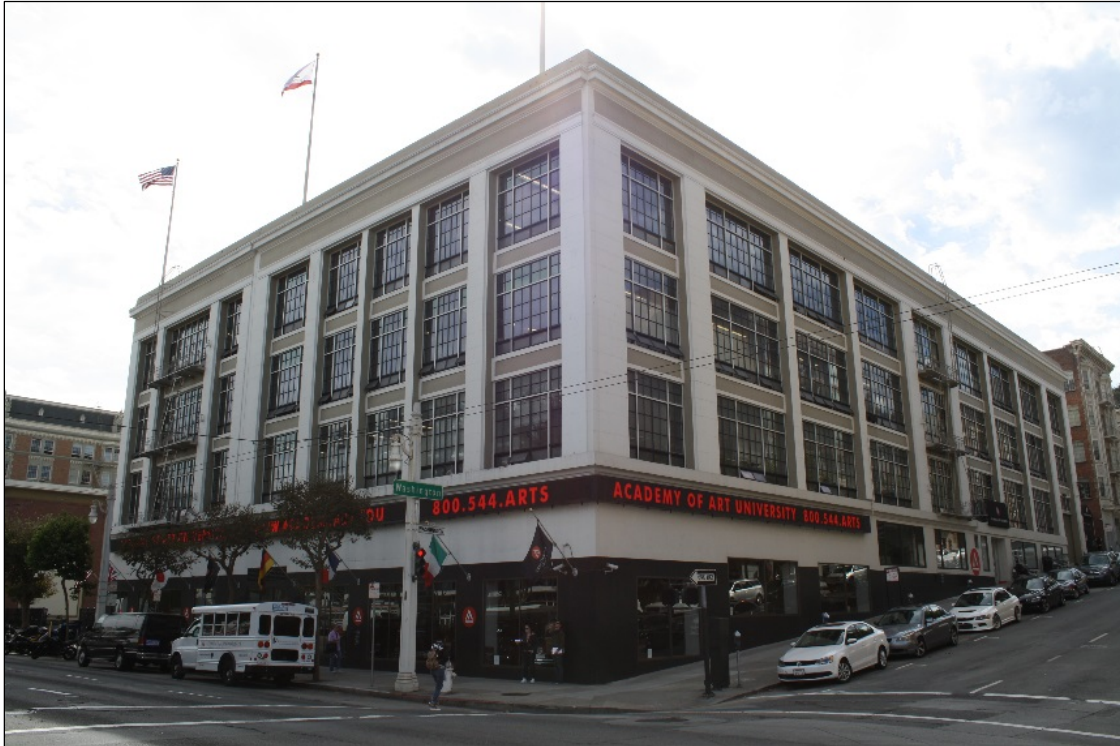
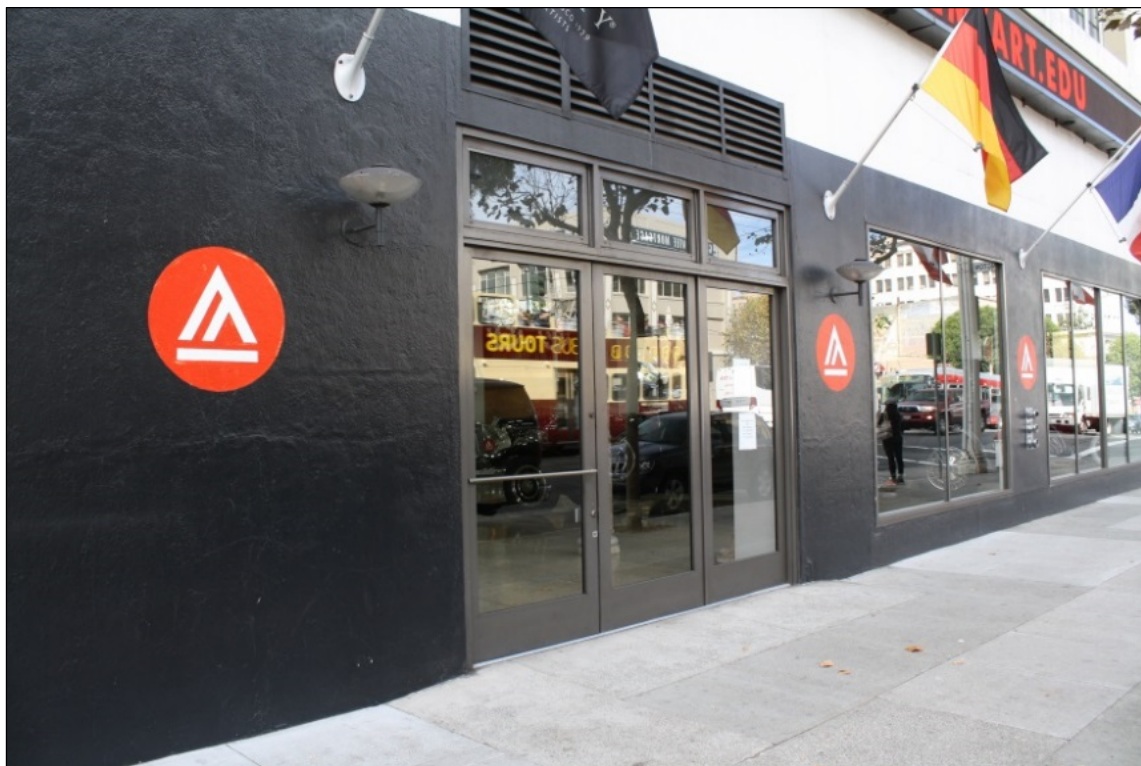
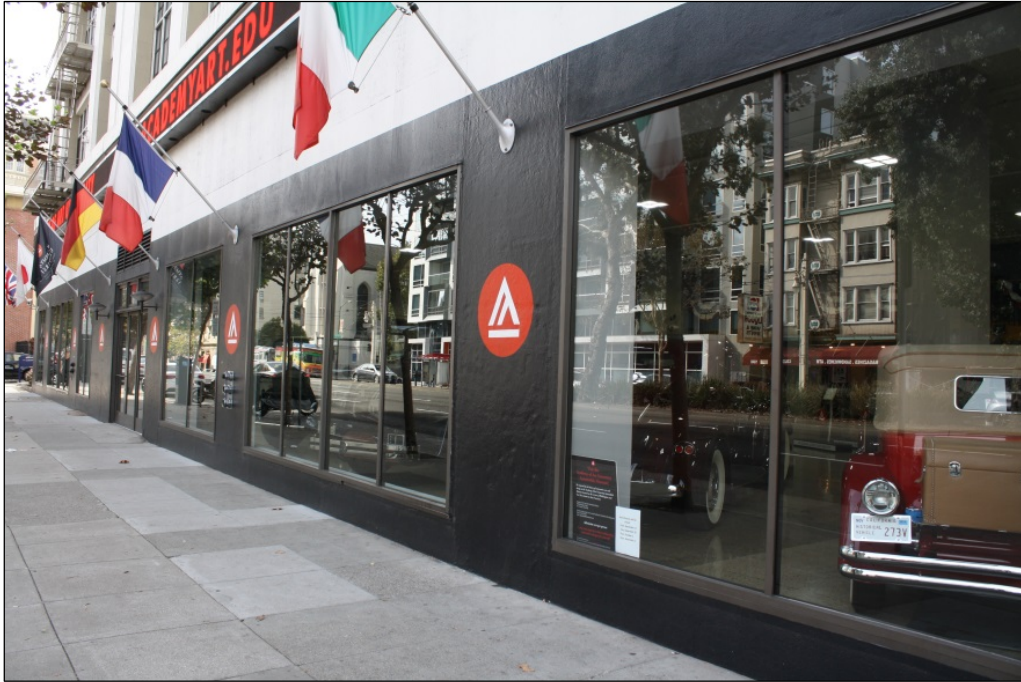
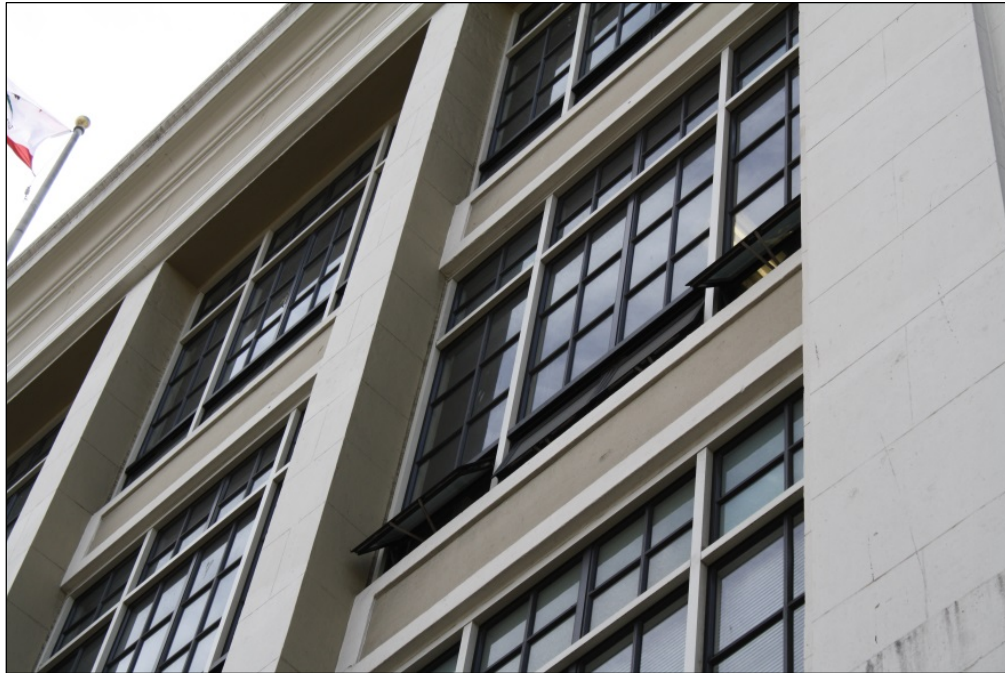
Figure 282. 1849 Van Ness Avenue.

Figure 283. 1849 Van Ness Avenue, close up of the main entry on the primary elevation.

Figure 284. 1849 Van Ness Avenue, close up of the first story on the primary elevation.

Figure 285. 1849 Van Ness Avenue, close up of the windows on the primary elevation.

The former automotive showroom at 1849 Van Ness Avenue was constructed in 1920 with a large addition to the south completed in 1926, resulting in its current rectangular plan. It is set flush to the sidewalk on a rectangular, sloped lot, with a primary elevation fronting Van Ness Avenue and secondary elevations facing the neighboring properties and Washington Street. The four-story structure is capped with a flat roof with a profiling cornice.

On the primary elevation, the 1920 portion is composed of five bays of equal width while the 1926 addition is composed of three bays with a wider middle bay. The main entry is a three-part aluminum framed glass folding door with transoms above. Large storefront windows line the first story with a smooth, unadorned frieze and cornice above separating the first story from the upper stories. An LED band sign and flag poles have been added just below the cornice line. Nonoriginal stacked multi-light windows on the upper stories are divided by vertical piers and paneled spandrels.

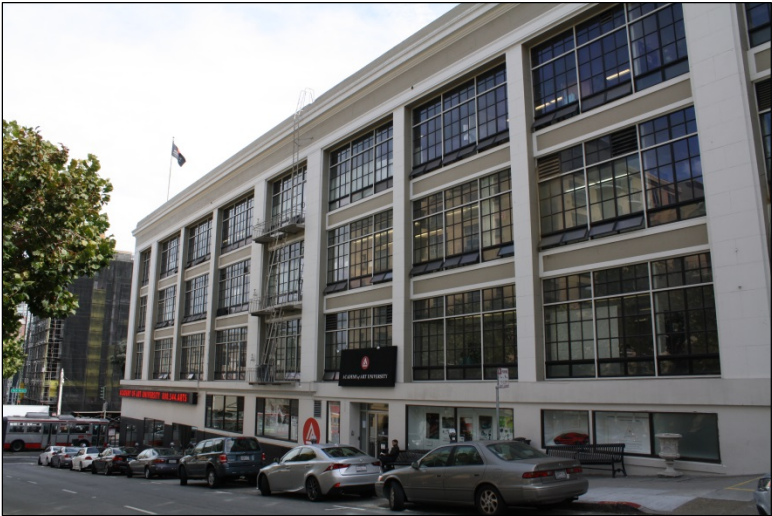
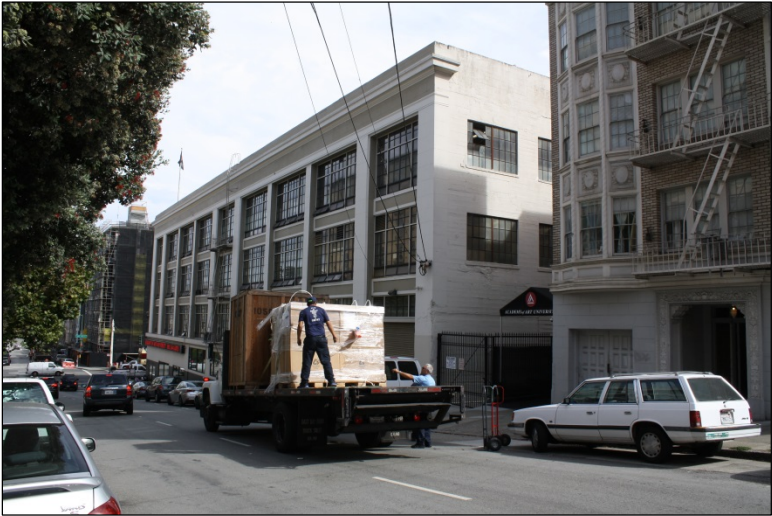
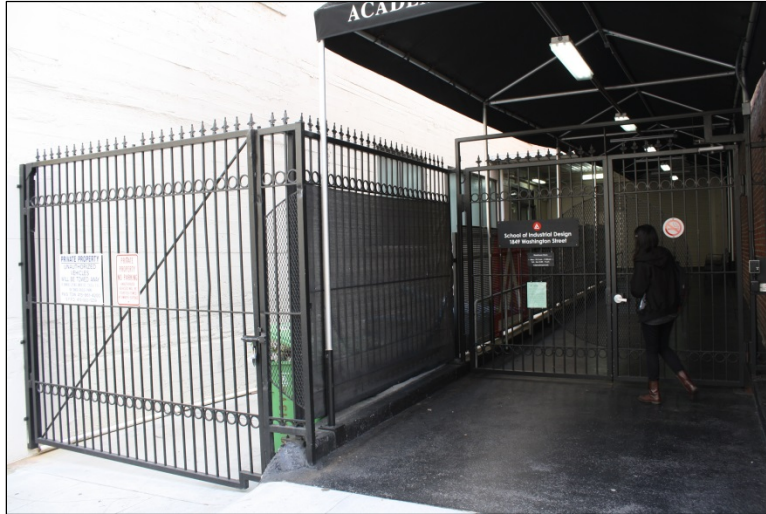
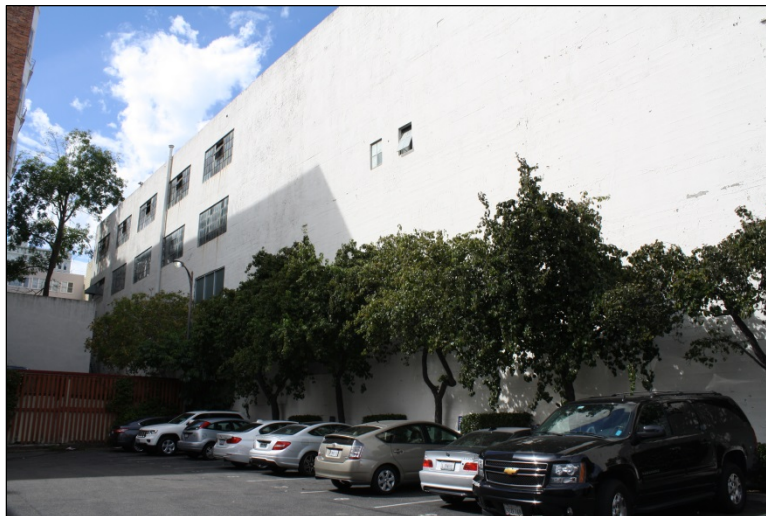
Figure 286. 1849 Van Ness Avenue, southeastern perspective of the north elevation.

Figure 287. 1849 Van Ness Avenue, southeastern perspective of the north and west elevations.

Figure 288. 1849 Van Ness Avenue, southern perspective the entry of the west elevation.

Figure 289. 1849 Van Ness Avenue, northwestern perspective of the southern elevation.

Secondary elevations are visible on the north, south, and west elevations. The north elevation continues the fenestration pattern established on the primary elevation. The first story has three smaller storefront windows beginning the eastern corner. Four long rectangular display windows flank a recessed aluminum framed glass double-door with sidelights and a transom. A double-door entry, accessed via a ramp with a security gate, and rectangular evenly spaced windows on the upper stories are extant on the west elevation.

The south elevation has minimal fenestration of the eastern half and large evenly spaced rectangular windows on the western half. Aluminum and metal multi-light with awning windows and fixed glass are present on the secondary elevations in a variety of configurations.

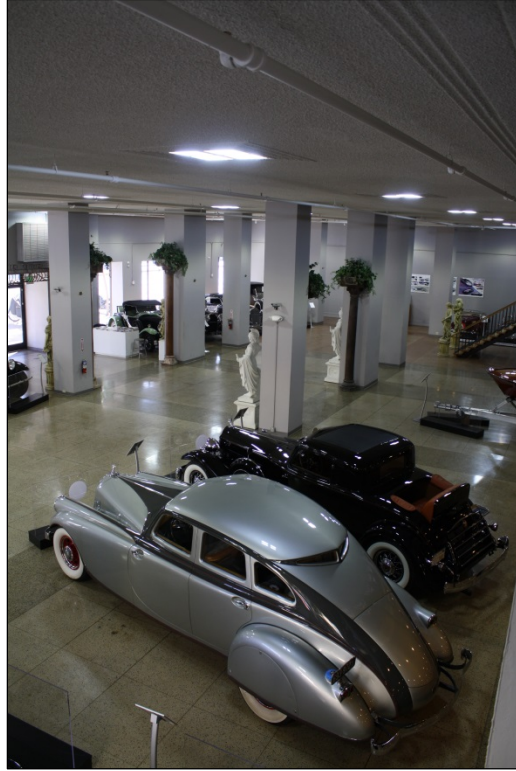
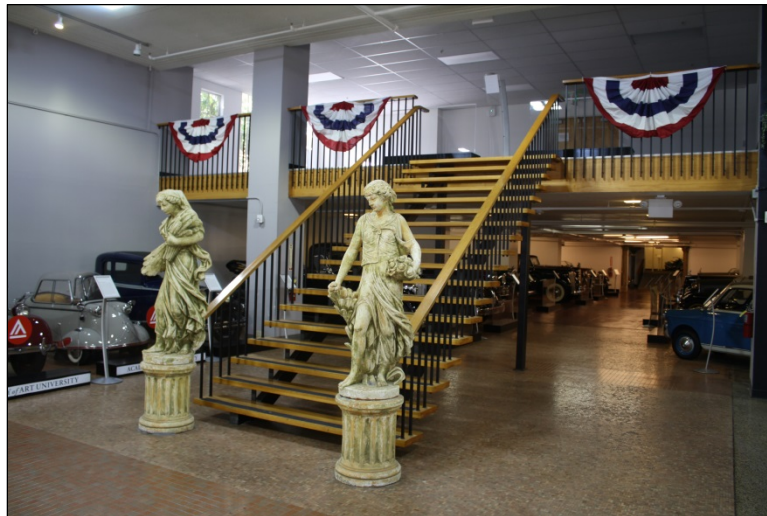
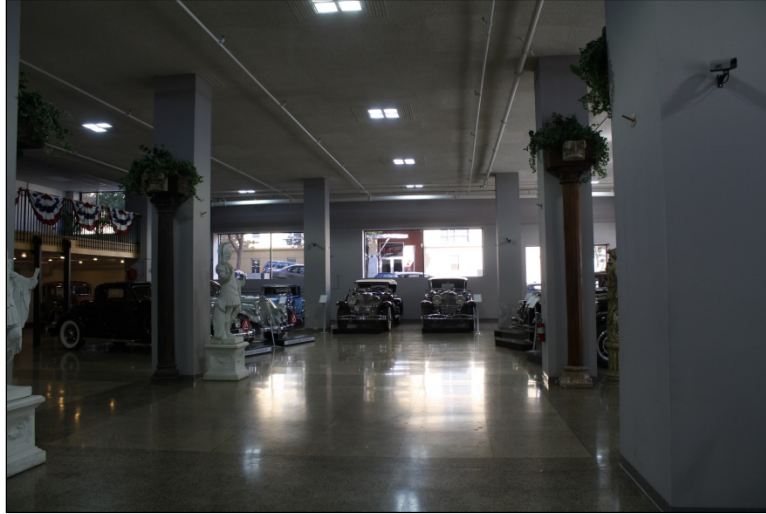
Figure 290. Interior showroom of subject property.

Figure 291. Interior showroom and stair to loft of subject property.

Figure 292. Interior showroom of subject property.

The main entry leads to a large open showroom with tall ceilings. Tile and terrazzo floors differentiate the original portion from the 1926 addition. A nonoriginal wood staircase in the addition leads to an open loft overlooking the showroom. A car ramp is located past the staircase and provides access to the rear showroom, which is differentiated with concrete floors and a lower ceiling. The upper stories have been altered to various degrees, largely the result of partitions added to create classrooms, workshops, and offices. Original extant features a wood truss roof system on the top floor of the south wing, interior auto ramps and elevator, and concrete floors with painted direction signs.

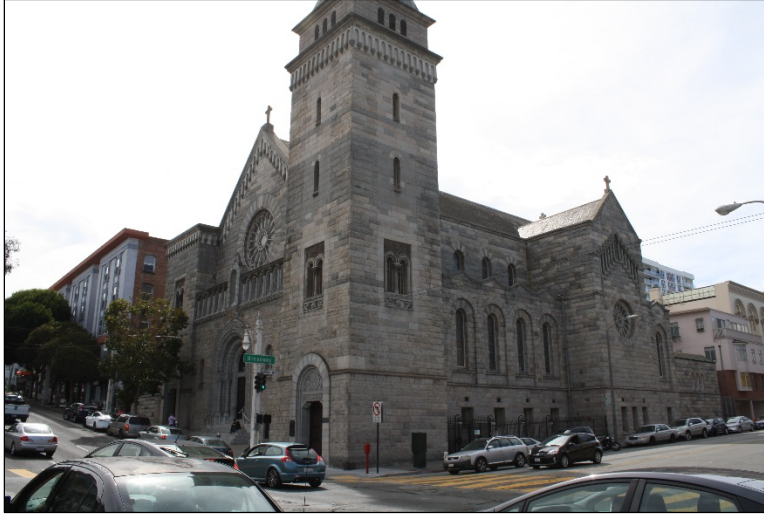
Comprised of varying volumes and heights, the Gothic-Richardsonian Romanesque style building displays an interweaving of Celtic and Romanesque themes throughout. The primary volume features a cross-gable roof, rounded half dome above the apse, and a flat roof on the sacristy addition to the west. Clad in masonry, granite curbstones, and terra cotta wall cladding, the church has a five-story northeast corner of the lot and two-story flat roof tower on the southeast corner. The rooflines are marked by arcading. Characteristic of the style, the structure features detailed ornamentation of the entry portals, arched windows, and rose and arched windows.

Figure 304. 2151 Van Ness Avenue.

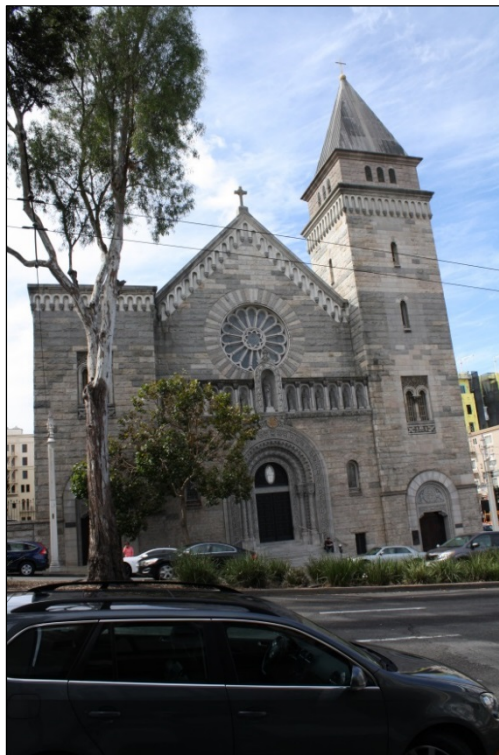
A central main entry with a detailed double-panel doors and a decorative stone surround with five concentric arches is featured on the primary elevation. Above the main entry is a row of deco style statues in arched niches, with the center niche standing taller than the rest, and a border molding. A rose window encircled by granite blocks is centered above the statues. Secondary entries flank the main entry on the ground floor of each tower with a pair of arched stained glass windows separated by a column above. Single narrow arched windows flank the main entry and define the upper stories of the northeastern tower. Ornamental Lombard bands are present on the gable ends and between the towers.

Figure 305. 2151 Van Ness Avenue, primary elevation.

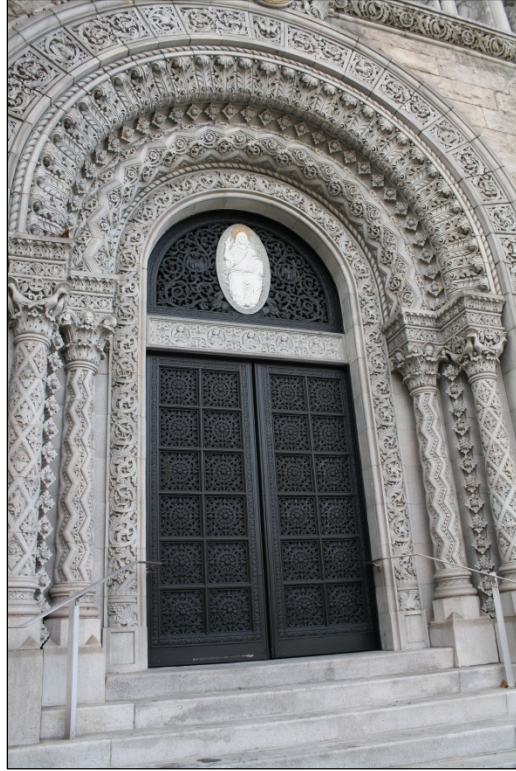
Figure 306. 2151 Van Ness Avenue, close up of the main entry on the primary elevation.

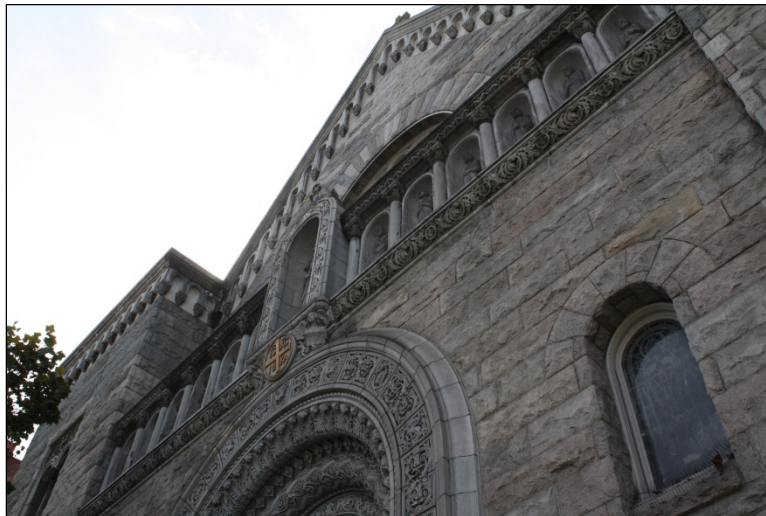
Figure 307. 2151 Van Ness Avenue, close up of the ornamentation on the primary elevation.

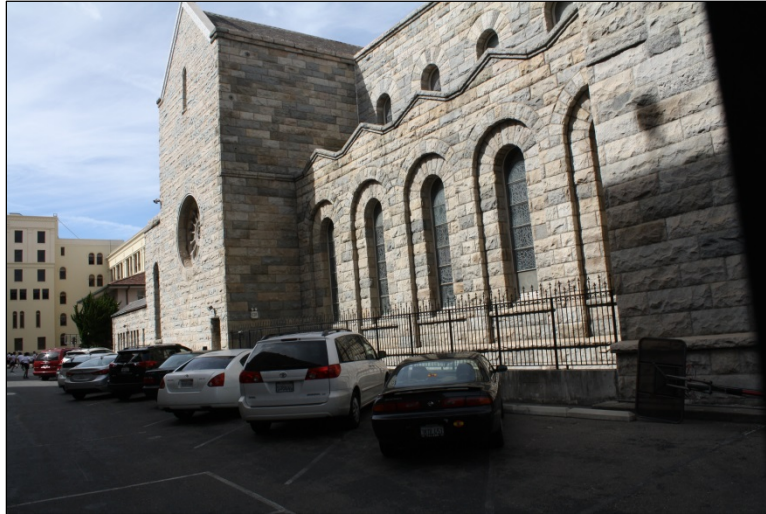
Secondary elevations are visible on the north, south, and west elevations. The north and south elevation feature tall arched arcades stained glass windows with surrounds along the nave. Smaller arcades of arched stain glass windows are located on the upper story of the north and south elevation along the nave and wrapping around the chancel on the west elevation. Rose windows with granite surrounds are located on the wings extending from the sanctuary. On the northern elevation, above the rose window is a V-shaped row of statues in arched niches with a border molding. Underneath the windows of the nave are single doors leading to the basement; there are four on the north elevation and one on the south elevation. Security

Figure 308. 2151 Van Ness Avenue, northwestern perspective of the south elevation.

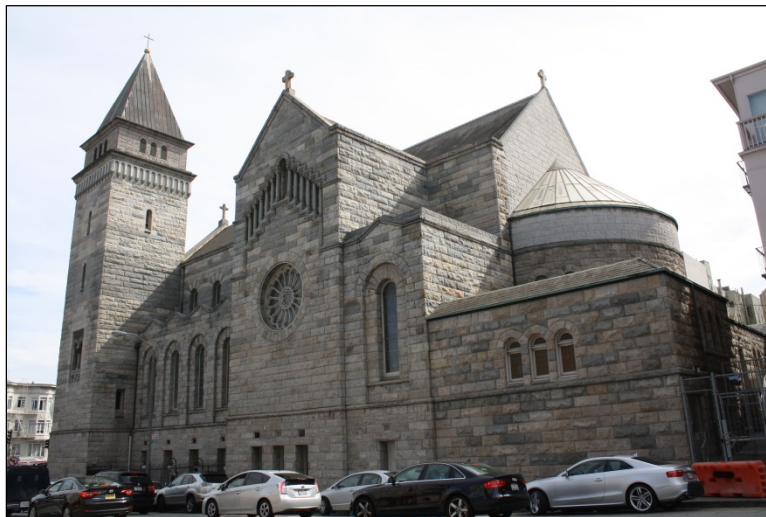
Figure 309. 2151 Van Ness Avenue, southeastern perspective of the north and west elevations.

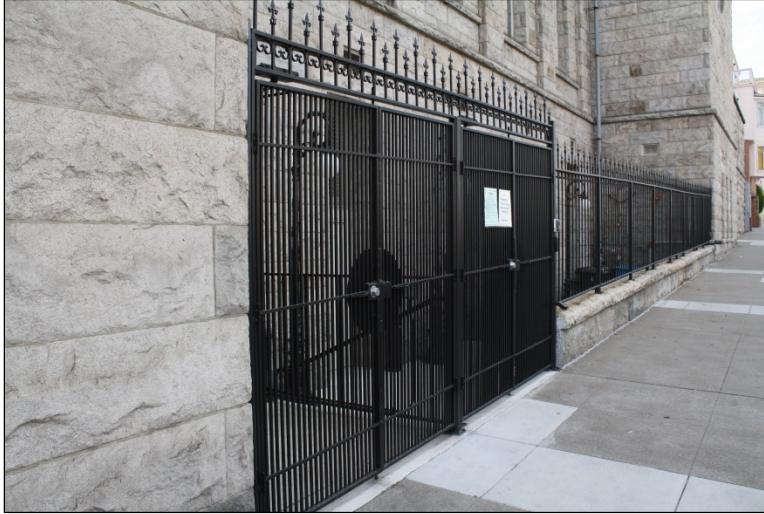
fencing has been added in front of the nave between the towers and extending wings along the north and south elevations, restricting access to the basement doors. Access to the western elevation is restricted by a chain-link metal fence with an inset door. On the ground story of the western elevation, in the northern corner, is a metal double-door which currently functions as the primary entry. Stained glass windows in circular, rose, and arched window openings are found on the secondary elevations in various configurations.

Figure 310. 2151 Van Ness Avenue, close up of the security gate in front of the basement doors on the north elevation.

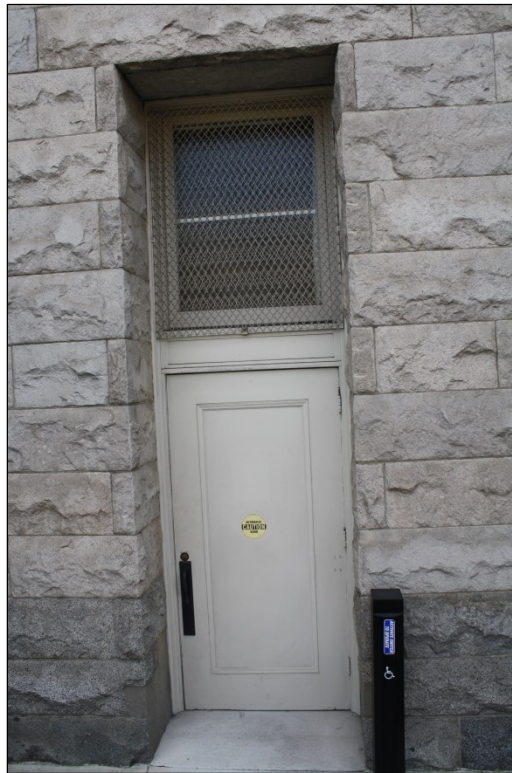
Figure 311. 2151 Van Ness Avenue, close up of the basement doors on the northern elevation.
