APPENDIX HR:
Historic Resource Evaluations

Overview of Historical Resources Review and Findings

410 BUSH STREET (ES-26)

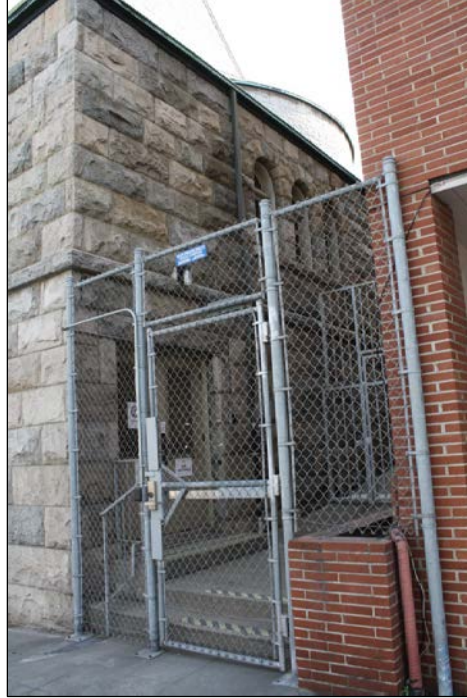
Figure 312. 2151 Van Ness Avenue, close up of the gate and entry door on the western elevation.

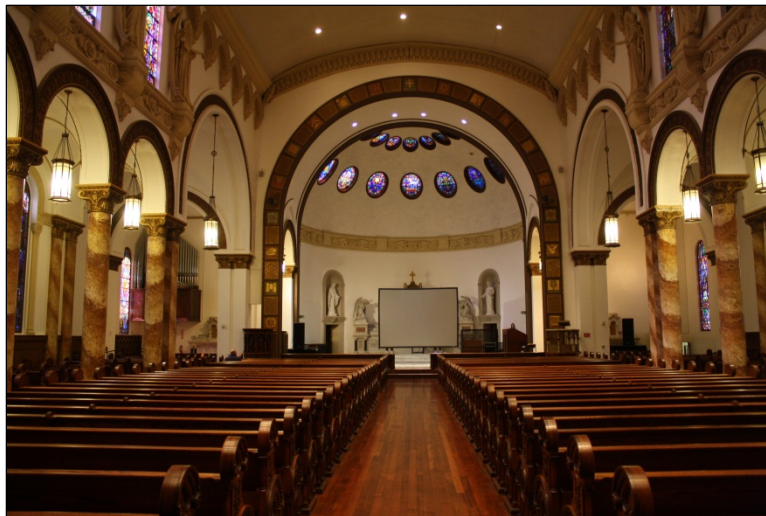
The main entry leads to a small rectangular narthex, which opens to the nave through paneled wood double-doors. The interior of the church is primarily intact from its original construction. Original features throughout the nave and sanctuary include the spatial arrangement, vaulted barrel and groin vault ceilings, rounded chancel and half-dome ceiling, plaster wall surfaces, marble columns with Romanesque capitals spanning the nave, marble alter, ornamental light fixtures, and wood floor, pews, carved paneling, wood wainscot, decorative wood doors, and a string course of angles around the nave with arched windows separated by statues. Seismic bracing has been added with the stair of the northeastern and southeastern towers. The basement-level gymnasium and stage surrounded by a decorative arched opening are also intact.

Figure 313. Interior nave looking towards the sanctuary of subject property.

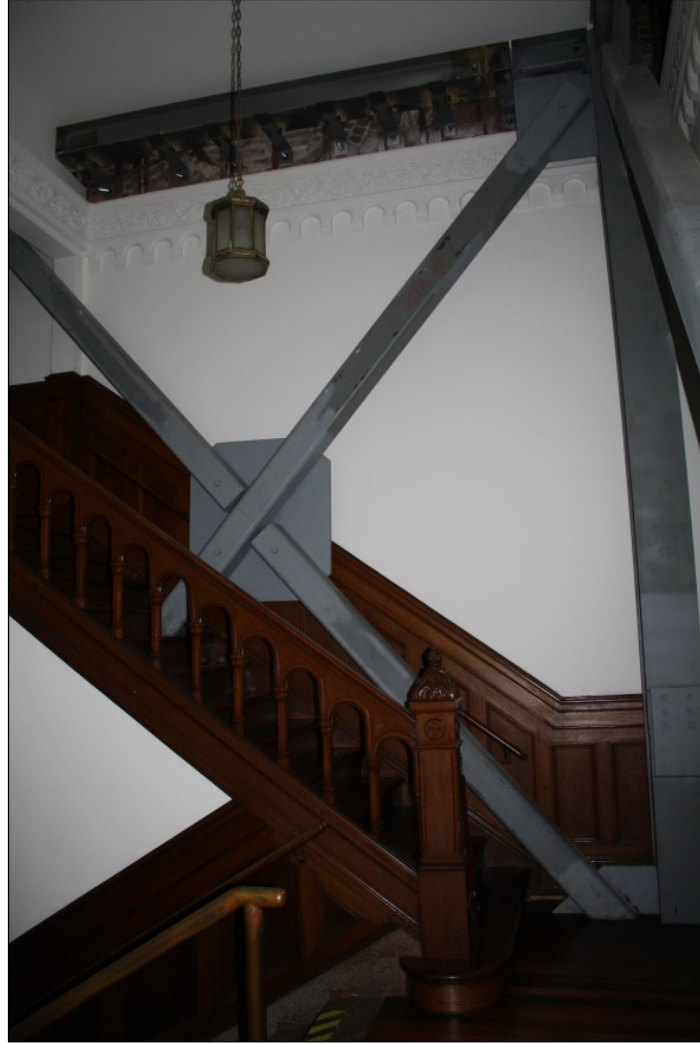
Figure 316. Interior seismic bracing installed in stairwells and hallways off the main nave of subject property.

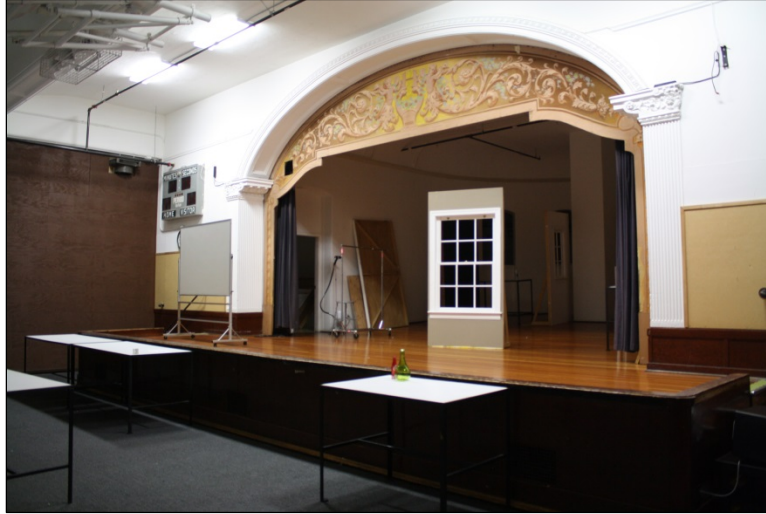
Figure 318. Interior basement stage of subject property.

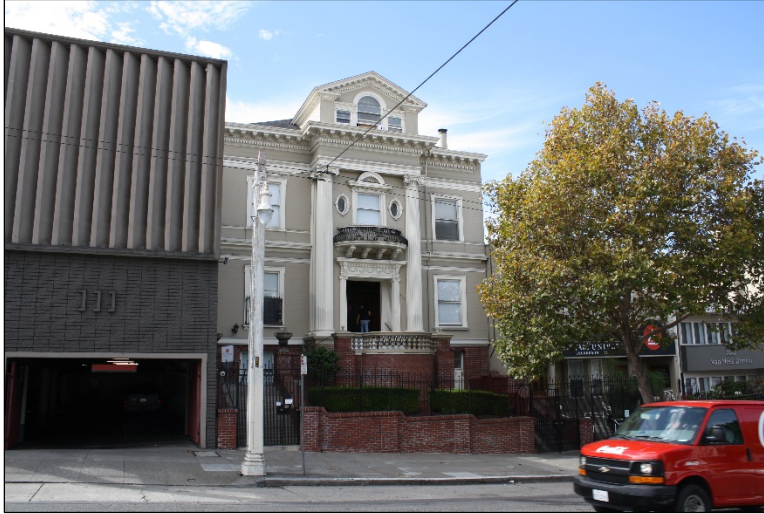
The building at 2209 Van Ness Avenue was constructed in 1901, originally as a single-family residence before its conversion to a restaurant, and then as home to the International Institute. The rectangular shaped plan building is set back and elevated from the sidewalk. Located on a rectangular, sloped lot, the building has a primary elevation fronting Van Ness Avenue and secondary elevations facing the neighboring properties. The Classical Revival style building has a three-and-a-half story volume is capped with a hipped roof and a symmetrical facade. The shallow roof eaves terminate in a molded cornice and dentil course.

Figure 332. 2209 Van Ness Avenue.

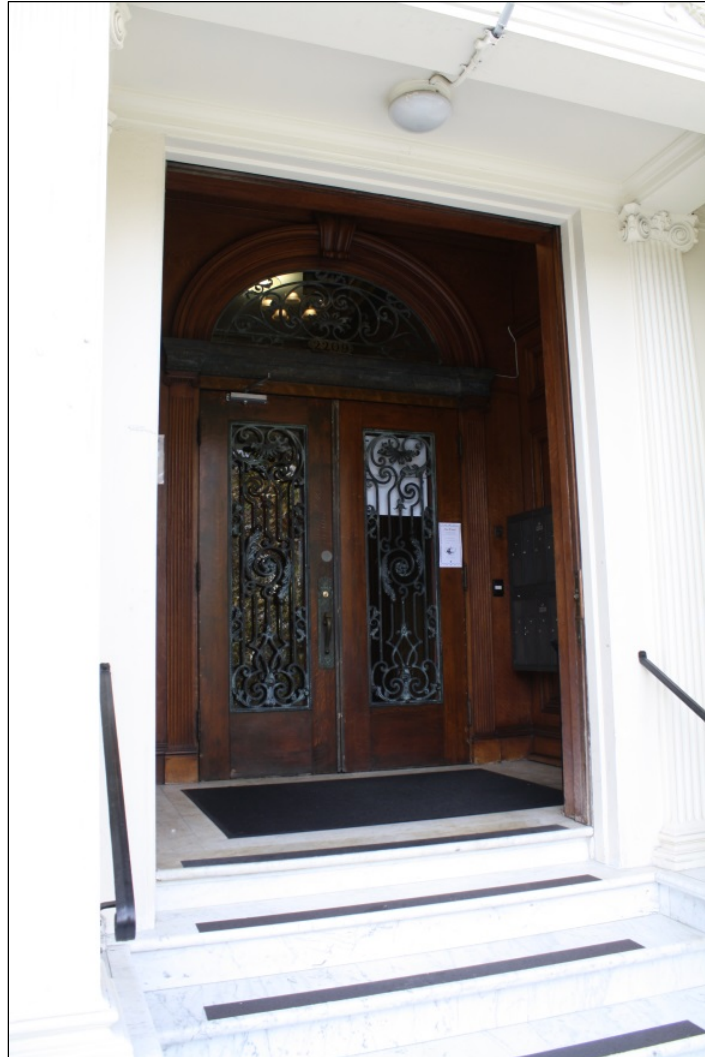
Classical Revival ornamental detailing is present throughout the primary facade. The rounded concrete porch with brick siding, granite steps, marble porch floor, and a concrete balustrade leads to a central main entry. The main entry features wood double-doors with glass panels and decorative screens and an arched transom above. A decorative surround and lintel frame the entry way. Prominent, two-story Ionic columns flank the main entry and a second-story balconette with decorative iron railing and scrolled brackets. Paired oculus windows overlook the second-story balconette. On the outside of the Ionic columns are wood-frame sash windows. The dormer protruding from the hipped roof surmounts the columns and has a centered Palladian window.

Figure 333. 2209 Van Ness Avenue, close up of the main entry on the primary elevation.

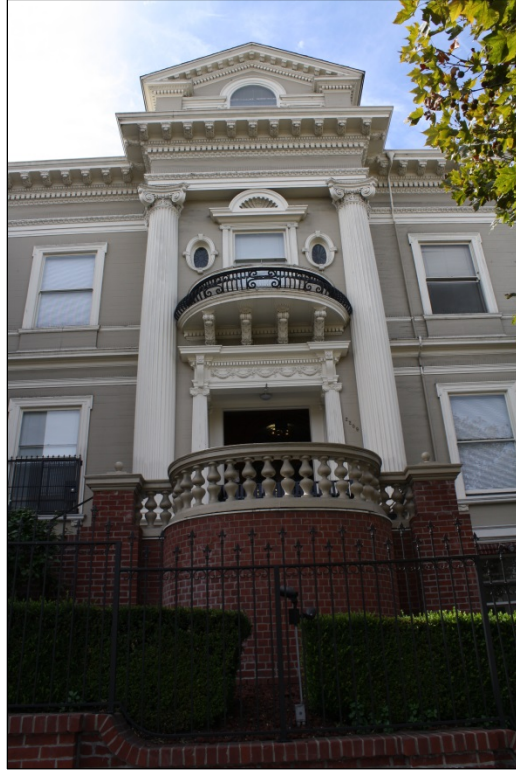
Figure 334. 2209 Van Ness Avenue, close up of the Classical Revival details on the primary elevation.

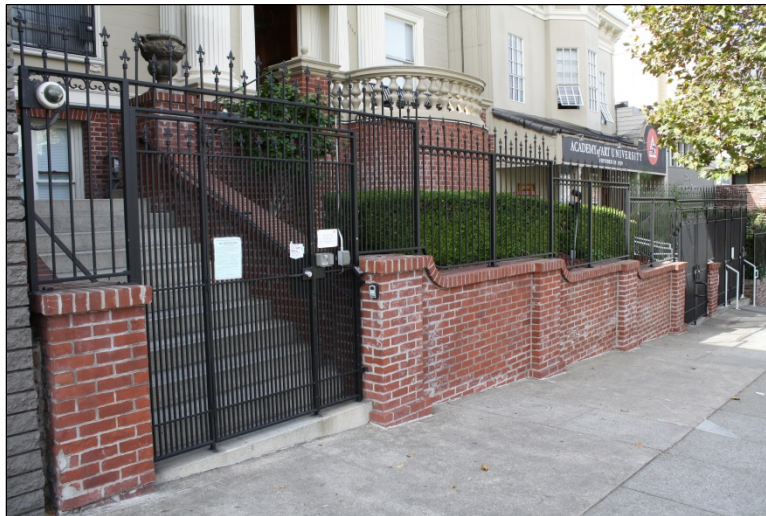
Figure 335. 2209 Van Ness Avenue, close up of the yard and security fence on the primary elevation.

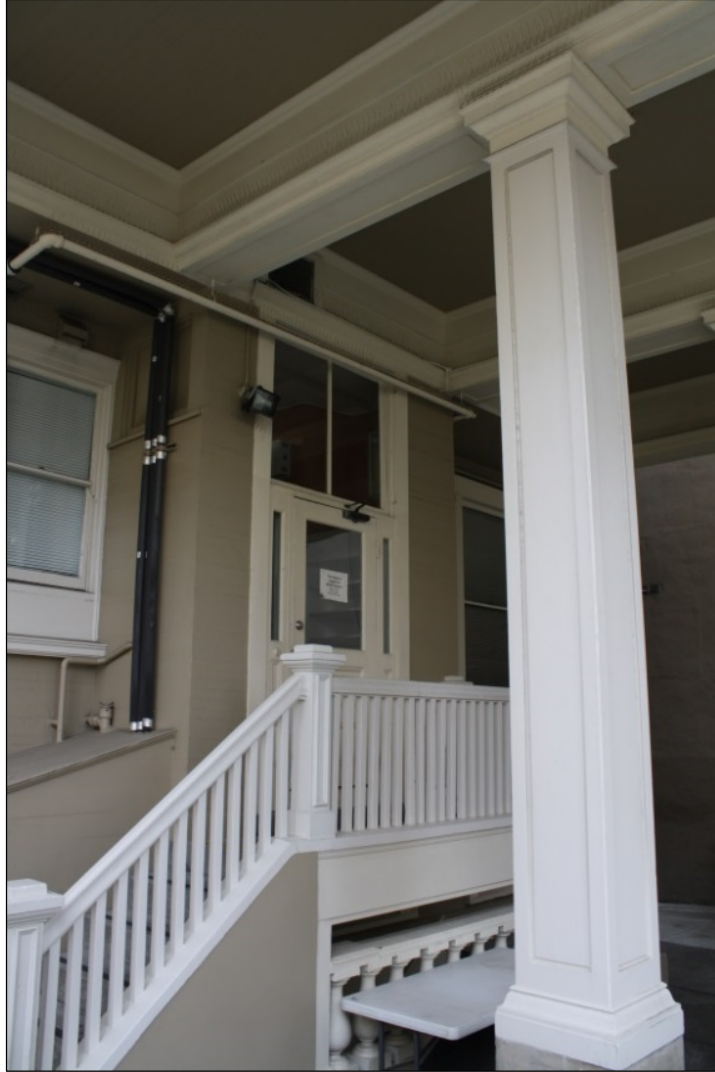
Secondary elevations are visible on the south and west elevations. The south elevation, visible along a narrow walkway leading to the rear of the property, features Classical Revival features and rectangular windows. The west (rear) elevation has doors leading to the first and basement stories with rectangular windows. A second story addition projects to the west and is supported by squared columns. A simplified version of the original structure's cornice line surrounds the addition's flat roof. Wood-framed sash windows and jalousie windows are present of the secondary elevations in various configurations. Security bars have been added over the basement story windows.

Figure 336. 2209 Van Ness Avenue, southeastern perspective of the first story on the north elevation.

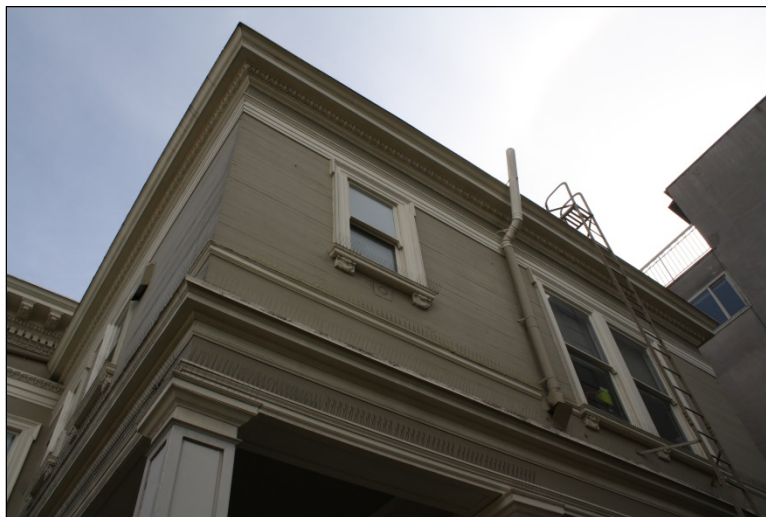
Figure 337. 2209 Van Ness Avenue, close up of the second story addition on the west elevation.

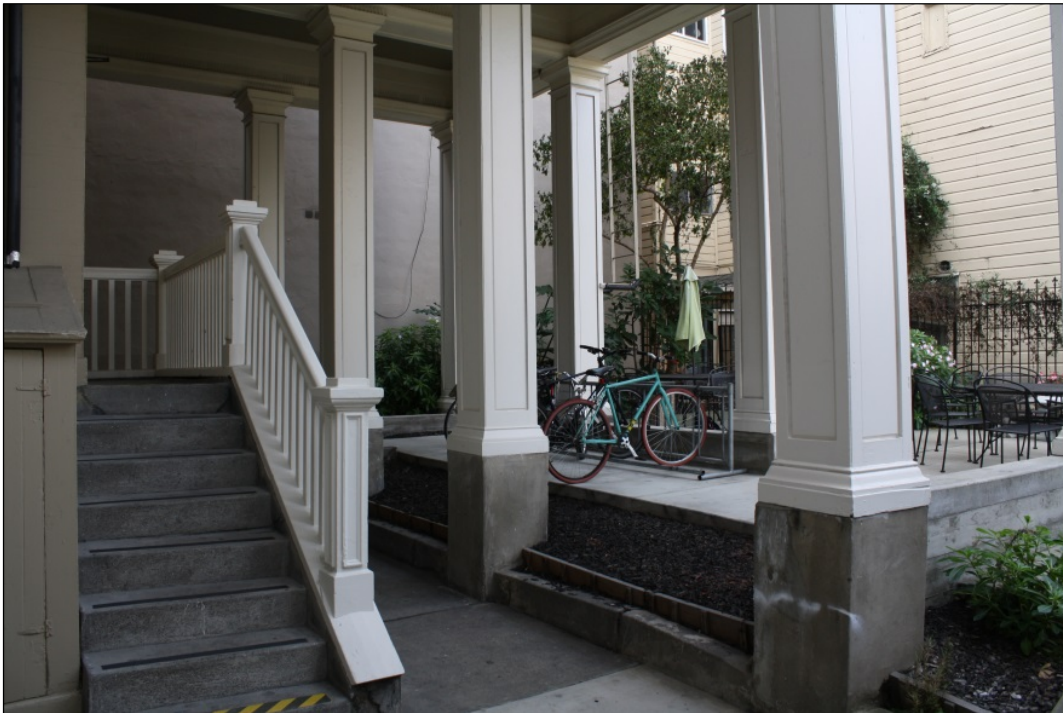
Figure 339. 2209 Van Ness Avenue, view of the columns under the second story addition and the rear patio.

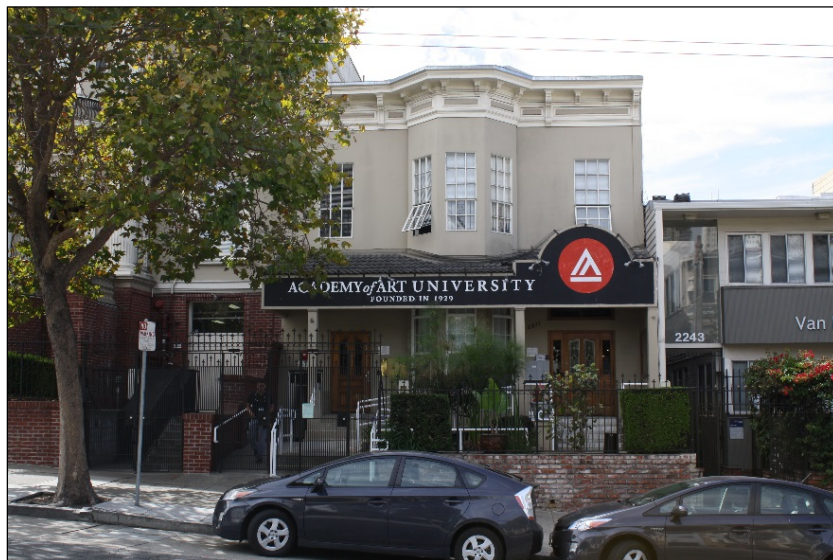
Figure 351. 2211 Van Ness Avenue.

The original façade was expanded to the south, east, and west during the structure’s conversion to a commercial use. The Italianate ornamental detailing and stucco finish continued on the additions. The main entry is located on the northern corner of the first story, while two secondary entries are located on southeast corner of the elevation. Stacked bay windows, characteristic of the style, are centered on the elevation. On the second story, single rectangular windows flank the bay windows. Multi-light awning windows are utilized on the elevation.

- Addition of southern bay between 1999 and 2005 (visual observation and historic maps and photographs)
- Replacement of windows and original doors prior to 2005 (visual observation and historic photographs)
- Removal of window surrounds prior to 2005 (visual observation and historic photographs)
- Removal of decorative bands above and below upper-level bay windows prior to 2005 (visual observation and historic photographs)
- Installation of awning prior to 2005 (visual observation and historic photographs)
- Installation of ADA ramp leading to primary (northern) entryway (visual observation and historic photographs)

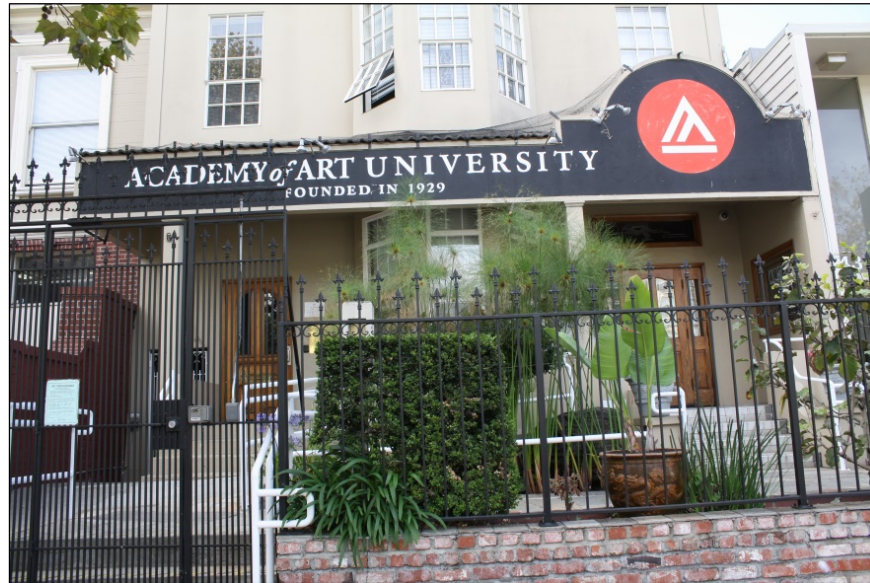
Figure 352. 2211 Van Ness Avenue, close up of the first floor on the primary elevation.

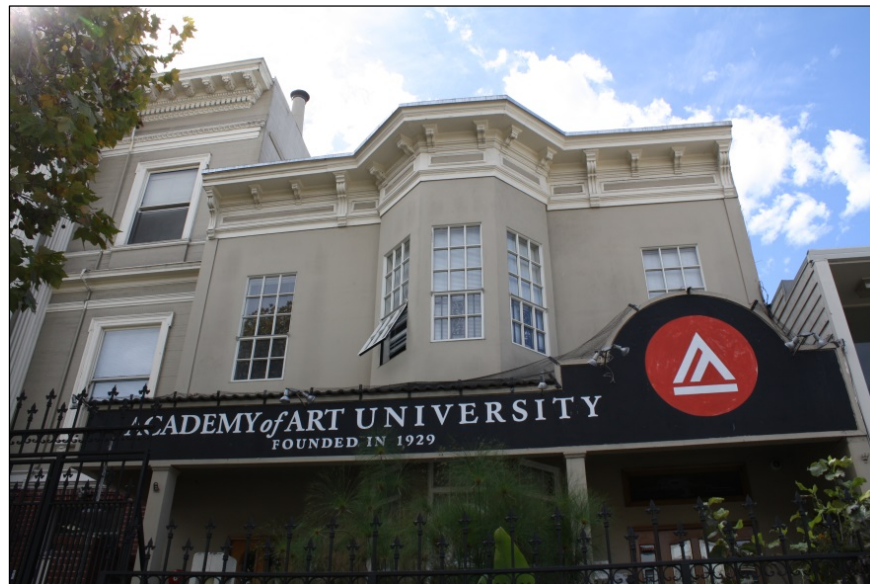
Figure 353. 2211 Van Ness Avenue, close up of the second story on the primary elevation.

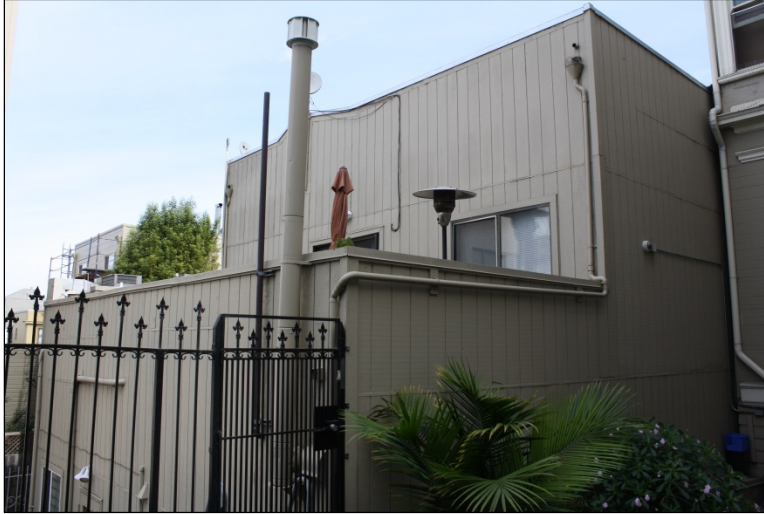
Secondary elevations are visible on the north, south and west elevation. The west elevation features wood siding with aluminum sliding windows in various configurations. The small portions of the north and south elevations which are visible are plain with no fenestration.

Figure 354. 2211 Van Ness Avenue, northeastern perspective of the upper stories of the west elevation

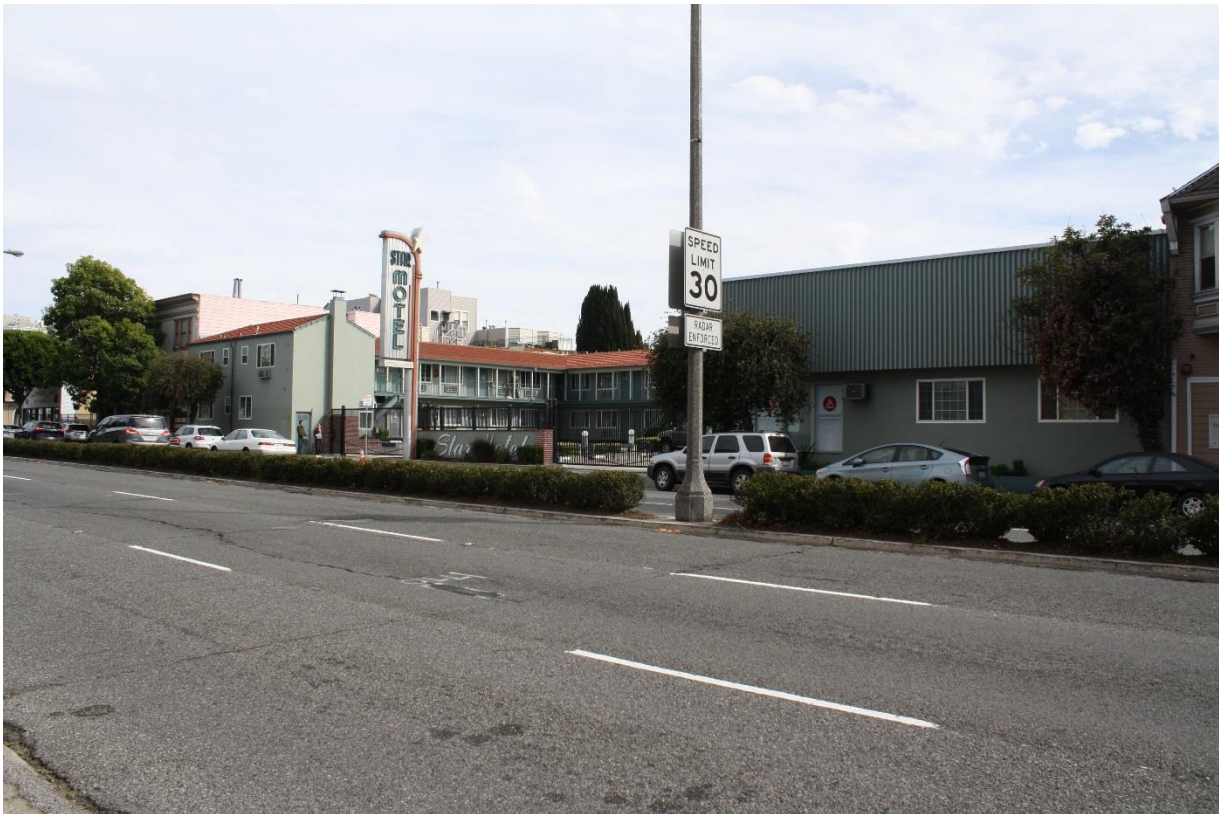
All of the original steel windows have been replaced with vinyl sliding windows with false muntins. Configurations include: tripartite window with a central fixed sash and sliding sash on either side, one-over-one sash with obscure glazing, and two-part sliding sash. Air-conditioning units have been installed below many of the windows. Modern metal sconces have been mounted on the walls.

Overall, the motel conveys the Midcentury Modern style with features such as: stacked brick dadoes, projecting cornice with board-and-batten siding, flat roofs, deep eaves, wraparound galleries, corner window, open riser stairways, neon sign, and wall sign.

Figure 3. Contextual view of Star Motel, 1727 Lombard Street, 2015 (Source: SWCA).

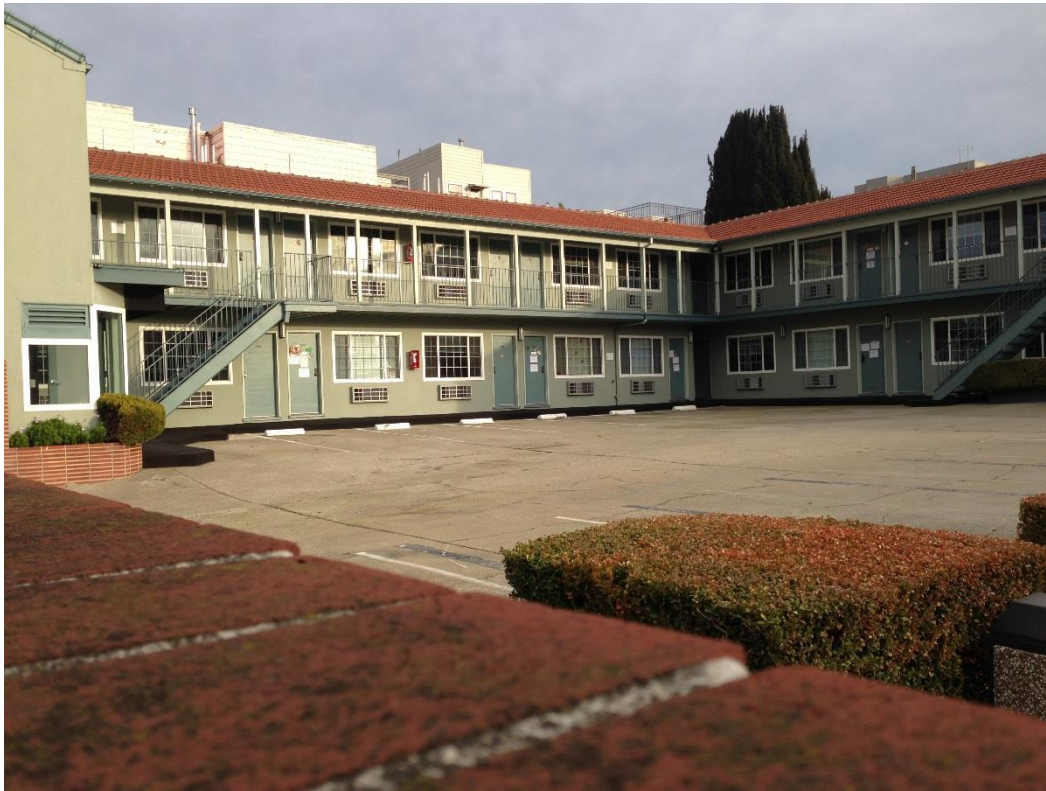
floor, there are two tripartite windows flanking a small one-over-one window. Around the corner, on the west façade, there is an external plaster-clad chimney that extends above the roofline. A steel door with metal vent is located north of the chimney, and a fixed window is located south of the chimney.

At the interior (motor court) side of this wing, there is a second-floor, cantilevered, wraparound gallery sheltered by the main roof. The gallery roof is supported by simple square posts (material unknown) and lintels and is surrounded by metal railings, a post-1957 alteration (Star Motel Postcard). On the north side of the motor court, there is a one-story bay window. On the south side, an exterior, steel, open-riser stairway leads to the wraparound gallery. At the southwest end of the building, there is a two-story projection topped by a hipped roof; there are tripartite windows on both the first and second floors of the projection. Typical of motels, the fenestration pattern of the building's motor court side is repetitive and consists largely of two tripartite windows alternating with two guest room doors.

Figure 4. Eastern wing (1953), Star Motel, 1727 Lombard Street, 2015 (Source: SWCA).

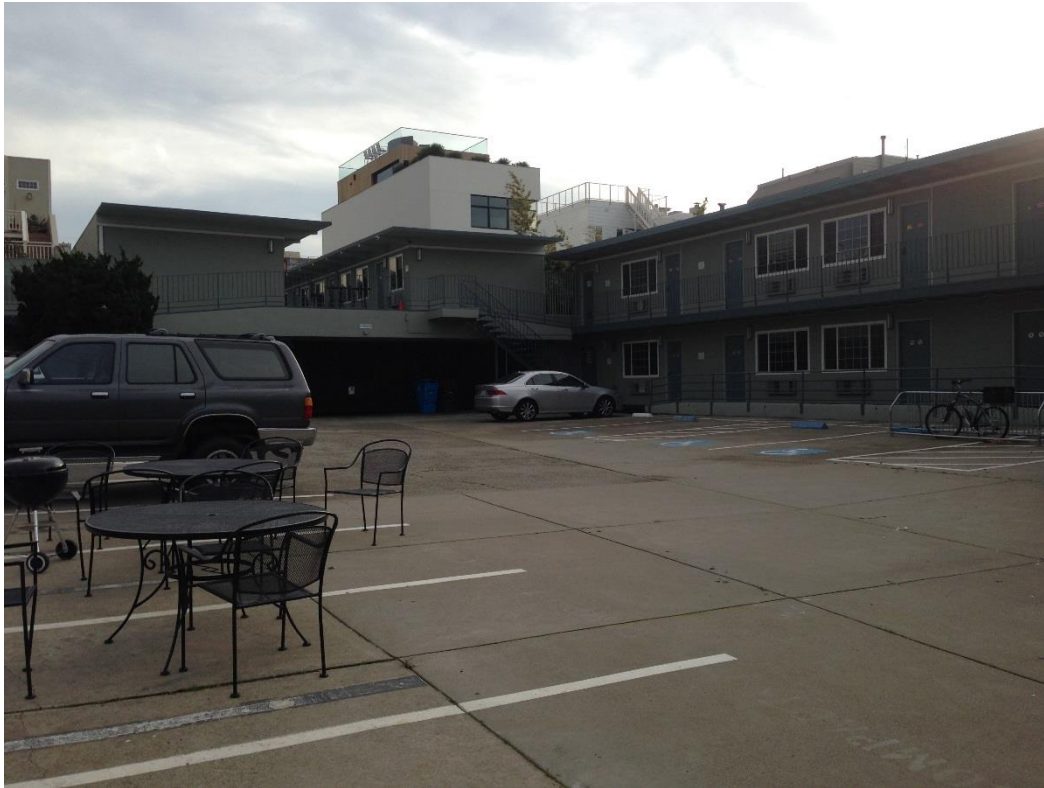
The west wing was constructed in 1960 by the architectural firm Skidmore & McWilliams (building permit). The west wing is more stylistically developed than the east wing. A flat roof with deep eaves tops the building, and simple molding is located at the intersection of the eaves and walls. The walls are presumably wood frame and appear to be clad in cement plaster. At the north end of the wing, which faces Lombard Street, the second floor is surrounded by a projecting cornice clad in vertical, closely spaced, board-and-batten siding; this gives the façade the appearance of a one-story building. At the first floor, there is a multi-paned wood-frame corner window that wraps from the north façade to the east. In addition, on the north façade west of the corner window, there are two tripartite windows. A neon “Office” sign is mounted on the wall. A low planting bed lines this façade at the sidewalk.

At the interior (motor court) side of this wing, there is a second-floor, cantilevered, wraparound gallery sheltered by the main roof. The wraparound gallery has simple square posts and is surrounded by a metal railing. The fenestration pattern of the motor court side of the building is repetitive and consists largely of two tripartite windows alternating with two guest room doors.

Figure 5. West and south wings (1960) Star Motel, 1727 Lombard Street, 2015 (Source: SWCA).

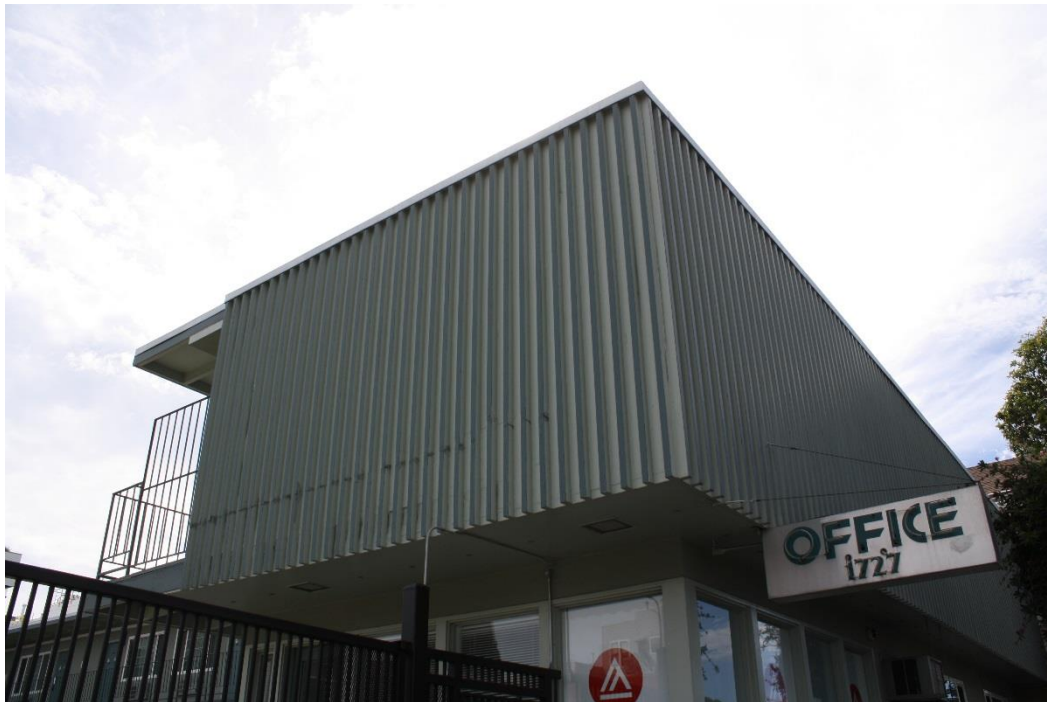
Figure 6. Office wing, Star Motel, 1727 Lombard Street, 2015 (Source: SWCA).

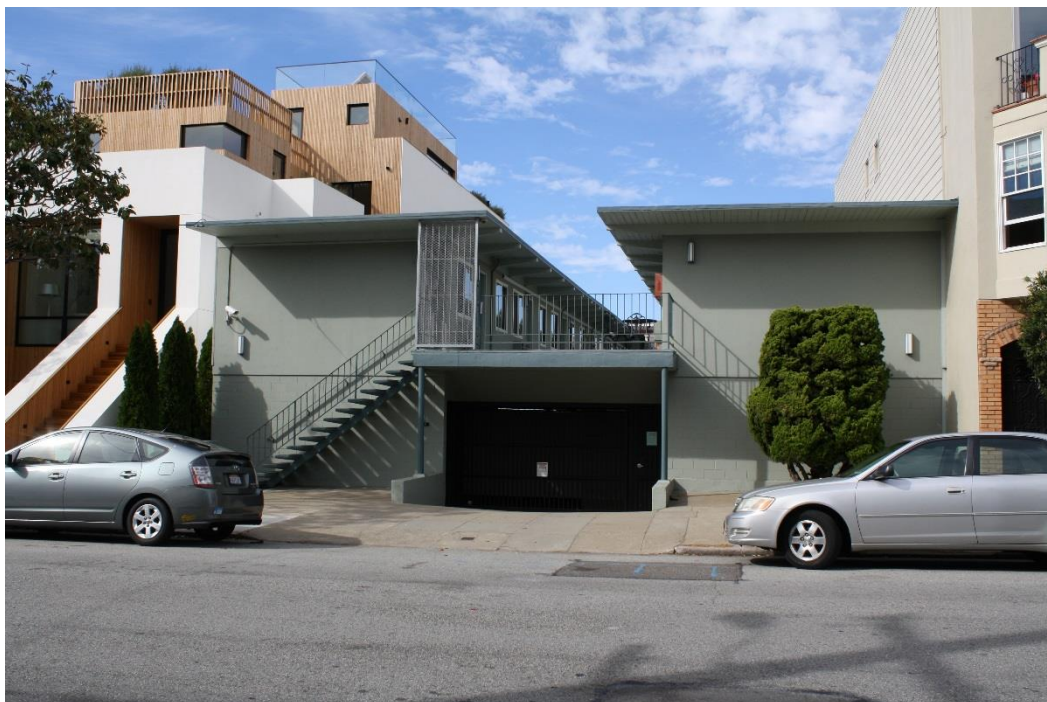
The south façade, which faces Greenwich Street, is similar in composition to the north façade: at the first floor there is an automobile entrance. At the west end, an open-riser concrete-and-steel stairway with metal railing leads to the second floor open corridor. A modern metal security gate is located at the top of the stairway. The floor of the corridor projects to create a landing for the stair; the landing is supported by steel pipes.

Figure 7. Rear (south) façade, Star Motel, 1727 Lombard Street, 2015 (Source: SWCA).

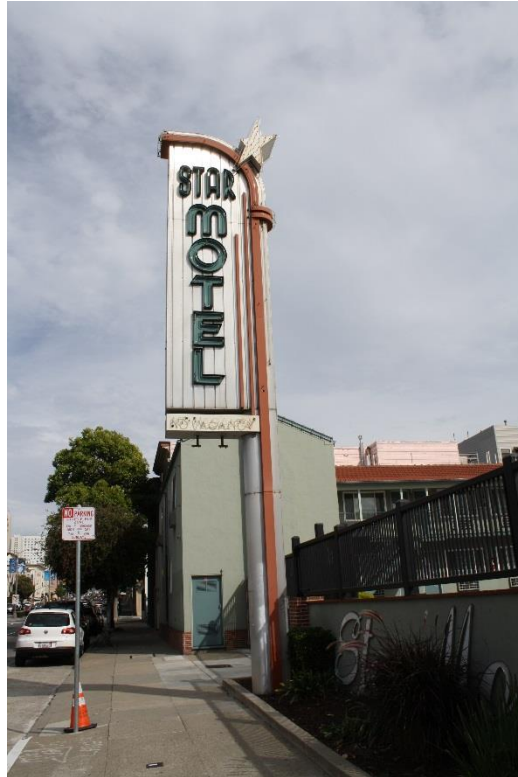
Figure 8. Signage, Star Motel, 1727 Lombard Street, 2015 (Source: SWCA).

Figure 8. Signage, Star Motel, 1727 Lombard Street, 2015 (Source: SWCA). 9

- Re-roofing at "front west building," 1989 (permit no. 628971);
- Alteration of vertical blade sign; neon tubing replaced, letters reading "Star & TV" removed, 1992 (permit no. 694187);

| DATE | PERMIT NUMBER | OWNER | ARCHITECT | COST | DESCRIPTION |
|---|---|--|--|---|---|
| Mar. 23, 1992 | 694187 | Star Motel | | \$4,000 | Alt. for "Star Motel" sign. Replace neon tubing, letters, and remove old top section of sign reading "Star & TV." |

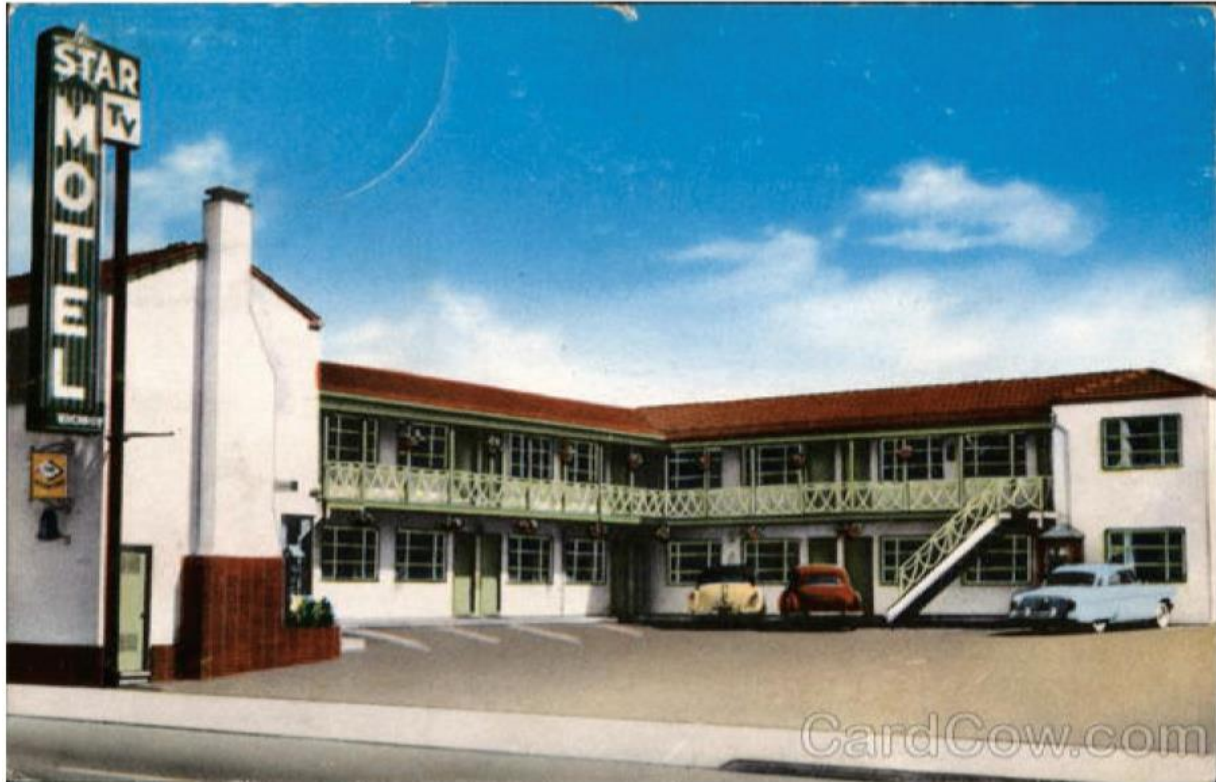
Figure 9. Postcard image of Star Motel, 1727 Lombard Street, 1957 (Source: CoardCow.com).

Figure 9. Postcard image of Star Motel, 1727 Lombard Street, 1957 (Source: CoardCow.com)..... 11

The following Sanborn Fire Insurance Maps, historic photographs, and historic aerial images present a visual overview of the property's construction chronology. Following the figures, Table 1 lists all permitted alterations to the subject property.

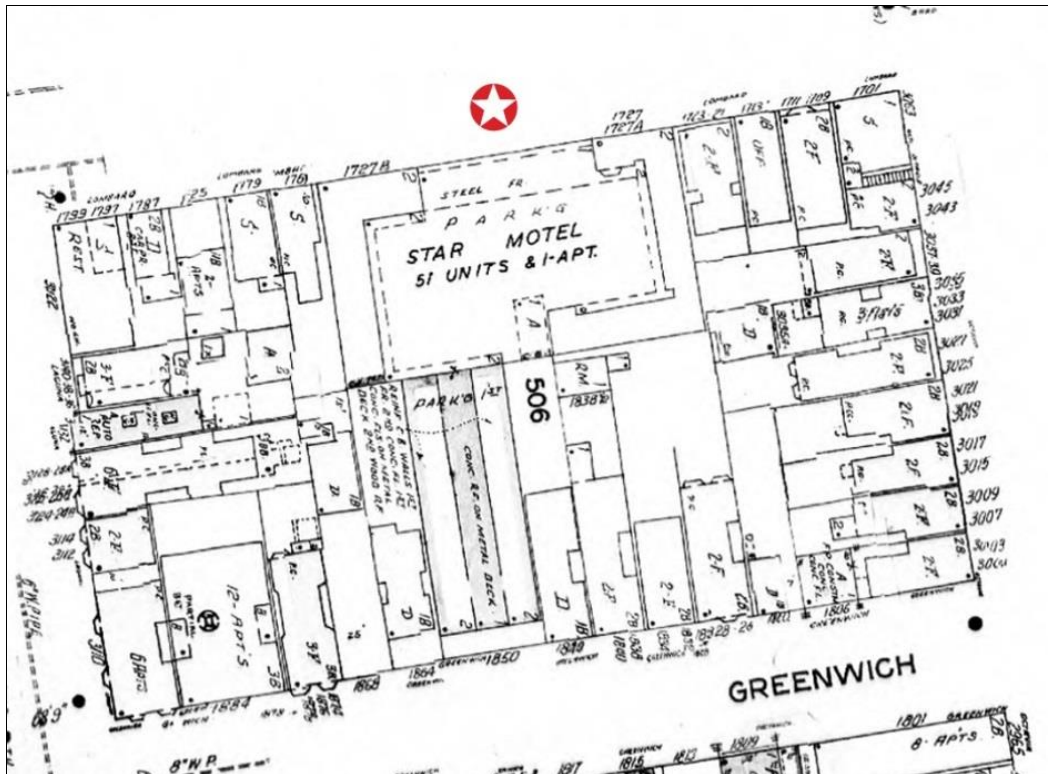
Figure 14. 1974 Sanborn Fire Insurance Map, 1727 Lombard Street. Source: Environmental Data Resources, 2015.

Figure 14. 1974 Sanborn Fire Insurance Map, 1727 Lombard Street. Source: Environmental Data Resources, 2015. 13

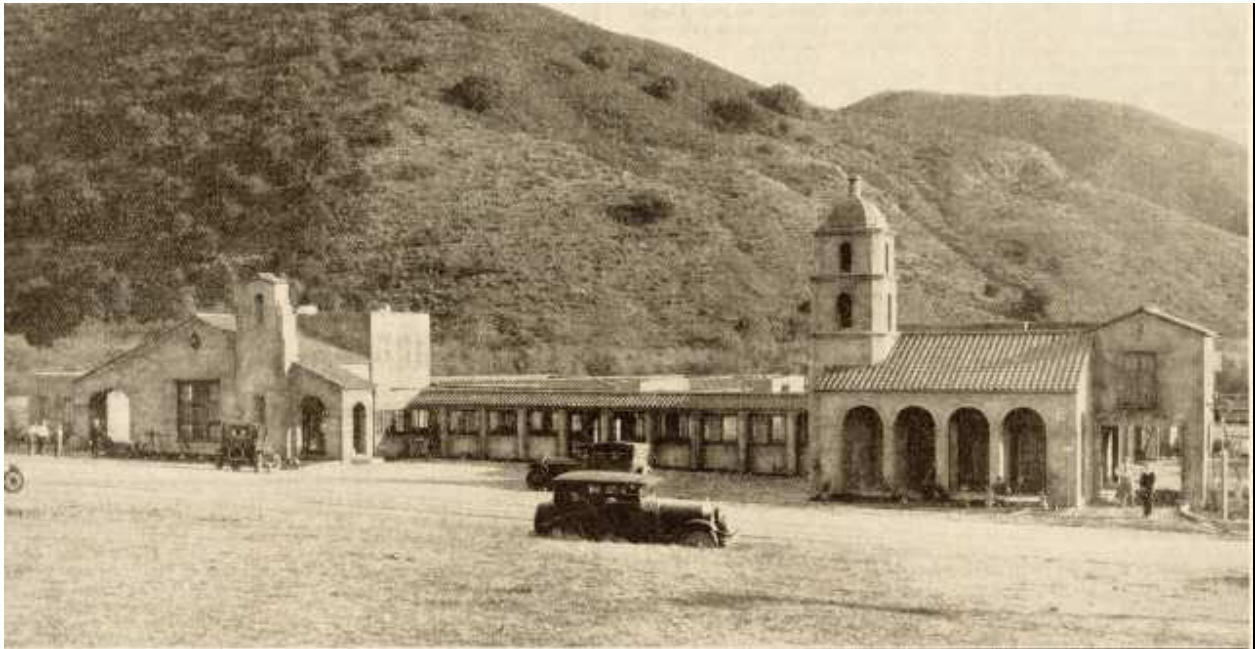
Figure 16. Milestone Mo-Tel in San Luis Obispo, California's first motel. Source: *Los Angeles Times*.

California's first motel—and the first in the country—was built in San Luis Obispo in 1925.³ Designed by architects Arthur and Alfred Heineman, the Milestone Mo-Tel was intentionally located in San Luis Obispo because it was the midpoint between Los Angeles and San Francisco.⁴ At that time, a drive across the state took two days—so drivers needing a break had few options for lodging outside of campgrounds. The Milestone Mo-Tel—with its private indoor bathrooms, restaurant, laundry facilities, and store—was a revolutionary alternative. The San Luis Obispo motel was the prototype for an 18-motel chain that Heineman and his brother, Alfred, intended to build along the Pacific Coast from Southern California to Canada, providing travelers with overnight stops every 150-200 miles. Evocative of the California Mission system, the motels were to be designed in the Mission Revival style, popular throughout California from the 1920s to 1940s. Though the Heinemans' motel chain never materialized, Heineman's trailblazing concept of a “mo-tel” stuck.

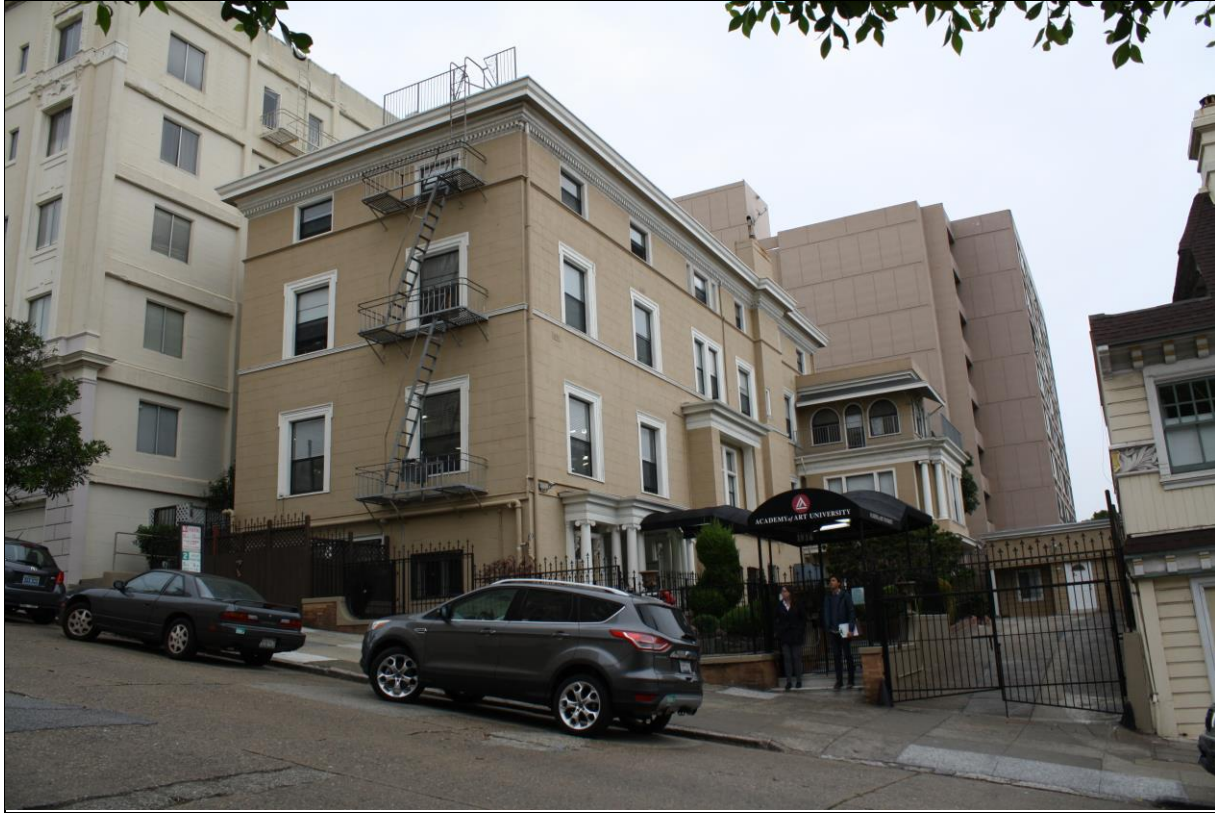
The walls of the first floor are painted brick laid in common bond with brick windowsills. The walls of the second, third, and fourth floors are reinforced concrete clad in plaster. At the west, south, and north façades, the plaster is scored to resemble smooth ashlar masonry. The walls of the east façade are covered with unscored plaster. A flat roof tops the building. On all façades, a cornice consisting of a series of moldings—including a dentil course and egg-and-dart molding—wraps the building. The walls are divided by horizontal coursing above the first floor windows with additional coursing at sill level below the third- and fourth-floor windows. The windows are replacement aluminum one-over-one sash unless otherwise noted. All original window openings are framed by wood trim; those of the second and third floors typically have eared architraves. The openings on the fourth floor are eyebrow windows.

Stylistically, the building exhibits Neoclassical influences, specifically the Greek Revival style, in its ornamentation: cornice with moldings and dentil course; portico with Doric columns, angled Ionic capitals, and entablature; eared architrave window trim; and eyebrow windows.

Figure 3. West and south façades, 1916 Octavia Street. Source: SWCA, 2015.

| Figure 3. West and south façades, 1916 Octavia Street. Source: SWCA, 2015. | 5 |

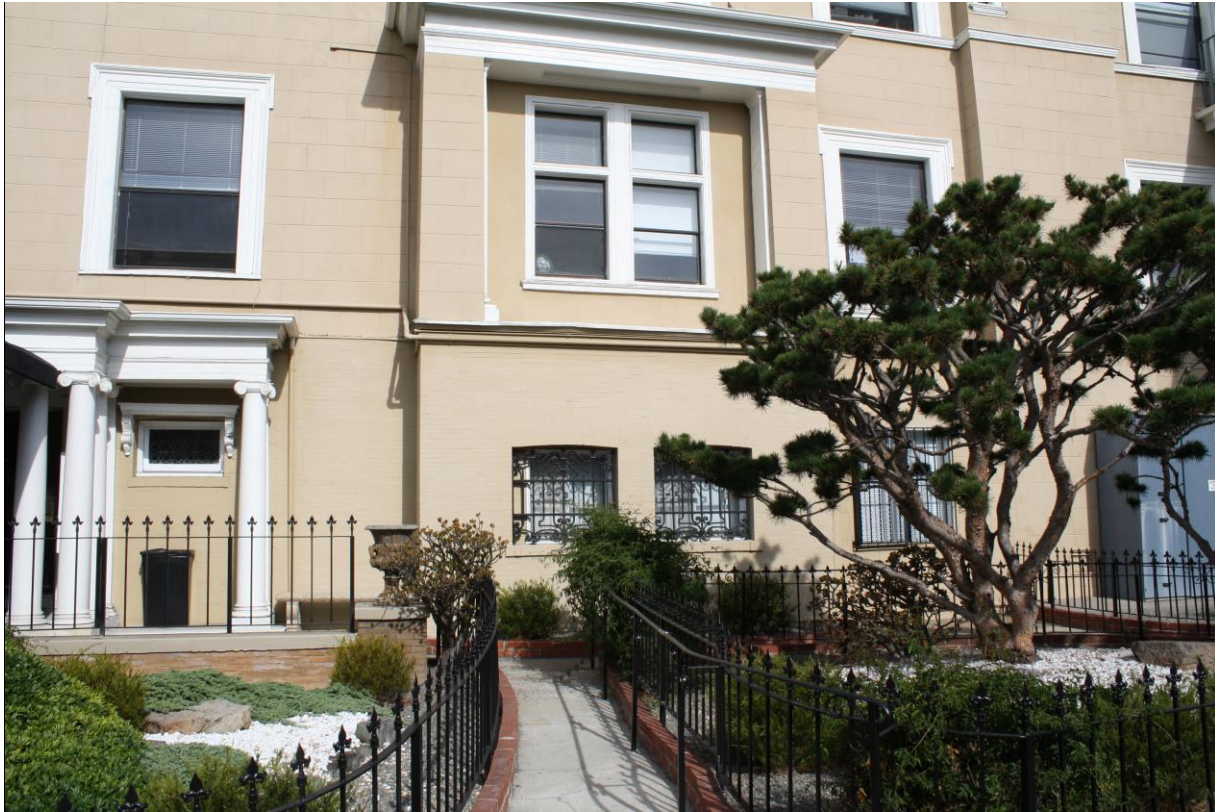
At the west end of the second floor, there are two windows. To the east, recessed in the bay, there is a pair of windows with transoms flanked by pilasters on the walls perpendicular to the windows. Further east on either side of the chimney, there are single windows. Above on the third floor, there are two windows that align with those below, a pair of windows above the projecting bay, a single window, a small window in the chimney, and finally, another single window. The fenestration pattern of the fourth floor largely aligns with those below. There are two windows, a tripartite window above the projecting bay, a single window, and one more window east of the chimney.

Figure 4. South façade, 1916 Octavia Street. Source: SWCA, 2015.

| Figure 4. South façade, 1916 Octavia Street. Source: SWCA, 2015. | 6 |

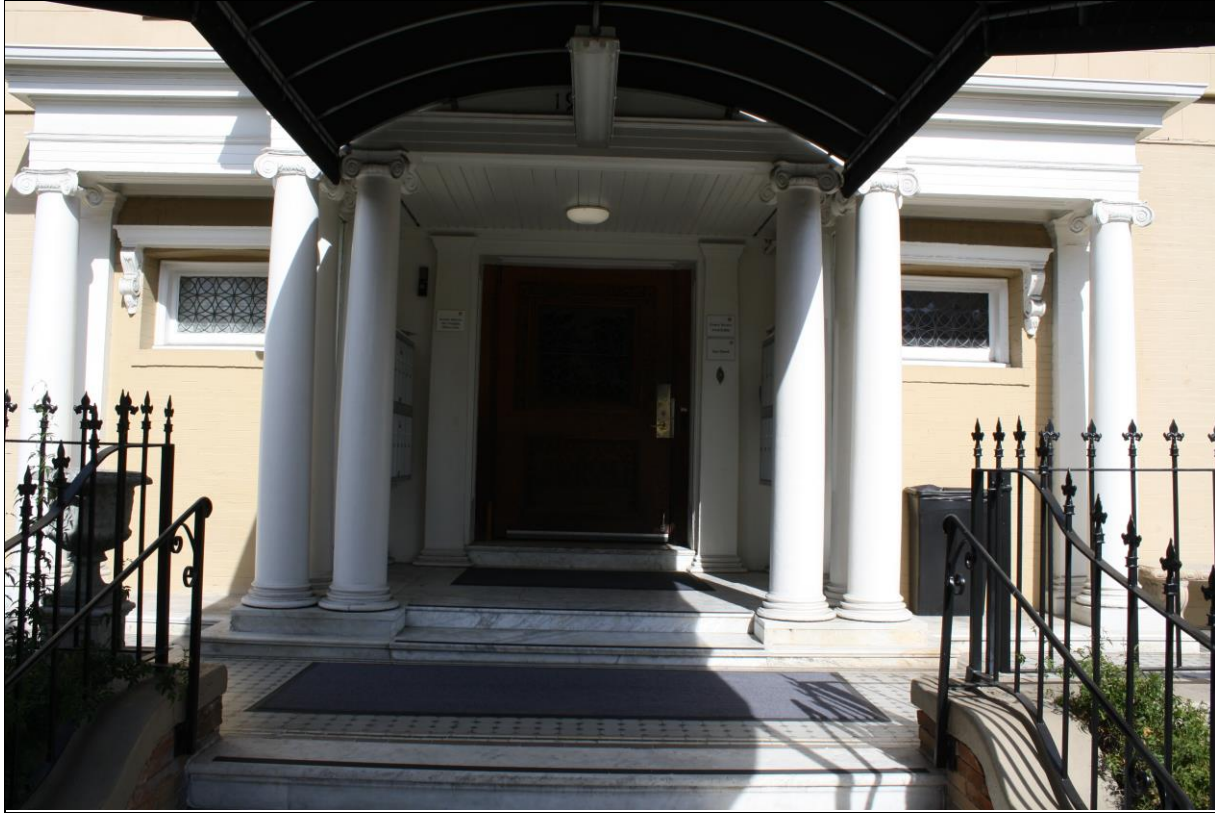
Figure 5. South façade, primary entrance, 1916 Octavia Street. Source: SWCA, 2015.

| Figure 5. South façade, primary entrance, 1916 Octavia Street. Source: SWCA, 2015. | 7 |

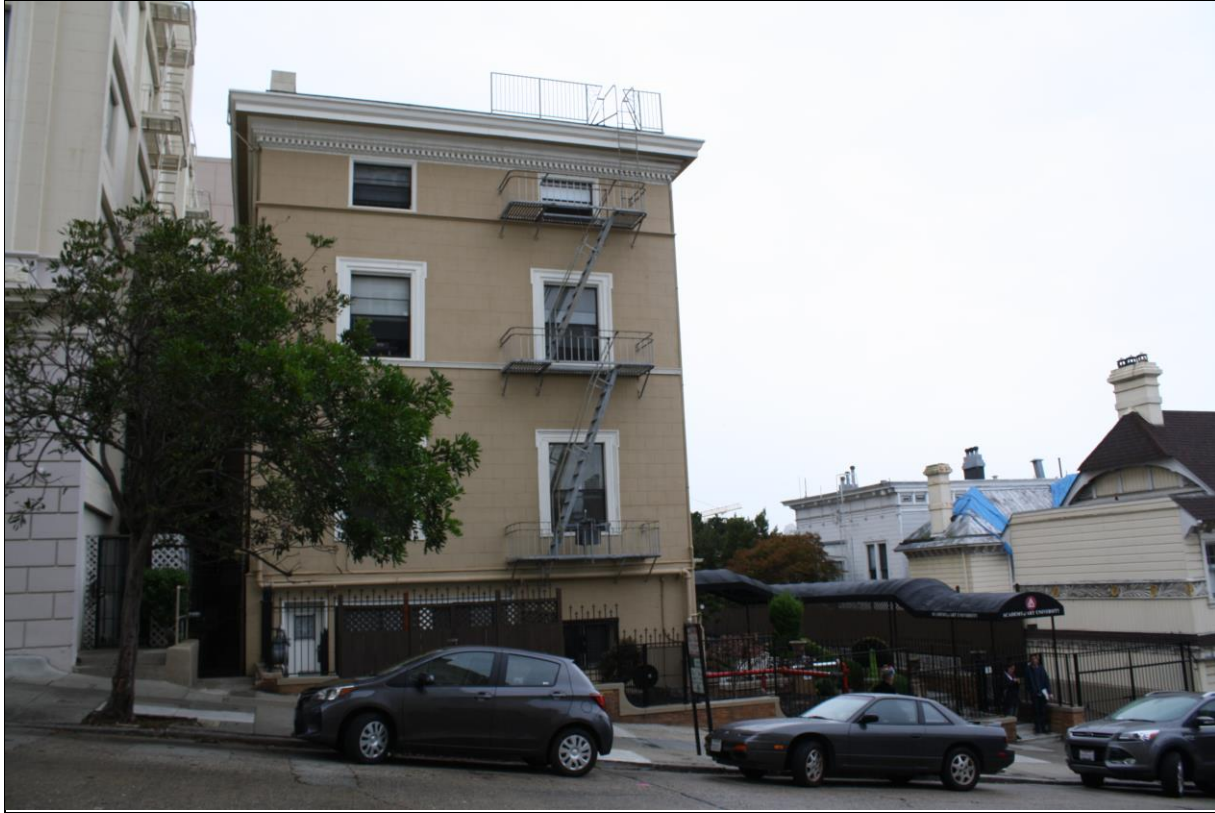
The west façade faces Octavia Street. At the second, third, and fourth floors, the façade is symmetrical and consists of two bays of window openings. A modern steel fire escape spans the southern windows from the second floor to the roof. The openings on the first floor of the west façade are utilitarian in character and asymmetrical. The first floor is largely obscured by the fencing at the front of the property. At the north end of the first floor, there is a wood door with vision light. To the south, there is a grouped window consisting of two pairs windows. Wood molding surrounds the openings, and a simple wood mullion divides the pairs. Wrought-iron grills cover the windows. A horizontal pipe covers the coursing between the first and second floors and extends to the planting beds.

Figure 6. West façade, 1916 Octavia Street. Source: SWCA, 2015.

| Figure 6. West façade, 1916 Octavia Street. Source: SWCA, 2015. | 8 |
