APPENDIX HR:
Historic Resource Evaluations

Overview of Historical Resources Review and Findings

410 BUSH STREET (ES-26)

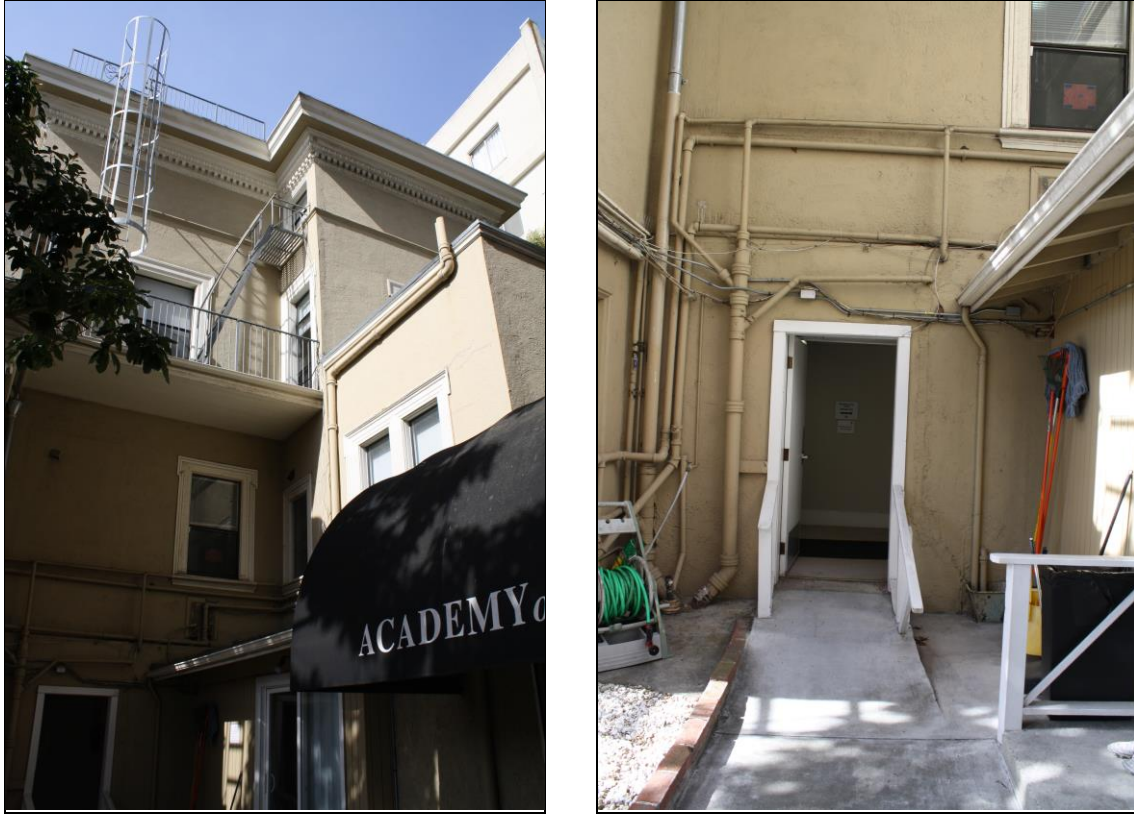
Figure 7. East façade, 1916 Octavia Street. Source: SWCA, 2015.

| Figure 7. East façade, 1916 Octavia Street. Source: SWCA, 2015..... | 9 |

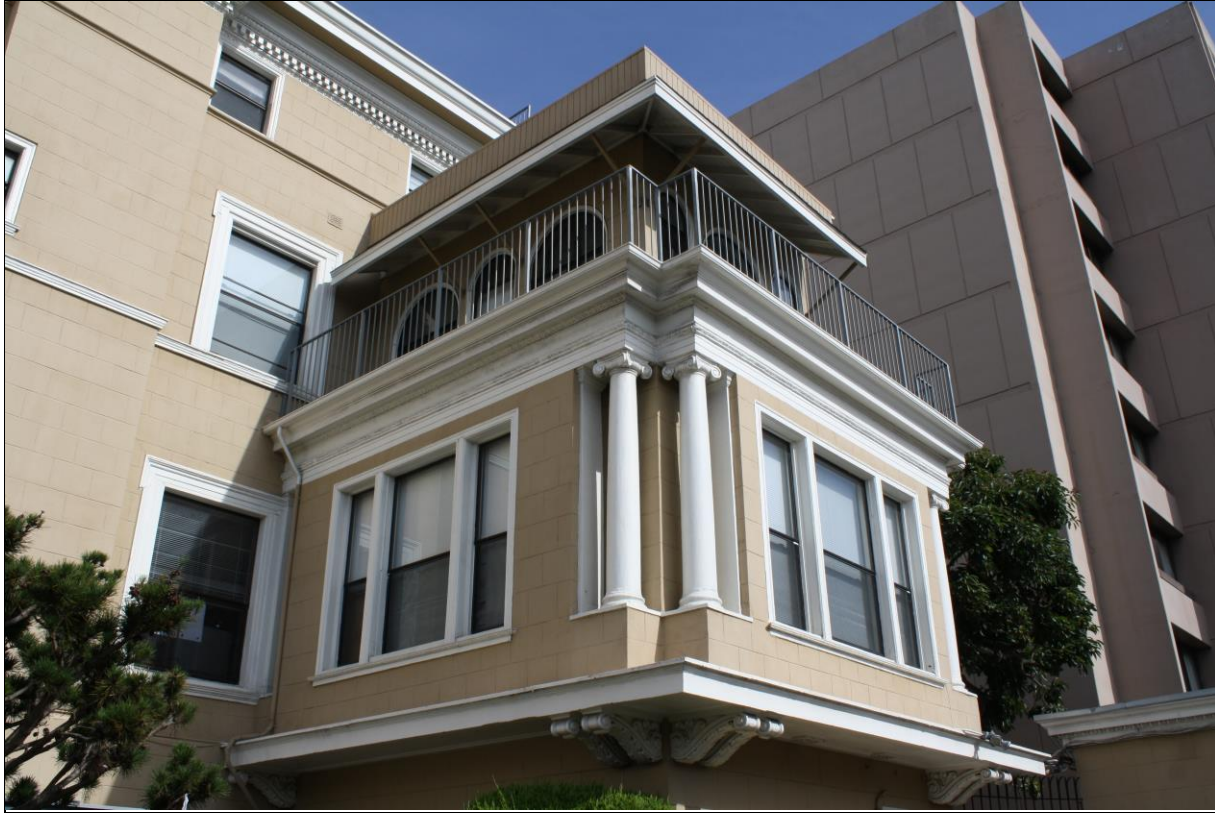
The three-story addition has a rectangular footprint and attaches to the east end of the main building's south façade. The first and second floors were constructed c. 1902 (Sanborn maps: 1899 and 1905) and largely match the main building in style and materials. The third floor of the addition was built c. 1957 (Sanborn map: 1950 and Here Today photo: 1964) and diverges in character, ornamentation, and materials. The walls at the first and second floors of the west and south façades are scored plaster simulating smooth ashlar masonry. Those of the east façade and all façades of the third floor are rough plaster. A flat awning with paired modillions at the corners separates the first and second floors. An entablature, including egg-and-dart molding, tops the second floor and is supported at the corners by Doric columns with angled Ionic capitals. The corners of the second floor are indented. At the third floor, the building steps back, and the roof of the second floor forms a third-floor balcony, which is surrounded by a metal railing. The roof of the addition is hipped with open eaves. A vertical board parapet surrounds the uppermost section of the roof. Between the hipped section and parapet, there is bead-and-reel molding.

Figure 8. Three-story addition at south façade, 1916 Octavia Street. Source: SWCA, 2015.

| Figure 8. Three-story addition at south façade, 1916 Octavia Street. Source: SWCA, 2015. | 10 |

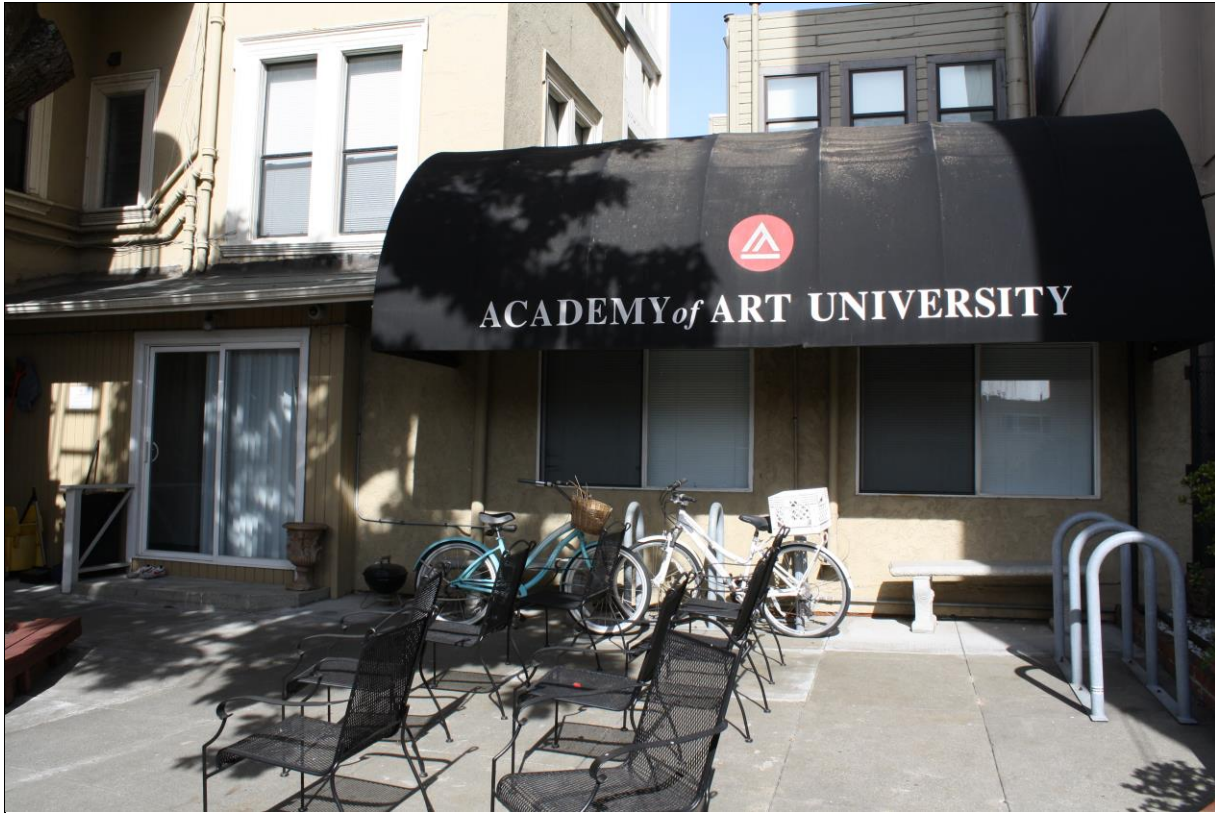
The rear addition is composed of a two-story section and a one-story section; flat roofs top both. The two-story section was constructed c. 1910, and the one-story section was built as an attached garage c. 1930 (Sanborn map: 1899, 1913 and 1950). By 1968, the garage opening had been infilled (Sanborn map: 1968). The walls of the rear addition are clad in vertical wood siding and plaster. At the south façade there is a vinyl sliding glass door and two aluminum sliding windows. A modern fabric awning over metal frame is mounted to the cornice of the one-story section.

Figure 9. Rear addition (two-story section at left, one-story garage addition at right), 1916 Octavia Street. Source: SWCA, 2015.

| Figure 9. Rear addition (two-story section at left, one-story garage addition at right), 1916 Octavia Street. Source: SWCA, 2015..... | 11 |

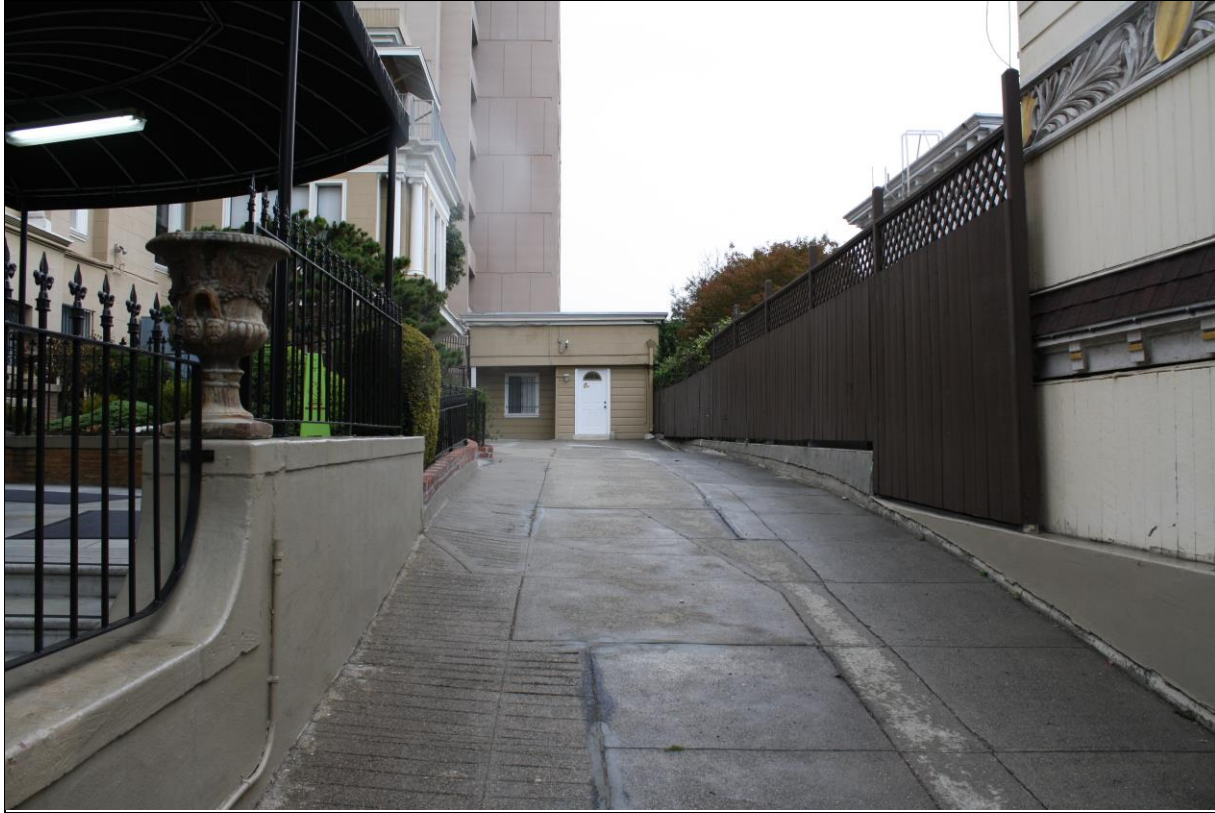
There is a small one-story garage at the southeast corner of the property. The building has a rectangular footprint and was constructed in 1930 (permit no. 183347). By 1999, the garage opening had been infilled (Sanborn map: 1999). The roof is flat, and simple molding lines the cornice. The upper wall of the wood-framed structure is clad in plaster scored to resemble smooth ashlar. The original garage opening has been infilled with horizontal, wood, drop siding walls. To the south, there is a paneled wood door with modified fanlight glazing. To the north, the wall steps back, and there is a single aluminum sliding window with simple wood frame and metal security grill.

Figure 10. Driveway and garage addition, 1916 Octavia Street. Source: SWCA, 2015.

| Figure 10. Driveway and garage addition, 1916 Octavia Street. Source: SWCA, 2015..... | 12 |

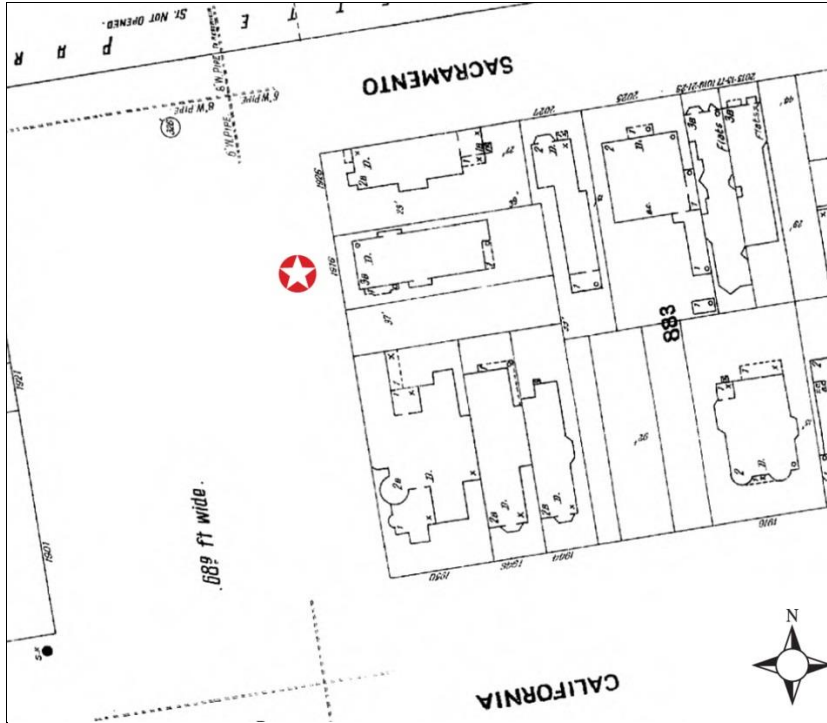
Figure 11. 1899 Sanborn Fire Insurance Map, 1916 Octavia Street. Source: Environmental Data Resources, 2015.

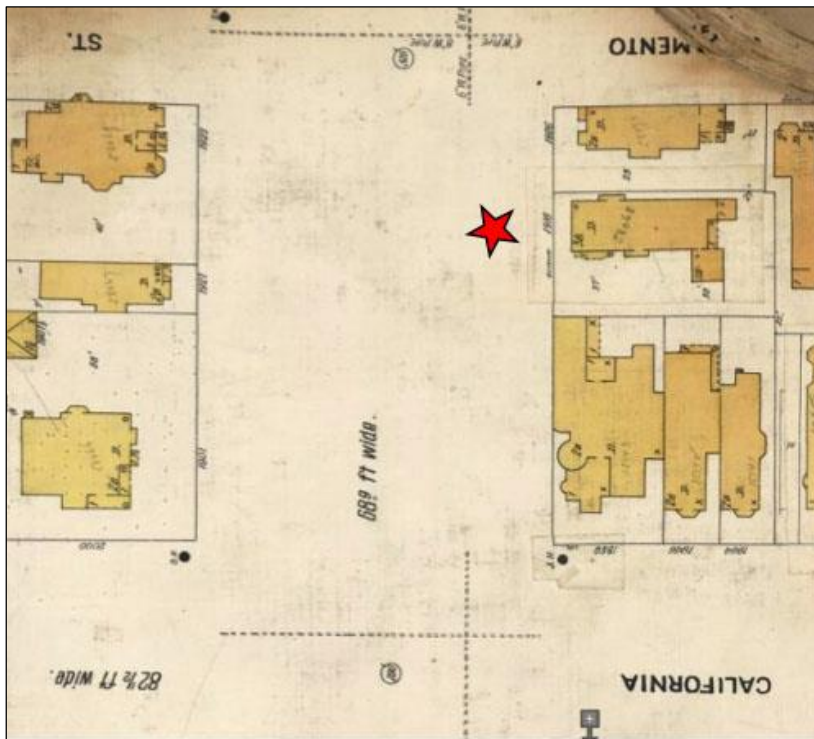
Figure 12. 1905 Sanborn Fire Insurance Map, 1916 Octavia Street. Source: Environmental Data Resources, 2015.

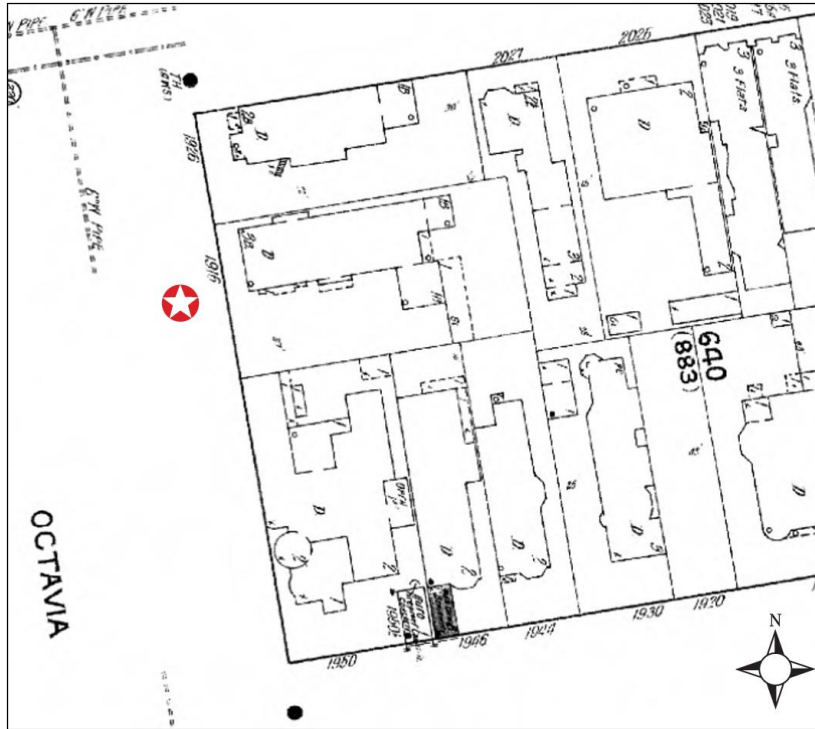
Figure 13. 1913 Sanborn Fire Insurance Map, 1916 Octavia Street. Source: Environmental Data Resources, 2015.

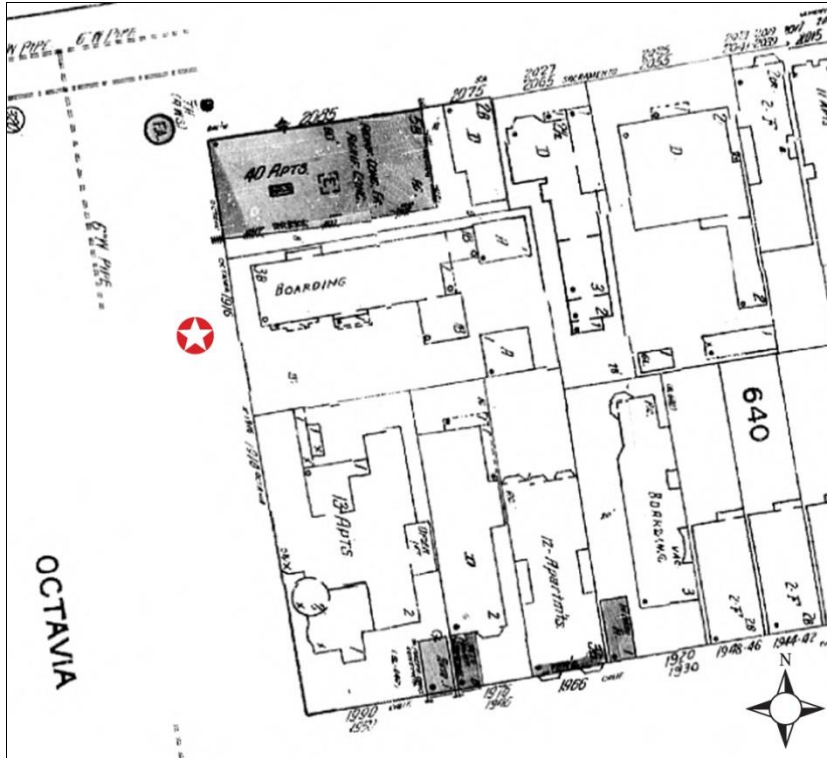
Figure 15. 1950 Sanborn Fire Insurance Map, 1916 Octavia Street. Source: Environmental Data Resources, 2015.

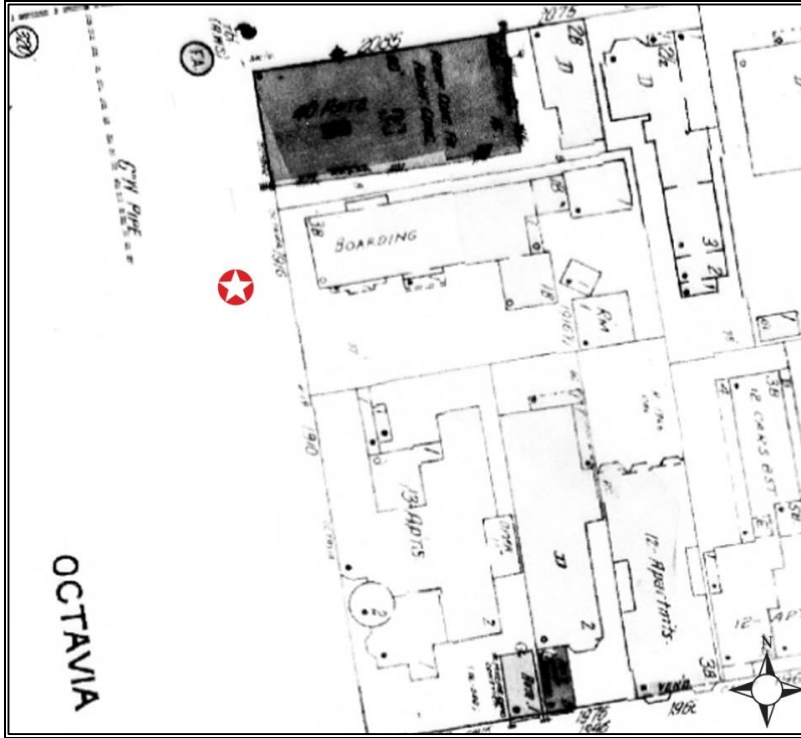
Figure 17. 1968 Sanborn Fire Insurance Map, 1916 Octavia Street. Source: Environmental Data Resources, 2015.

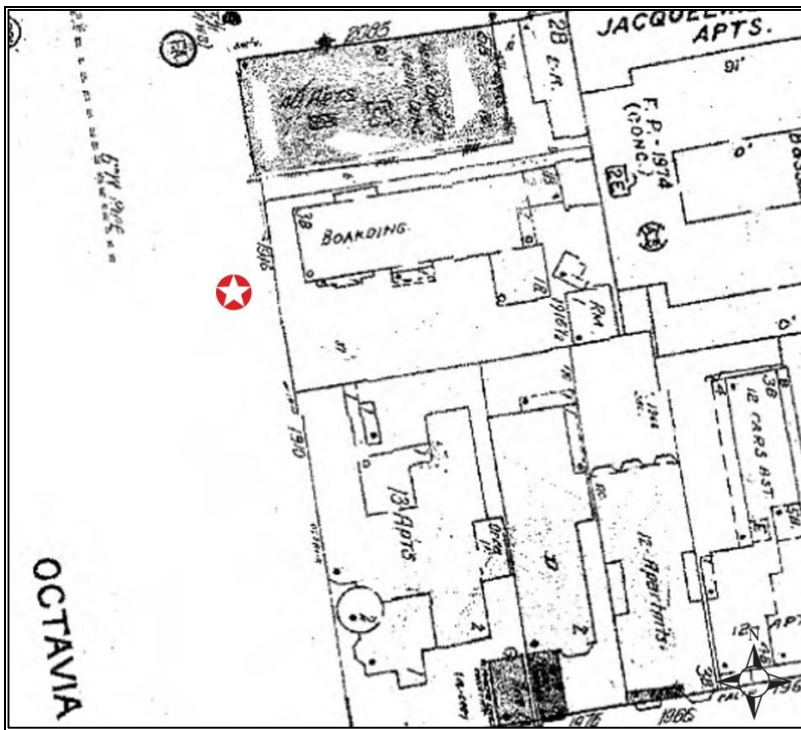
Figure 18. 1999 Sanborn Fire Insurance Map, 1916 Octavia Street. Source: Environmental Data Resources, 2015.

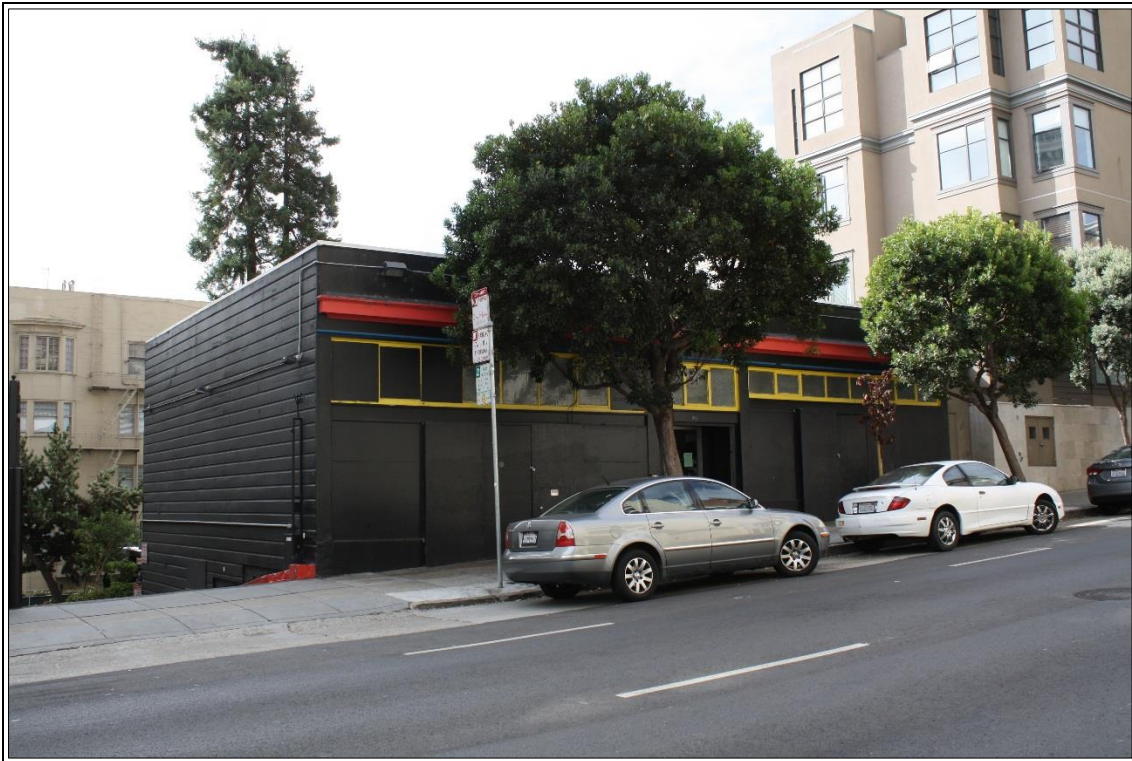
The north facade is a three-part storefront, which has been modified. Close to the center, there is a recessed entrance with a wood three-light transom above. In the recessed entrance, there is a pair of modern glazed aluminum doors. A folding metal security gate is mounted at the front of the recessed entrance. The eastern section of this facade has a wood transom composed of eight lights, although several of the lights have been covered. These transoms are taller than those of the central entrance bay. In the western section, there is another transom composed of eight lights. These are shorter than those of the central entrance bay. Both the western and eastern sections appear to have been built as storefront windows above bulkheads. The storefront openings have been infilled with plywood panels, some of which are irregular and project. The glazing of the transoms is textured, and some of the lights are awning sash. A simple wood cornice divides the walls above the transoms from the parapet above.

Figure 4. North façade, 1069 Pine Street. Source: SWCA, 2015.

| Figure 4. North façade, 1069 Pine Street. Source: SWCA, 2015. | 7 |

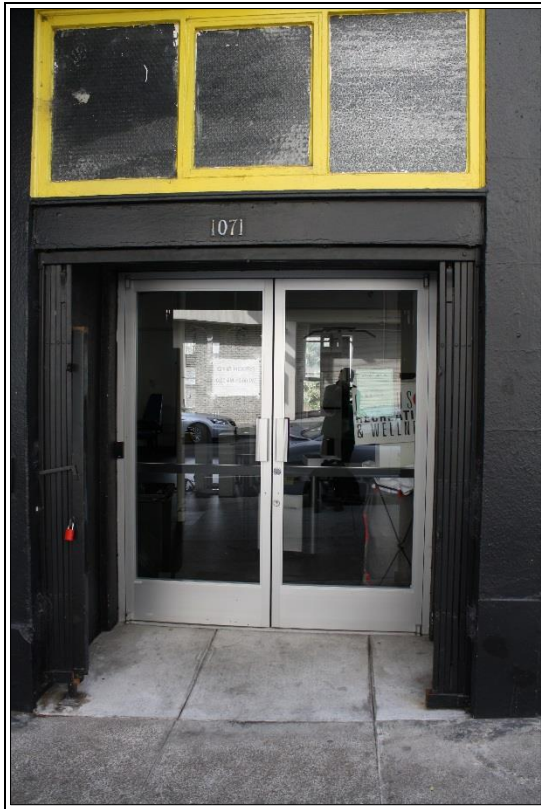
Figure 5. Primary entrance, north façade, 1069 Pine Street. Source: SWCA, 2015.

| Figure 5. Primary entrance, north façade, 1069 Pine Street. Source: SWCA, 2015. | 8 |

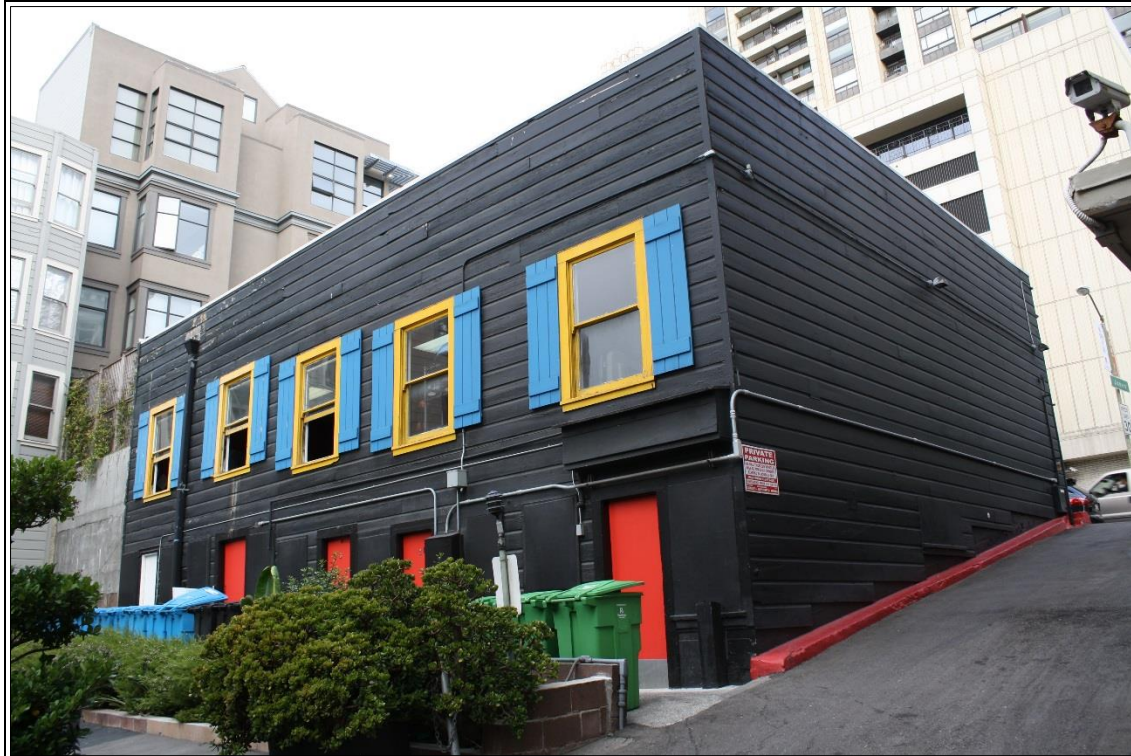
At the basement level, there are five wood doors with simple wood trim. A wood hood is mounted above the easternmost door. The doors are not aligned and step up the slope of the lot from east to west. The trim and sills of four windows are visible, but the openings have been covered with plywood panels. At the second floor, there are five wood, double-hung windows with horns at the upper sash. The trim and sills are wood, and wood plank shutters flank the openings.

Figure 6. South and east facades, 1069 Pine Street. Source: SWCA, 2015.

| Figure 6. South and east facades, 1069 Pine Street. Source: SWCA, 2015. | 9 |

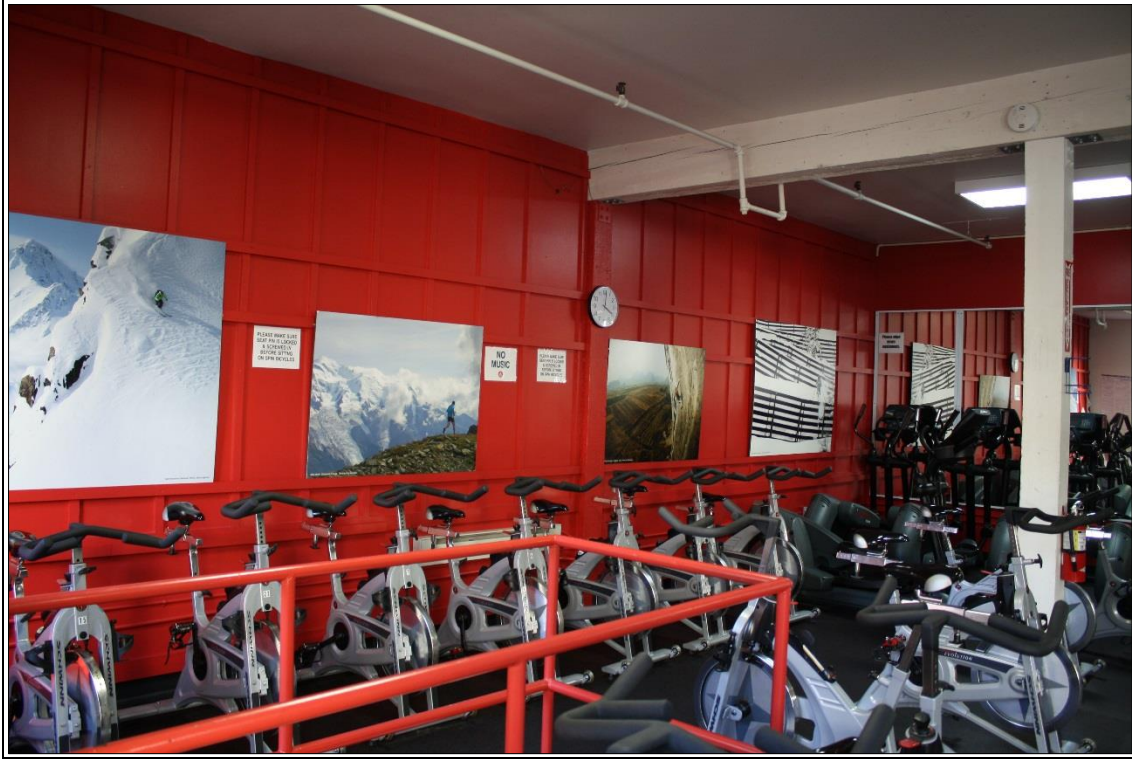
The building is used as a gym, and the interior is composed of several large open spaces, which are filled with equipment. The wood post-and-lintel structure of the building is visible at the interior. The interior sides of the exterior walls are paneled with vertical and horizontal battens at the seams. The interior walls appear to be plaster, and aluminum windows provide views between the rooms. The floor is covered with rubber mat. Fluorescent lights, ceiling fans, and fire sprinklers are mounted to the drop ceiling.

Figure 7. Interior, 1069 Pine Street. Source: SWCA, 2015.

| Figure 7. Interior, 1069 Pine Street. Source: SWCA, 2015. | 10 |

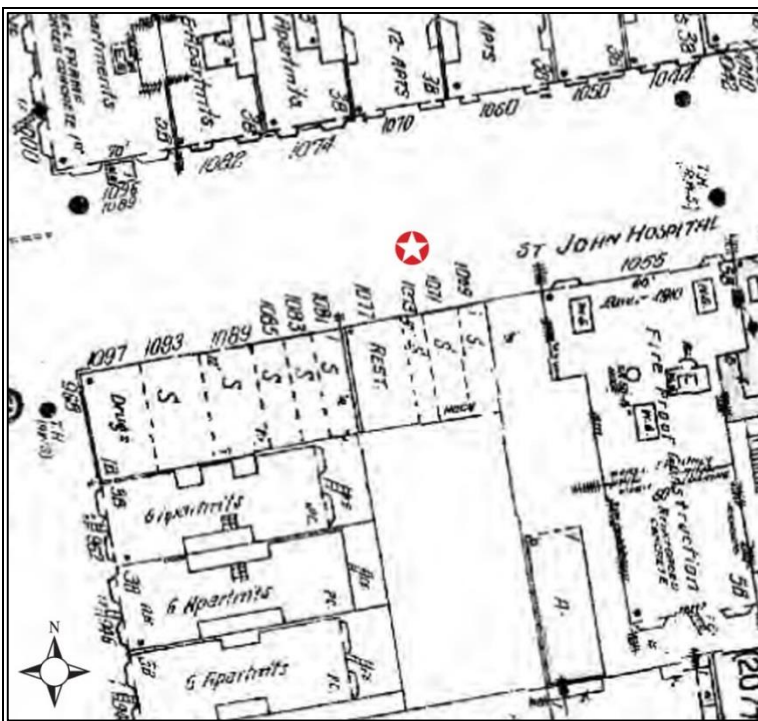
Figure 9. 1948 Sanborn Fire Insurance Map, 1069 Pine Street. Source: Environmental Data Resources, 2015.

| Figure 9. 1948 Sanborn Fire Insurance Map, 1069 Pine Street. Source: Environmental Data Resources, 2015. | 12 |

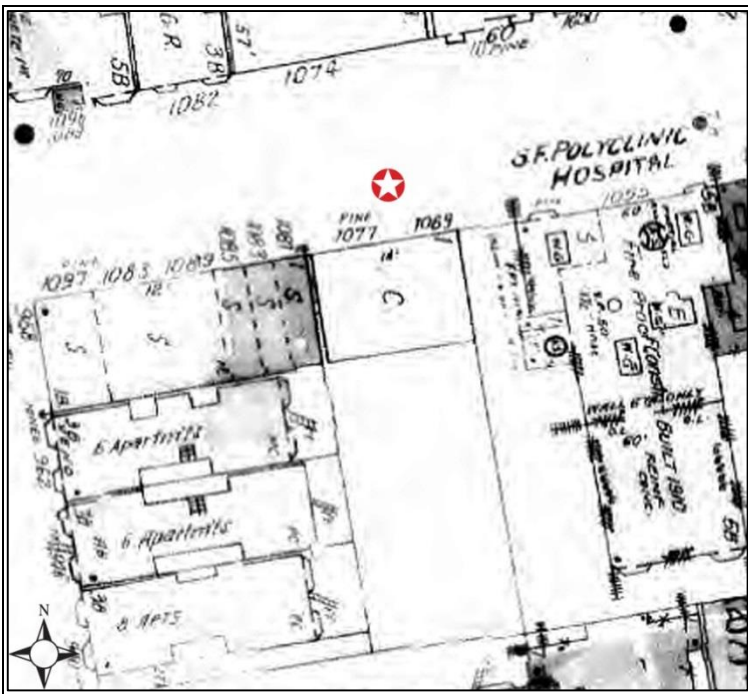
Figure 11. 1974 Sanborn Fire Insurance Map, 1069 Pine Street. Source: Environmental Data Resources, 2015.

| Figure 11. 1974 Sanborn Fire Insurance Map, 1069 Pine Street. Source: Environmental Data Resources, 2015. | 13 |

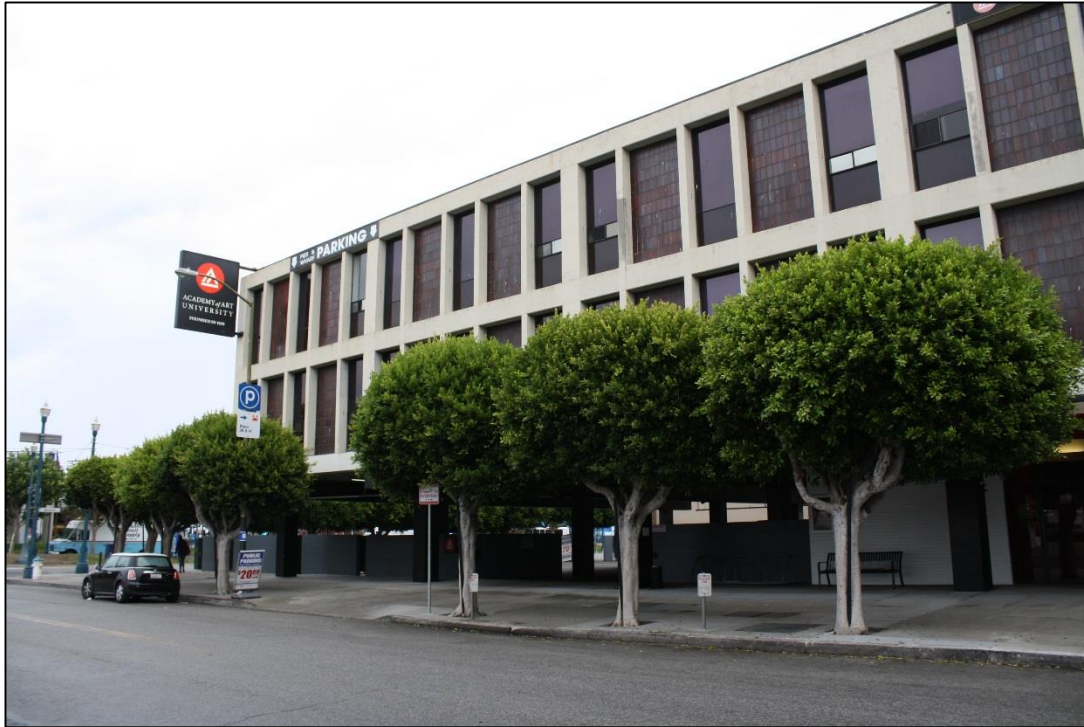
At the west façade, which faces Stockton Street, there are seven structural bays. Most of the first floor is an open parking garage, but at the center of the building’s west end, there is an enclosed portion that houses the lobby and ancillary spaces and equipment. The enclosure’s exterior walls are brick laid in common bond. Although originally tan brick, the walls have since been painted (see historic photograph, c. late 1970s/early 1980s). The primary entrance to the building is located in the enclosure’s west wall and is composed of a pair of aluminum glazed doors with sidelights and transom. The second and third floors are consistent with the fenestration pattern and materials of the other facades as described in the General section.

Figure 4. West façade, 2340 Stockton Street. Source: SWCA, 2015.

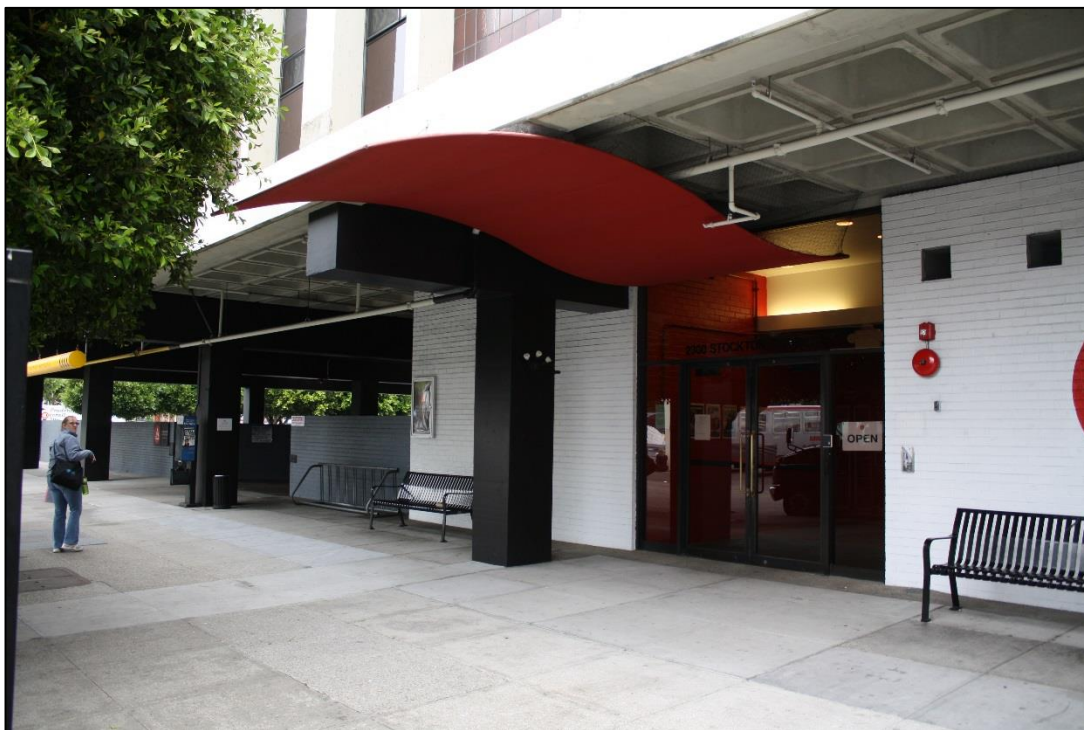
Figure 5. West façade, entrance detail, 2340 Stockton Street. Source: SWCA, 2015.

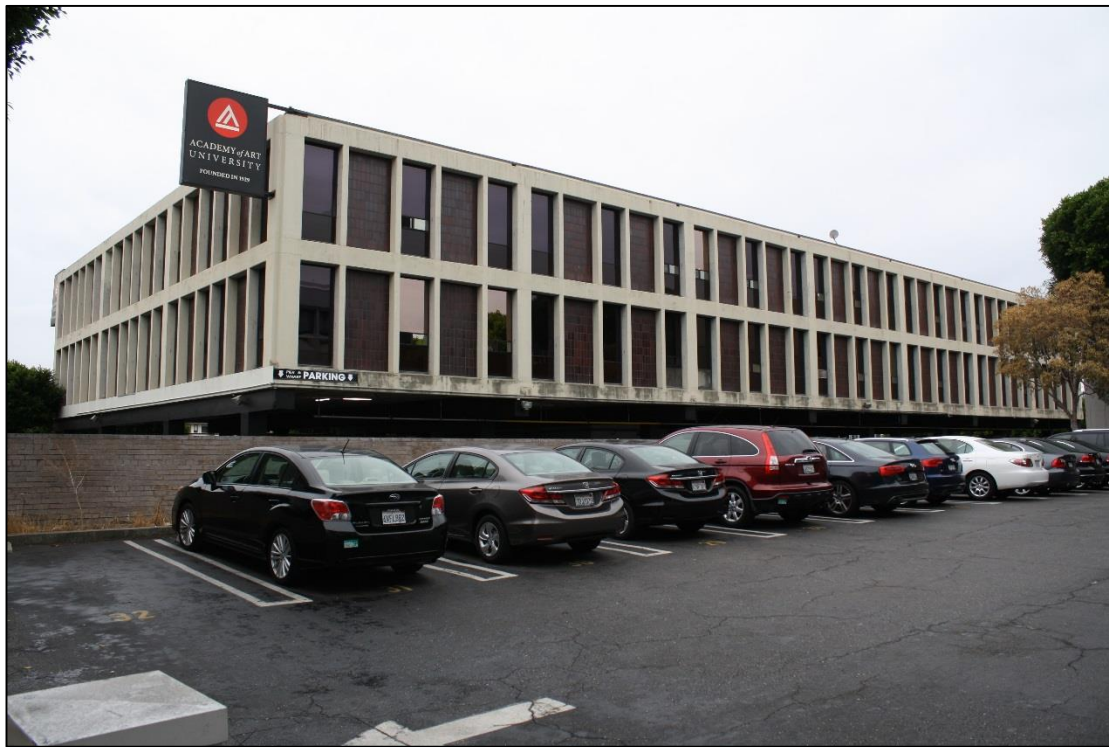
The east (rear) façade is very similar in appearance to the west (primary) façade and is divided into seven structural bays. Metal vents have been inserted in some of the windows at an unknown date. This facade is otherwise consistent with the fenestration pattern and materials of the other facades as described in the General section.

Figure 6. East façade, 2340 Stockton Street. Source: SWCA, 2015.

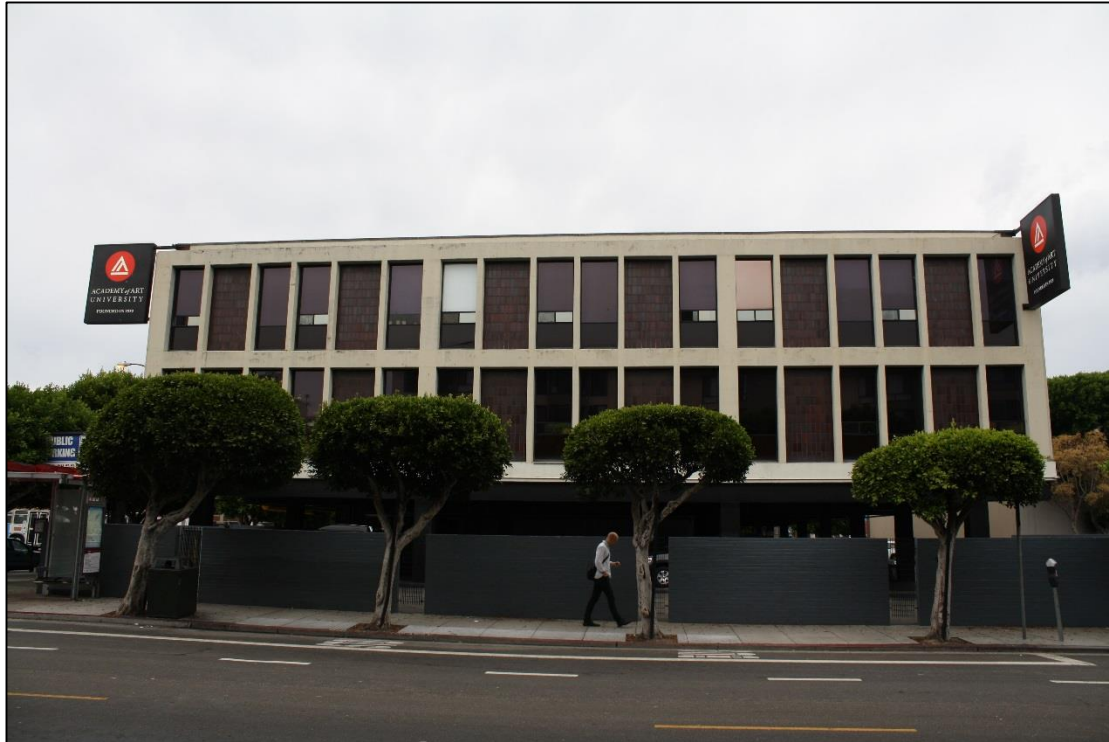
The north and south facades, which face Beach and North Point Streets respectively, have three structural bays. These facades are otherwise consistent with the fenestration pattern and materials as described in the General section.

Figure 7. South façade, 2340 Stockton Street. Source: SWCA, 2015.

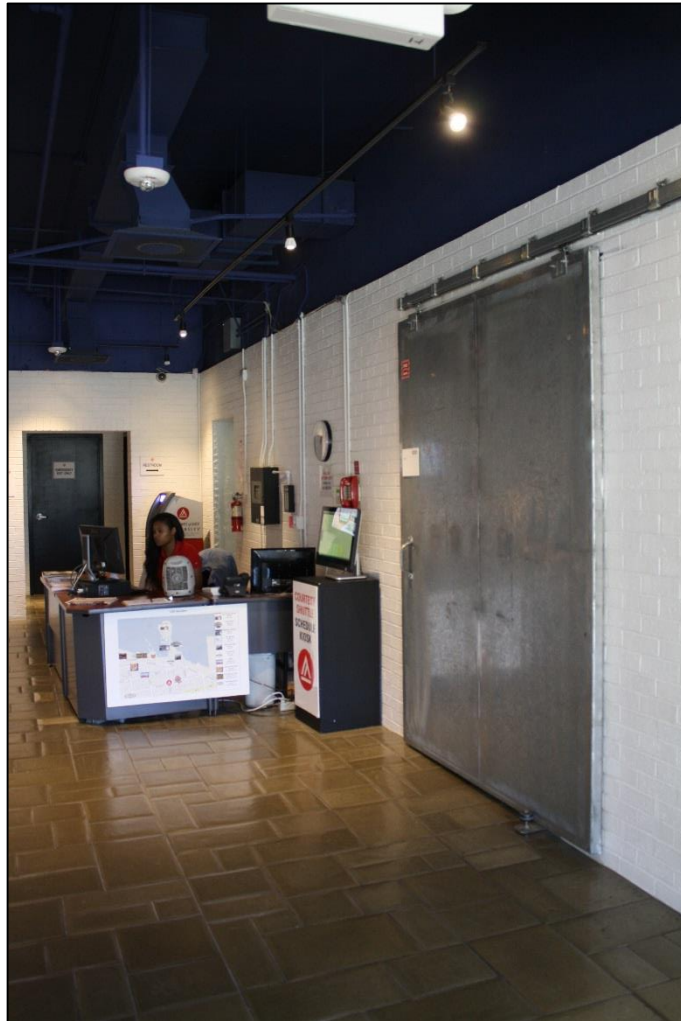
The interior of the Otis Elevator Building is largely characteristic of an office building dating to the early 1970s and does not appear to be extensively altered. The small lobby at the first floor features painted brick walls laid in common bond and original imprinted concrete floors. Alterations include new track lighting, televisions on the northern wall, and a sliding barn-style door on the southern wall. The surrounding parking garage is largely open. In the garage, the concrete piers and beams of the building's structural system are visible. At the ceiling, precast concrete coffers fill the spaces between the beams.

Figure 8. Lobby, 2340 Stockton Street. Source: SWCA, 2015.

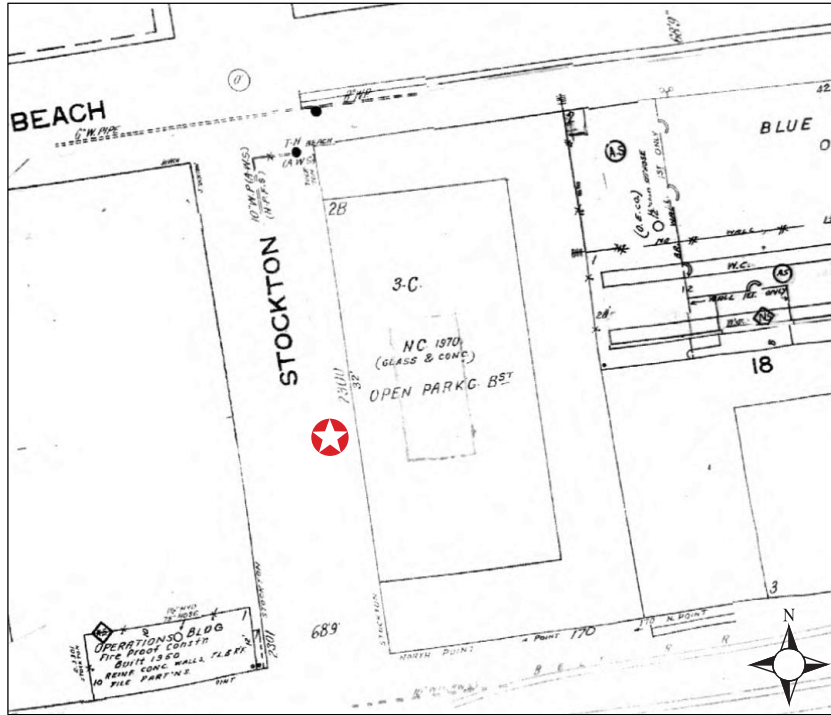
Figure 13. 1986 Sanborn Fire Insurance Map, 2340 Stockton Street. Source: Environmental

Data Resources, 2015.
