COMMENTS AND RESPONSES ON THE DRAFT EIR

THE 34TH AMERICA'S CUP

JAMES R. HERMAN CRUISE TERMINAL AND NORTHEAST WHARF PLAZA

SAN FRANCISCO PLANNING DEPARTMENT CASE NO. 2010.0493E
STATE CLEARINGHOUSE NO. 2011022040

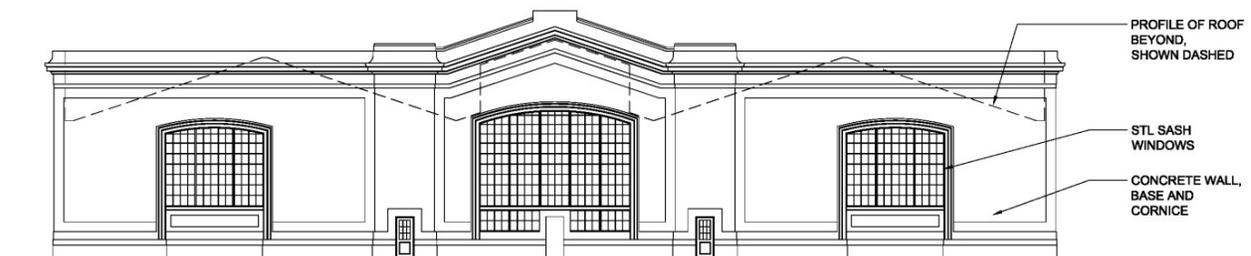
Original reinforced concrete wall at outshore end of Pier 29. This wall was demolished when Pier 27 was constructed in 1965. Drawing courtesy AECOM.

Pier 29 was the southernmost of a group of seven new piers (numbered 29 to 41) proposed in the early 1910s for San Francisco's northern waterfront. The substructure of Pier 29 was completed in November 1916. The Pier 29 shed was completed in July 1917, and the bulkhead building in 1918. The outshore end of the pier originally consisted of a reinforced concrete wall with three large arched windows, approximately 13 feet wide by 15 feet high.

Pier 29 was significantly altered when Pier 27 was constructed in 1965. To enable the outshore end of Pier 29 to open directly into Pier 27, Pier 29 was "cut back" in a stepped fashion, and the reinforced concrete wall at the outshore end of Pier 29 and several bays along the south wall of the Pier 29 shed were removed. At the same time, Pier 29's substructure was extended to accommodate the end of Pier 27, and steel framing and flat roofs were added to the northern end of Pier 29 where it joined Pier 27. In addition, the area south of Pier 29 was filled in to support a triangular asphalt parking lot and driveway in the space between the two piers.

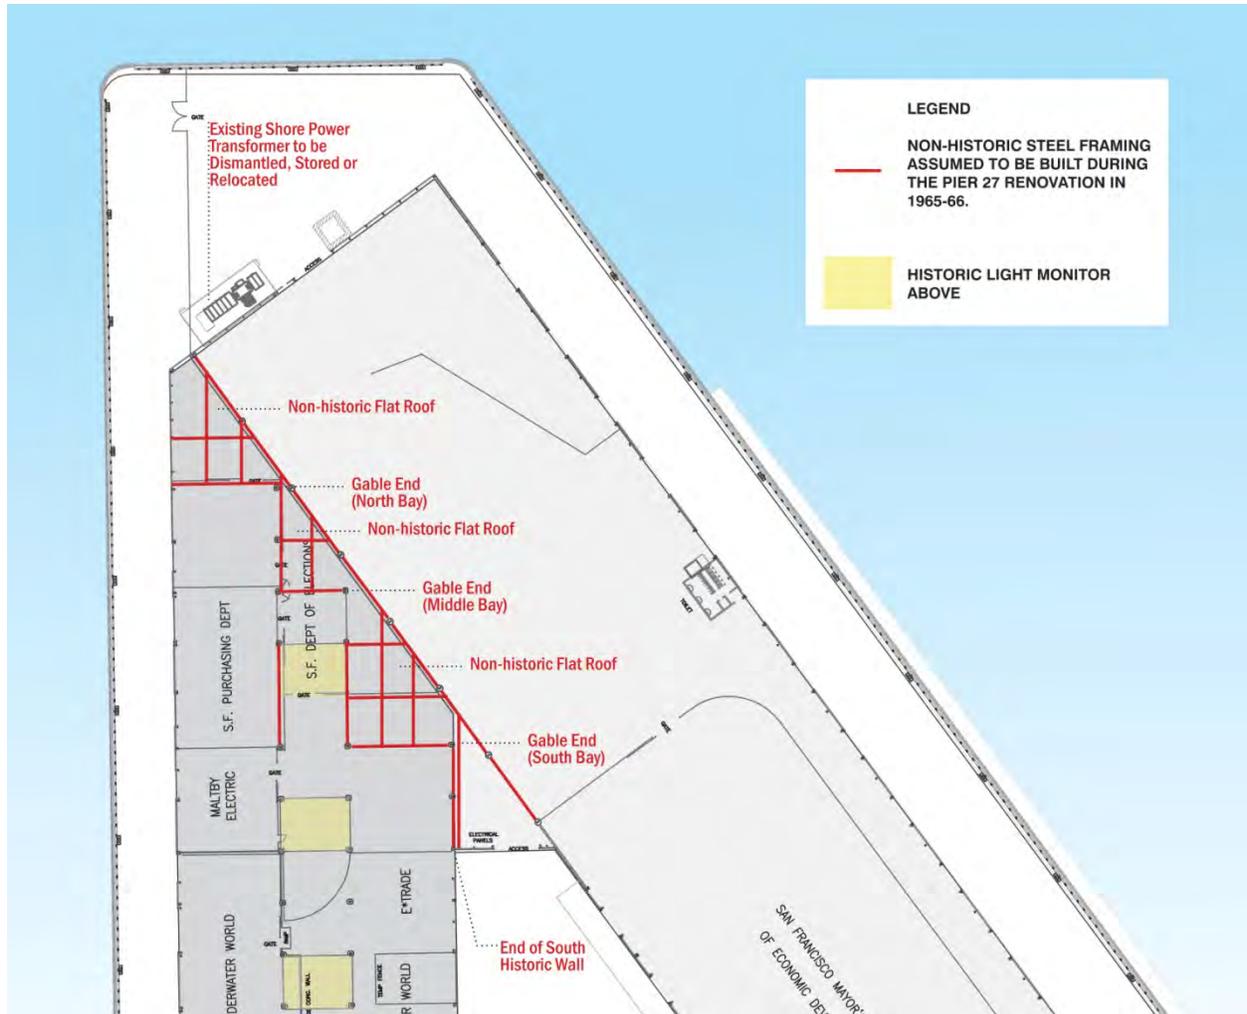
The shed at Pier 29 was clipped in the 1960s in order to connect it to the new Pier 27. Image courtesy AECOM.

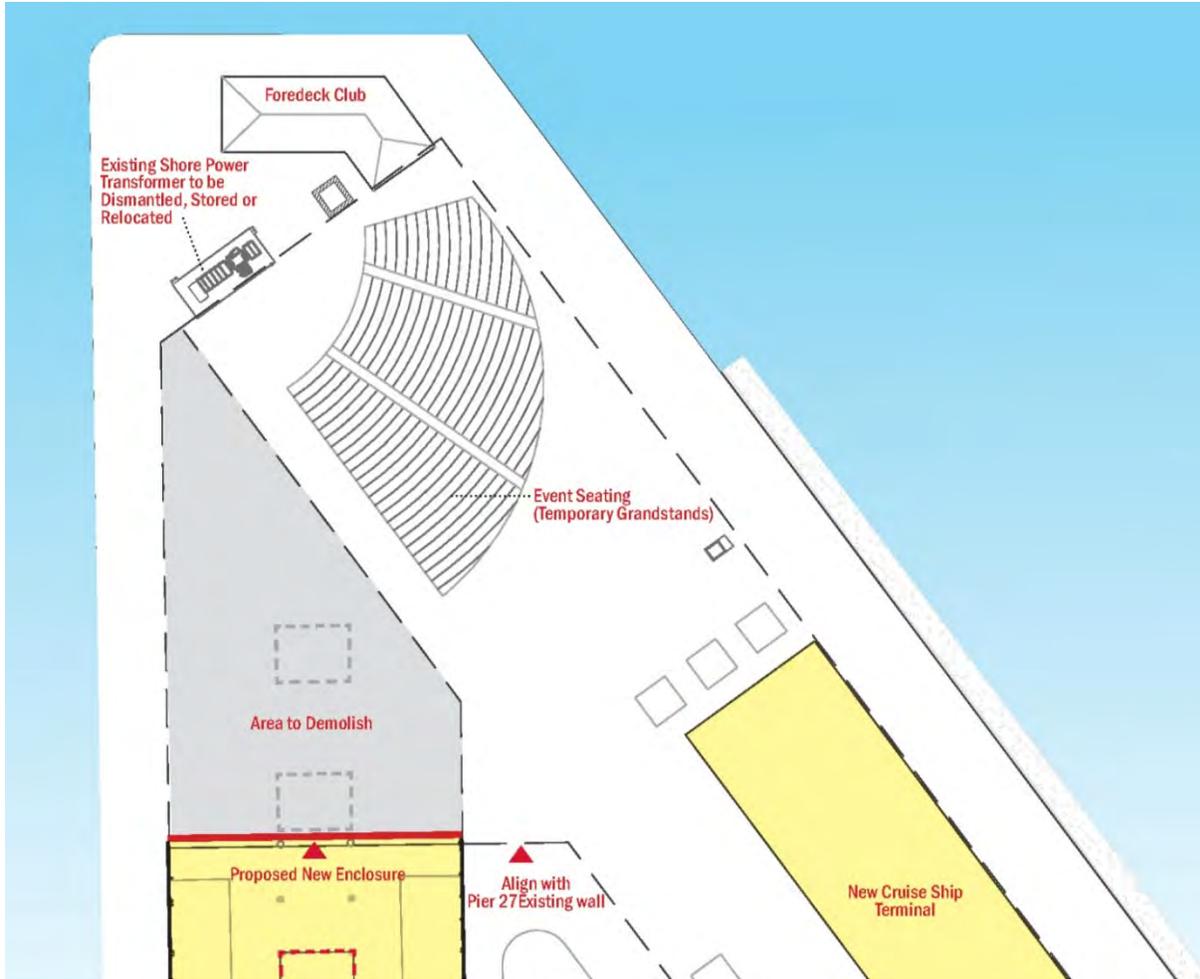
America's Cup Improvements, Piers 27-29. Image courtesy AECOM.

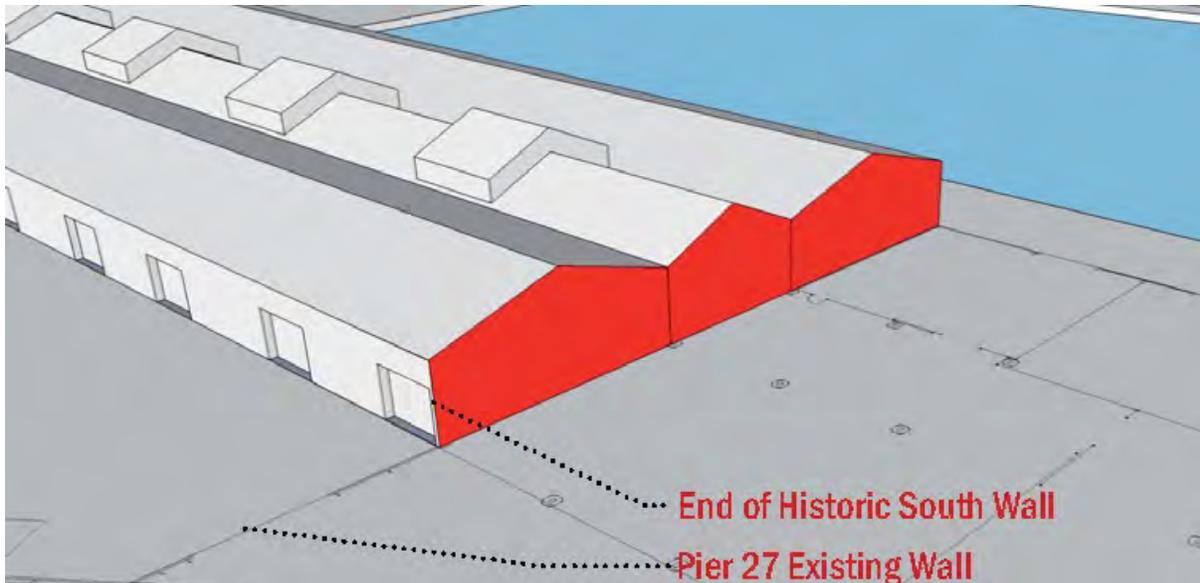
View looking west, showing proposed new Pier 29 enclosure wall. Image courtesy AECOM.

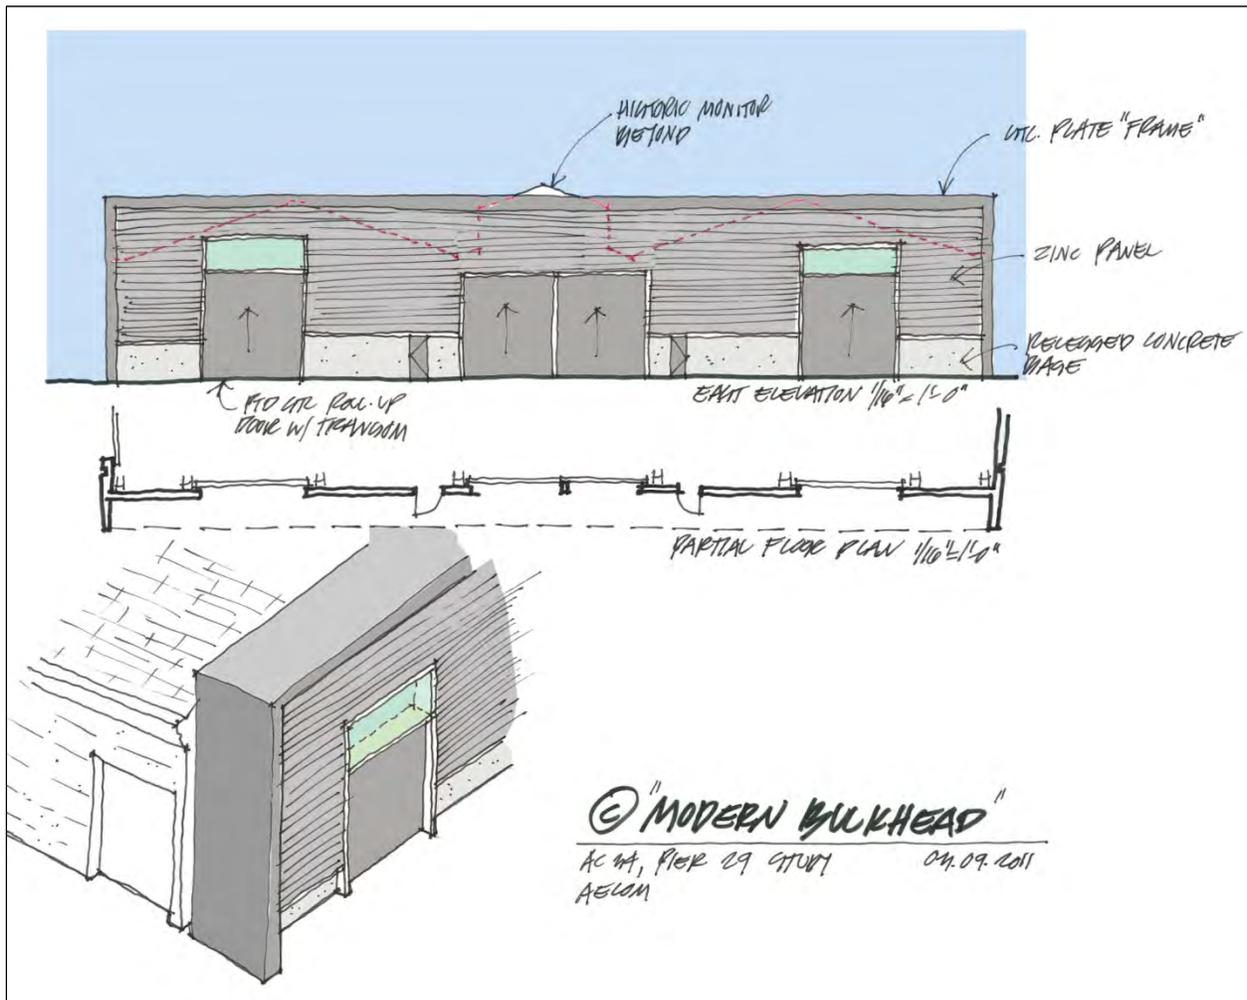
"Modern Bulkhead" alternative. Image courtesy AECOM.

The "Modern Bulkhead" alternative entailed construction of a rectangular end wall with no gable. Though such a wall would be clearly distinguishable from the rest of the historic building, its shape and appearance would be inconsistent with the character of similar pier structures along the San Francisco waterfront. Thus this alternative was also rejected.

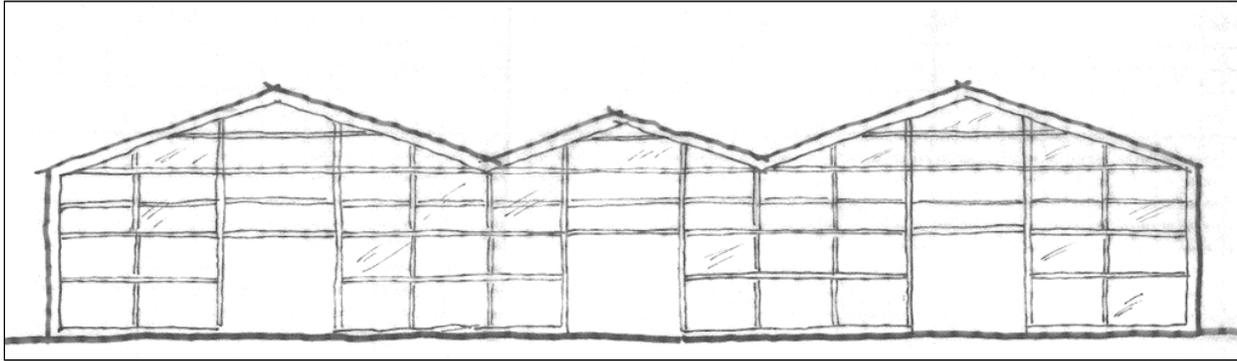
"Glass and Metal End Wall" alternative. Image courtesy AECOM.

Under this alternative, the new end wall of Pier 29 would consist of an exposed, metal-framed curtain wall or assembly in a grid layout, with individual cells of the grid in-filled with metal or glass panels. The wall would contain three rollup doors – centered beneath the three gables – and two person doors. The bottom course of the grid would consist of metal panels and the bay closest to Pier 27 would include metal panel up to the height of the rollup doors. Frame and metal panel colors would be complimentary to the trim colors of the pier shed. Panel sizes depicted in the above sketch represent the concept rather than actual sizes.

According to Standard 9 of the *Secretary's Standards*, new additions to a historic building need to be both differentiated from and compatible with the existing building. Like the "Modern Bulkhead" alternative, this alternative passes the differentiation test, as the extensive use of glass and metal panels in the new wall would clearly distinguish it from the existing building. The visual permeability of the proposed end wall, however, is incompatible with the character of the existing building and other similar pier structures along the San Francisco waterfront. With its extensive use of glass, the proposed end wall is markedly at odds with the building's historic outshore end, which was characterized by window and door openings set into an opaque wall. Nor does the proposed grid relate to any aspect of the design or ornamentation of the existing building. Thus the "Glass and Metal End Wall" alternative does not appear to be sufficiently compatible with the character of the existing building to satisfy the *Secretary's Standards*.

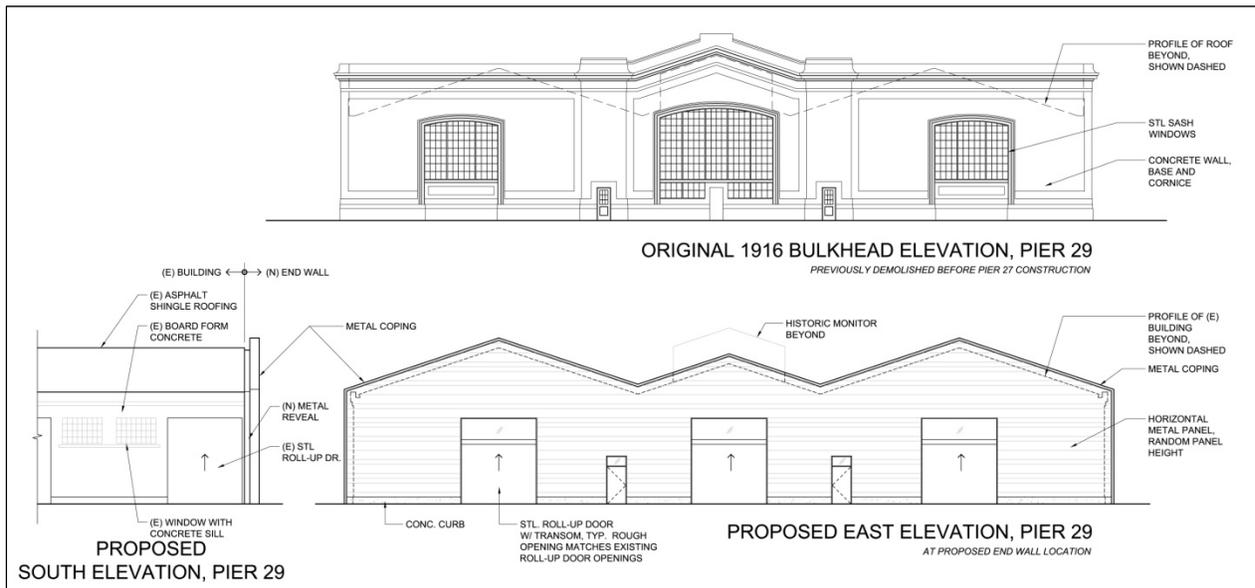
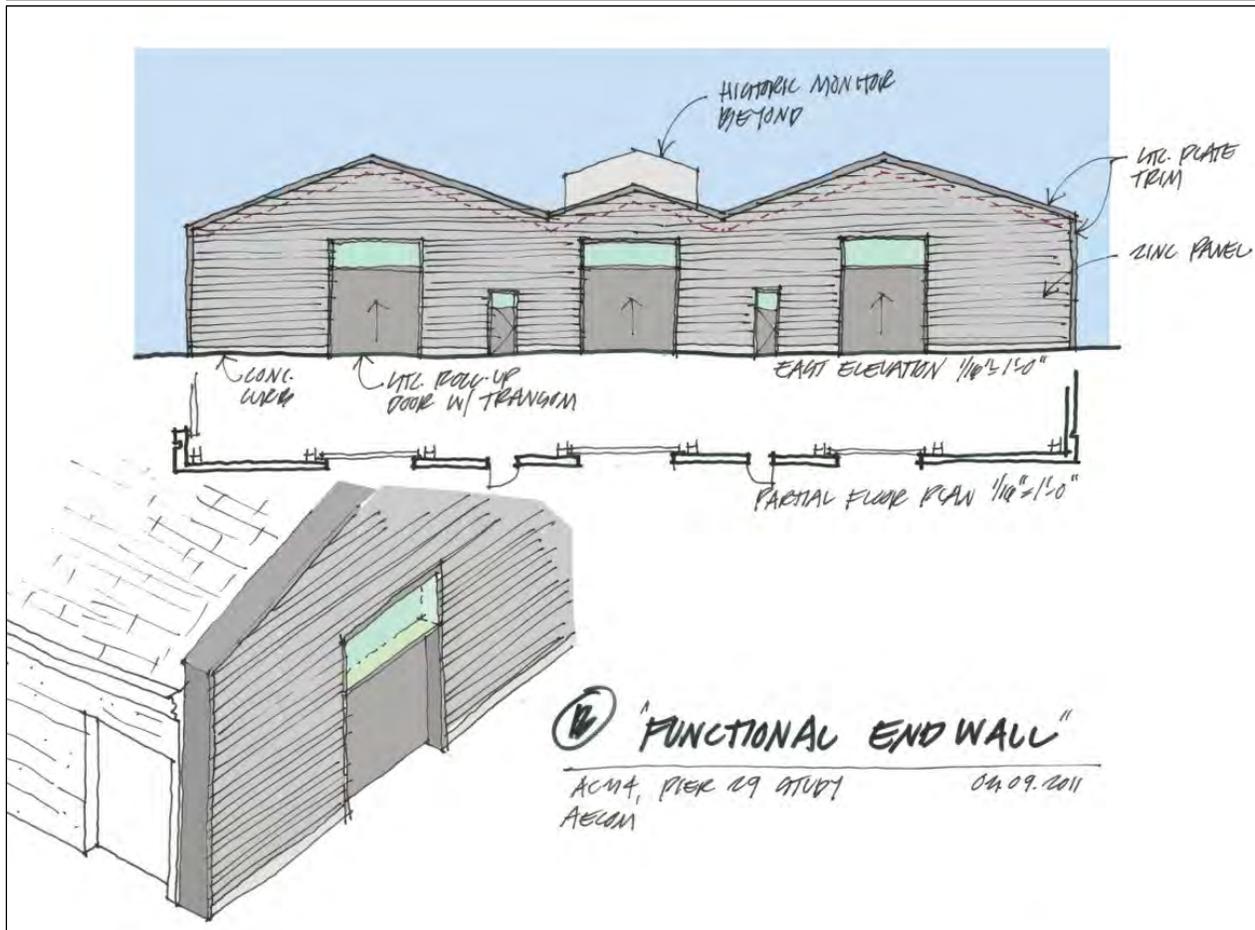
The preferred alternative, "Functional End Wall." Images courtesy AECOM.

The preferred "Functional End Wall" alternative entails construction of a three-gabled end wall that matches the profile of the existing building. The wall would be clad in horizontal metal paneling and would have metal coping. Steel roll-up doors with transom would occupy each of the three bays, with pedestrian doors in between.

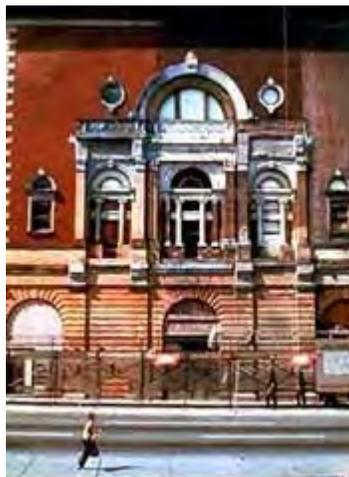
Ninety years of accumulated dirt and pollutants are being removed from this historic theater using an appropriate chemical cleaner, applied in stages. Photo: Richard Wagner, AIA.

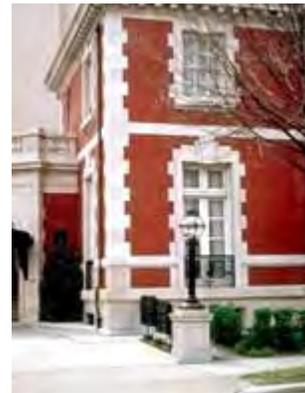
The decorative trim on this brick building is architectural terra-cotta intended to simulate the limestone foundation. Photo: NPS files.

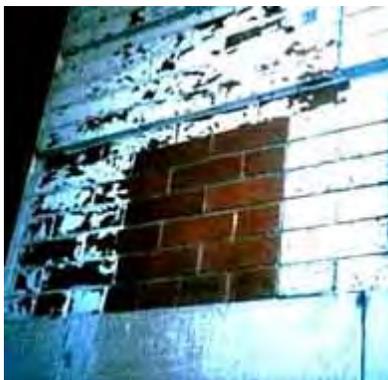
Any cleaning method should be tested before using it on historic masonry. Photo: NPS files.

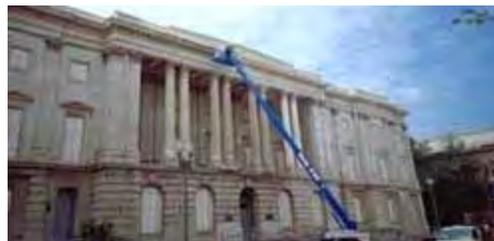
Low-to-medium-pressure steam (hot-pressurized water washing) is a gentle method of softening heavy soiling deposits and cleaning historic marble. Photo: NPS files.

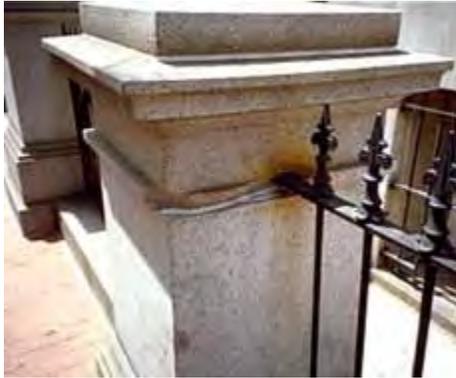
The iron stain on this granite post may be removed by applying a commercial rust-removal product in a poultice. Photo: NPS files

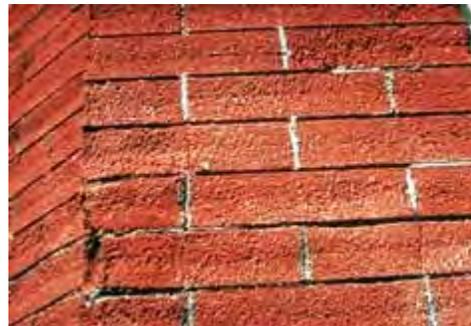
Sandblasting has permanently damaged this brick wall. Photo: NPS files

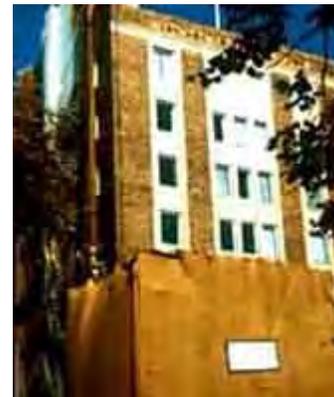
The lower floors of this historic brick and architectural terra-cotta building have been covered during chemical cleaning to protect pedestrians and vehicular traffic from potentially harmful overspray. Photo: NPS files.

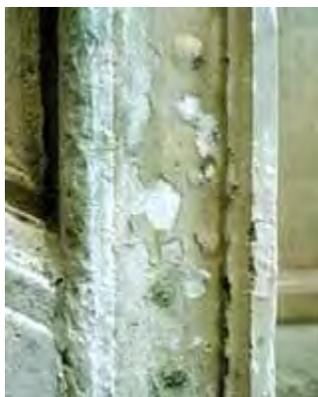
This clear coating has failed and is pulling off pieces of the stone as it peels. Photo: NPS files

Some modern water-repellent coatings which contain a binder intended to replace the natural binders in stone that have been lost through weathering and natural erosion are described in product literature as both a water repellent and a consolidant. The fact that the newer water-repellent coatings penetrate beneath the masonry surface instead of just forming a layer on top of the surface may indeed convey at least some consolidating properties to certain stones. However, a water-repellent coating cannot be considered a consolidant. In some instances, a water-repellent or "preservative" coating, if applied to already damaged or spalling stone, may form a surface crust which, if it fails, may exacerbate the deterioration by pulling off even more of the stone.

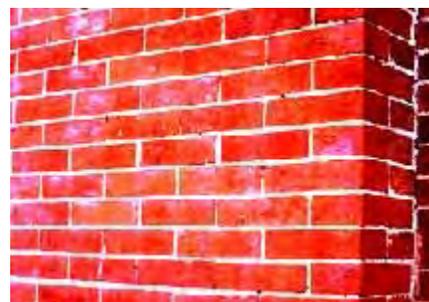
Improper cleaning methods may have been responsible for the formation of efflorescence on this brick. Photo: NPS files.

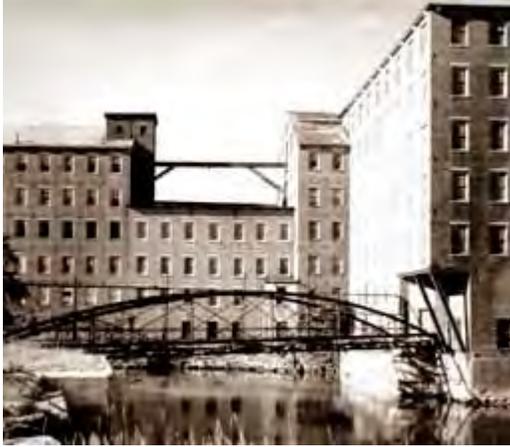
Windows are frequently important visual focal points, especially on simple facades such as this mill building. Replacement of the multi-pane windows with larger panes could dramatically alter the appearance of the building. Photo: NPS files.

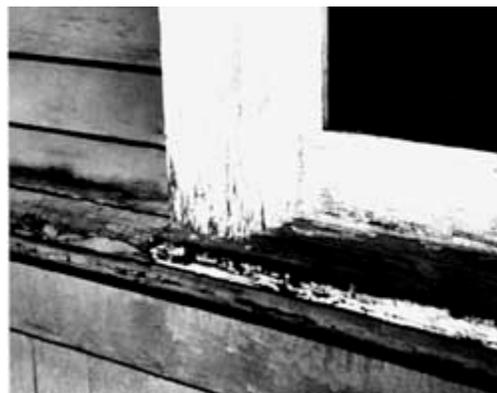
Deterioration of poorly maintained windows usually begins on horizontal surfaces and at joints, where water can collect and saturate the wood. Photo: NPS files.

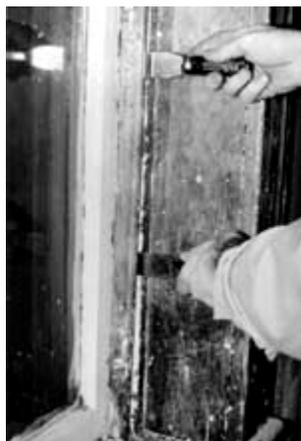
After removing paint from the seam between the interior stop and the jamb, the stop can be pried out and gradually worked loose using a pair of putty knives as shown. Photo: NPS files.

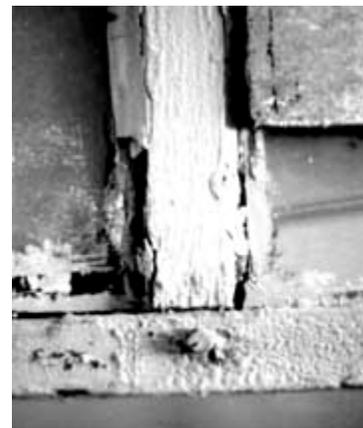
This historic double-hung window has many layers of paint, some cracked and missing putty, slight separation at the joints, broken sash cords, and one cracked pane. Photo: NPS files.

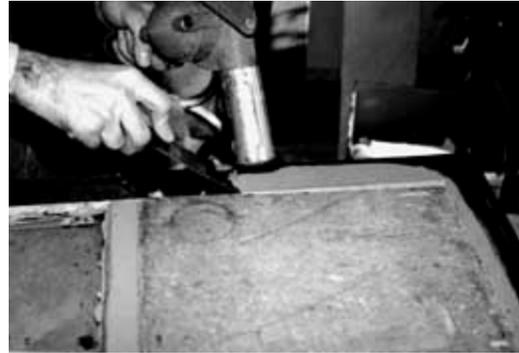
Sash can be removed and repaired in a convenient work area. Paint is being removed from this sash with a hot air gun. Photo: NPS files.

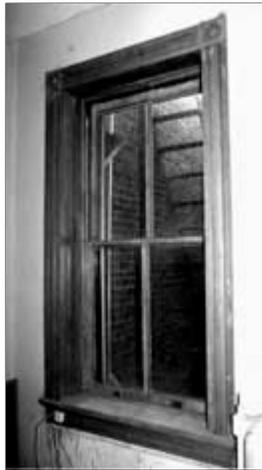
Following the relatively simple repairs, the window is weathertight, like new in appearance, and serviceable for many years to come. Photo: NPS files.

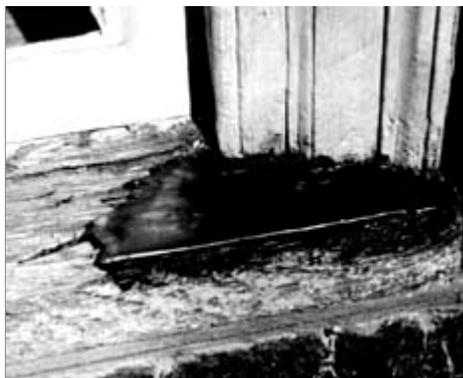
This illustrates a two-part epoxy patching compound used to fill the surface of a weathered sill and rebuild the missing edge. When the epoxy cures, it can be sanded smooth and painted to achieve a durable and waterproof repair. Photo: NPS files.

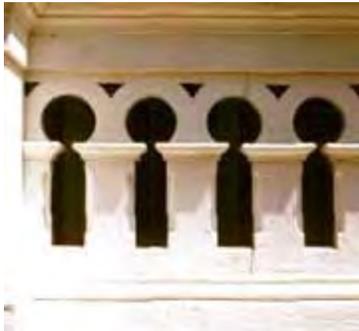
The paint on this exterior decorative feature is sound.
Photo: NPS files.

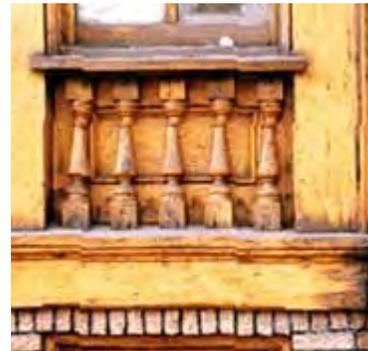
When the protective and decorative paint finish was removed and an inappropriate clear finish applied, the exterior character of the building was altered. Photo: NPS files.

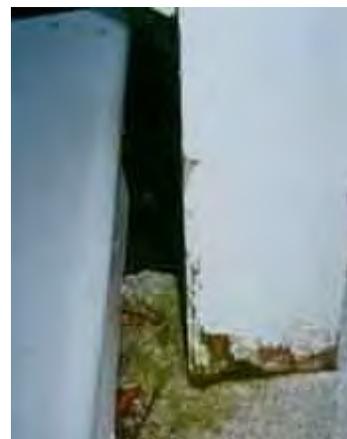
The problem evidenced here by mossy growth and deteriorated wood must be resolved and the wood allowed to dry out before the wood is repainted. Photo: NPS files.

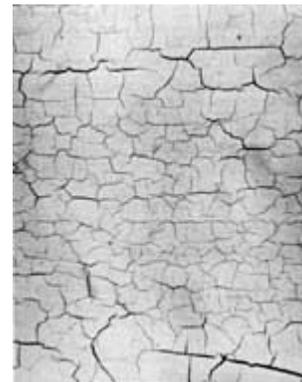
Crazing--or surface cracking--is an exterior surface condition which can be successfully treated by sanding and painting. Photo: Courtesy, National Decorating Products Association.

Crazing--fine, jagged interconnected breaks in the top layer of paint--results when paint that is several layers thick becomes excessively hard and brittle with age and is consequently no longer able to expand and contract with the wood in response to changes in temperature and humidity. As the wood swells, the bond between paint layers is broken and hairline cracks appear. Although somewhat more difficult to detect as opposed to other more obvious paint problems, it is well worth the time to scrutinize all surfaces for crazing. If not corrected, exterior moisture will enter the crazed surface, resulting in further swelling of the wood and, eventually, deep cracking and alligatoring, a Class III condition which requires total paint removal.

Crazing can be treated by hand or mechanically sanding the surface, then repainting. Although the hairline cracks may tend to show through the new paint, the surface will be protected against exterior moisture penetration.

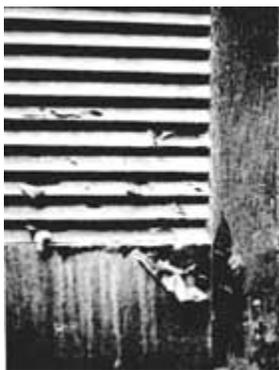
Here, a latex top coat was applied directly over old oil paint, resulting in intercoat peeling. The latex was unable to adhere. If latex is used over oil, an oil-base primer should be applied first. Photo: Mary L. Oehrlein, AIA.

Intercoat peeling can be the result of improper surface preparation prior to the last repainting. This most often occurs in protected areas such as eaves and covered porches because these surfaces do not receive a regular rinsing from rainfall, and salts from airborne pollutants thus accumulate on the surface. If not cleaned off, the new paint coat will not adhere properly and that layer will peel.

Another common cause of intercoat peeling is incompatibility between paint types. For example, if oil paint is applied over latex paint, peeling of the top coat can sometimes result since, upon aging, the oil paint becomes harder and less elastic than the latex paint. If latex paint is applied over old, chalking oil paint, peeling can also occur because the latex paint is unable to penetrate the chalky surface and adhere.

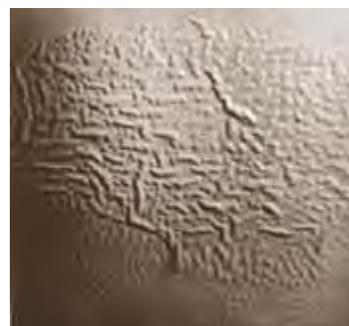
Wrinkled layers can generally be removed by scraping and sanding as opposed to total paint removal. Photo: Courtesy, National Decorating Products Association.

Another error in application that can easily be avoided is wrinkling. This occurs when the top layer of paint dries before the layer underneath. The top layer of paint actually moves as the paint underneath (a primer, for example) is drying. Specific causes of wrinkling include: (1) applying paint too thick; (2) applying a second coat before the first one dries; (3) inadequate brushing out; and (4) painting in temperatures higher than recommended by the manufacturer.

The wrinkled layer can be removed by scraping followed by hand or mechanical sanding to provide as even a surface as possible, then repainted following manufacturer's application instructions.

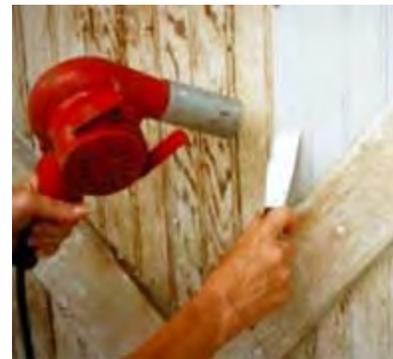
The nozzle on the electric heat gun permits hot air to be aimed into cavities on solid decorative surfaces, such as this carriage house door. After the paint has been sufficiently softened, it can be carefully removed with a scraper. Photo: NPS files.

Electric heat gun: The electric heat gun (electric hot-air gun) looks like a hand-held hairdryer with a heavy-duty metal case. It has an electrical resistance coil that typically heats between 500 and 750 degrees Fahrenheit and, again, uses about 15 amps of power which requires a heavy-duty extension cord. There are some heat guns that operate at higher temperatures but they should not be purchased for removing old paint because of the danger of lead paint vapors. The temperature is controlled by a vent on the side of the heat gun. When the vent is closed, the heat increases. A fan forces a stream of hot air against the painted woodwork, causing a blister to form. At that point, the softened paint can be peeled back with a putty knife. It can be used to best advantage when a paneled door was originally varnished, then painted a number of times. In this case, the paint will come off quite easily, often leaving an almost pristine varnished surface behind. Like the heat plate, the heat gun works best on a heavy paint buildup. (It is, however, not very successful on only one or two layers of paint or on surfaces that have only been varnished. The varnish simply becomes sticky and the wood scorches.)

Although the heat gun is heavier and more tiring to use than the heat plate, it is particularly effective for removing paint from detail work because the nozzle can be directed at curved and intricate surfaces. Its use is thus more limited than the heat plate, and most successfully used in conjunction with the heat plate. For example, it takes about two to three hours to strip a paneled door with a heat gun, but if used in combination with a heat plate for the large, flat area, the time can usually be cut in half. Although a heat gun seldom scorches wood, it can cause fires (like the blow torch) if aimed at the dusty cavity between the exterior sheathing and siding and interior lath and plaster. A fire may smolder for hours before flames break through to the surface. Therefore, this thermal device is best suited for use on solid decorative elements, such as molding, balusters, fretwork, or "gingerbread."

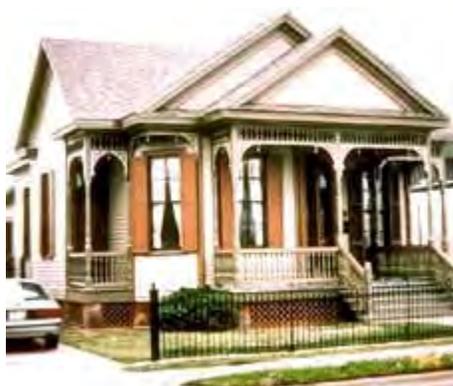
Decorative features were painted with a traditional oil-based paint as a part of the rehabilitation. Photo: NPS files.

Based on the assumption that the exterior wood has been painted with oil paint many times in the past and the existing top coat is therefore also an oil paint, it is recommended that for CLASS I and CLASS II paint surface conditions, a top coat of high quality oil paint be applied when repainting. The reason for recommending oil rather than latex paints is that a coat of latex paint applied directly over old oil paint is more apt to fail. The considerations are twofold. First, because oil paints continue to harden with age, the old surface is sensitive to the added stress of shrinkage which occurs as a new coat of paint dries. Oil paints shrink less upon drying than latex paints and thus do not have as great a tendency to pull the old paint loose.

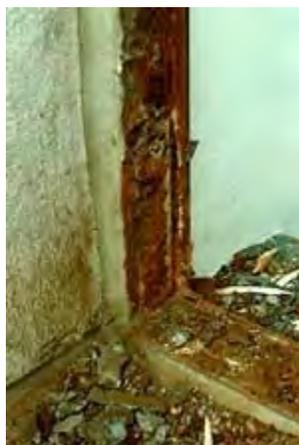
A severely deteriorated frame, such as this, can be replaced in kind. Photo: Henry Chambers, AIA.

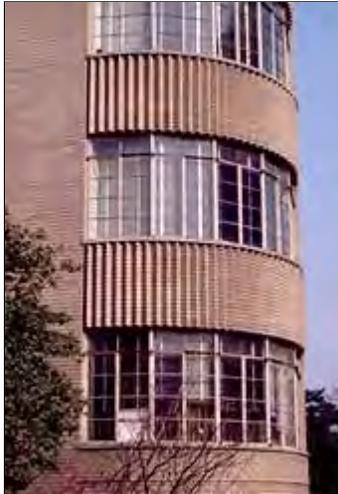
The historic steel sash is shown in place, prior to its removal and replacement with inappropriate aluminum sash (see below). Photo: NPS files.

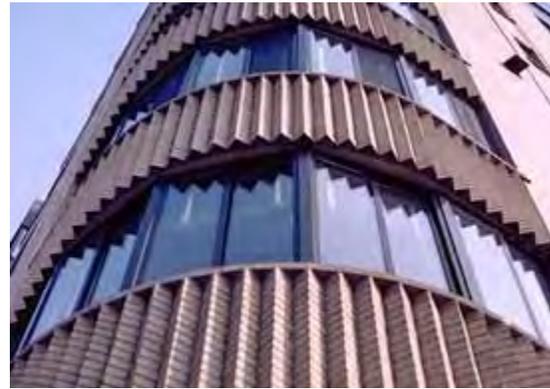
The historic steel sash (see photo above) was removed and replaced with modern aluminum sash, resulting in a negative visual impact on the building's historic character. Photo: NPS files.

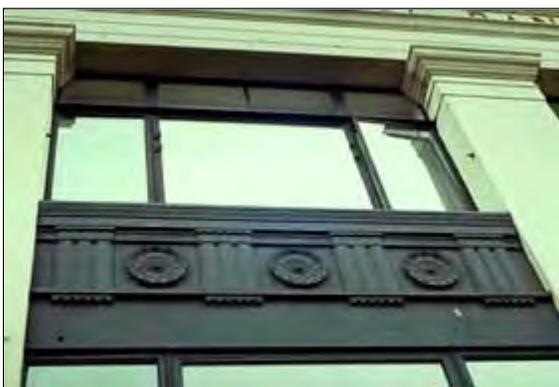
Historic steel sash can be fitted with dual glazing to improve thermal efficiency. Photo: NPS files.

The third weatherization treatment is to install an additional layer of glazing to improve the thermal efficiency of the existing window. The decision to pursue this treatment should proceed from careful analysis. Each of the most common techniques for adding a layer of glazing will effect approximately the same energy savings (approximately double the original insulating value of the windows); therefore, cost and aesthetic considerations usually determine the choice of method. Methods of adding a layer of glazing to improve thermal efficiency include adding a new layer of transparent material to the window; adding

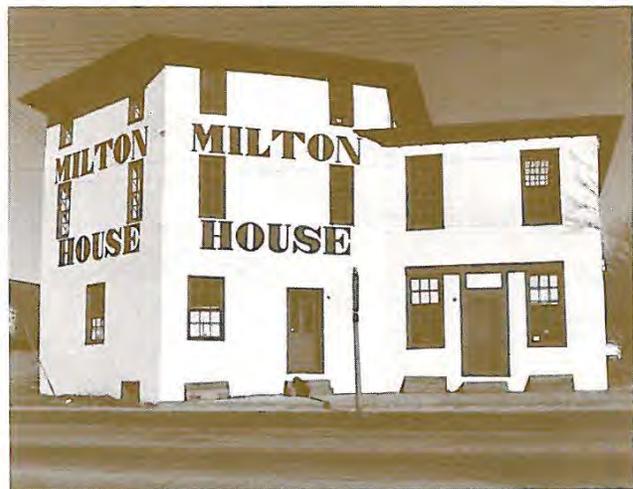
Fig. 1. Milton House, Milton, Wisconsin (1844). An early example of gravel wall construction with 12- to 15-inch thick monolithic concrete walls coated on the exterior with stucco. Photo: William B. Coney.

Despite its early use, concrete was slow in achieving widespread acceptance as a building material in the United States. In 1853, the second edition of Orson S. Fowler's *A Home for All* publicized the advantages of "gravel wall" construction to a wide audience, and poured gravel wall buildings appeared across the United States (see fig. 1). Seguin, Texas, 35 miles east

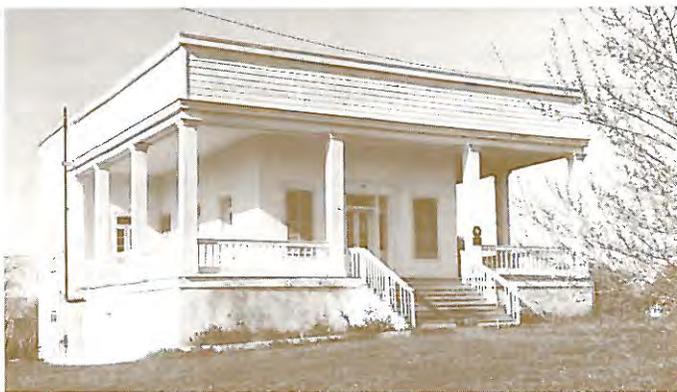
Fig. 2. Sebastopol House, Seguin, Texas (1856). This Greek Revival dwelling is one of the few remaining poured-in-place concrete structures in this Texas town noted for its construction of over 90 concrete buildings in the mid-nineteenth century. The high parapets surrounding the flat roof were lined and served as a water reservoir to cool the house. Photo: Texas Historical Commission.

of San Antonio, came to be called "The Mother of Concrete Cities" for some 90 concrete buildings made from local "lime water" and gravel (see fig. 2). Impressed by the economic advantages of poured gravel wall or "lime-grout" construction, the Quartermaster General's Office of the War Department embarked on a campaign to improve the quality of building for frontier military posts. As a result, lime-grout structures were built at several western posts, such as the buildings that were constructed with 12- or 18-inch-thick walls at Fort Laramie, Wyoming between 1872 and 1885. By the 1880s sufficient experience had been gained with unreinforced concrete to permit construction of much larger buildings. The Ponce de Leon Hotel in St. Augustine, Florida, is a notable example from this period (see fig. 3).

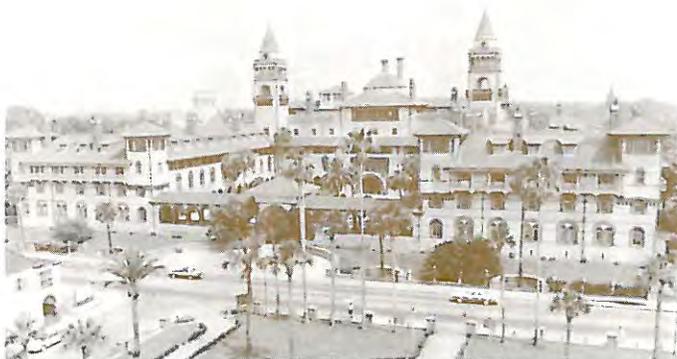
Fig. 3. Ponce de Leon Hotel, St. Augustine, Florida (1885-87). An example of unreinforced concrete used on a grand scale, this Spanish Colonial Revival hotel was designed by Carrere and Hastings and commissioned by railroad magnate Henry Flagler. The building now serves as the main campus hall for Flagler College. Photo: Flagler College.

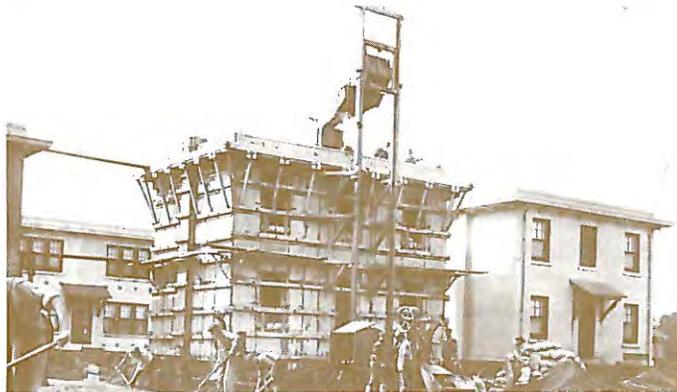
Fig. 4. Thomas A. Edison's Cast-in-Place Houses, Union Township, New Jersey (1909). This construction photo shows the formwork for the cast-in-place reinforced concrete houses built as low-cost housing using a standard 25- by 30-foot module. Photo: Edison National Historical Site.

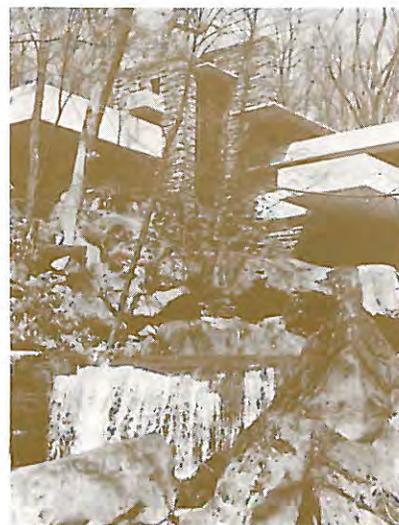
Fig. 5. "Fallingwater," near Mill Run, Pennsylvania (1936-37). This dramatic reinforced concrete residence by Frank Lloyd Wright is anchored into bedrock on the hillside and cantilevered over the stream. The great tensile strength of reinforced concrete made this type of construction possible. Photo: Paul Mayen.

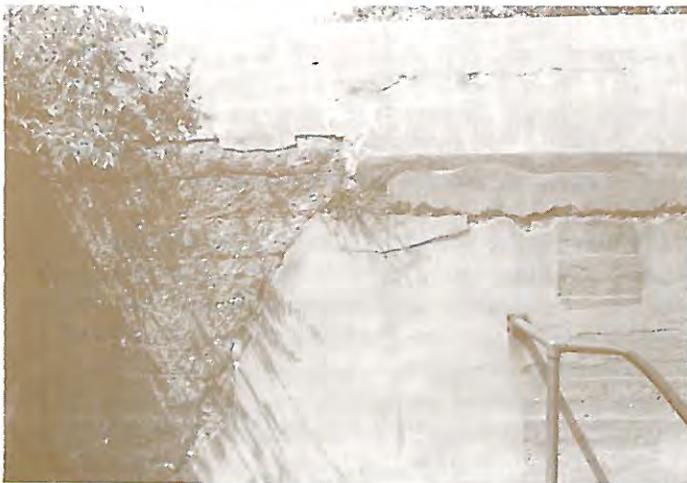
Fig. 6. Battery Fortifications, Ft. Washington, Maryland (1891-97). This unreinforced concrete fortification exhibits several kinds of deterioration: the diagonal structural crack due to uneven settlement, the long horizontal crack at the cold joint, the spalling of the concrete surface coating, and vegetative growth. Photo: Sharon C. Park, AIA.

Deterioration in concrete can be caused by environmental factors, inferior materials, poor workmanship, inherent structural design defects, and inadequate maintenance (see figs. 6, 7, and 8).

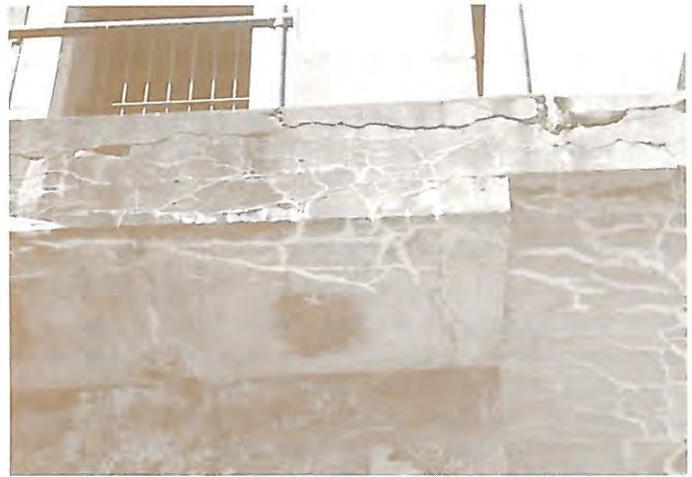
Fig. 7. Battery Commander's Station, Ft. Washington, Maryland (1904). This reinforced concrete tower with a cantilevered balcony is showing serious deterioration. Water has penetrated the slab, causing freeze-thaw spalling around the posts and corrosion of the reinforcing bars. This internal corrosion is causing expansion inside the slab and creating major horizontal cracks in the concrete. Under the balcony can be seen the network of hardened white calcified deposits, which have exuded through cracks in the concrete as a result of alkali-aggregate reaction. Photo: Lee H. Nelson, FAIA.

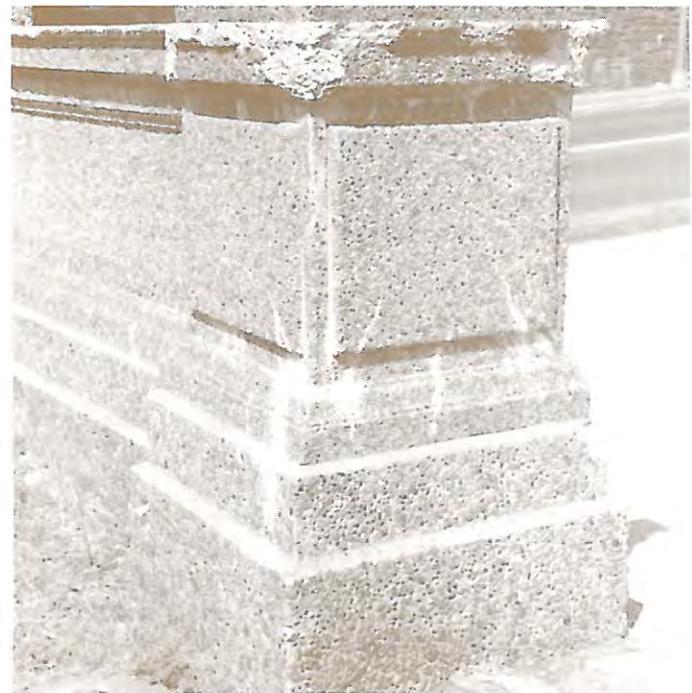
Fig. 8. Meridian Hill, Washington, D.C. (1934). This reinforced concrete pier has lost much of its projecting molding partly from accidental impact and partly from spalling induced by freeze-thaw action. Evidence of moisture leaching out from the interior through cracks is seen as white deposits on the surface of this exposed aggregate concrete. Photo: Lee H. Nelson, FAIA.

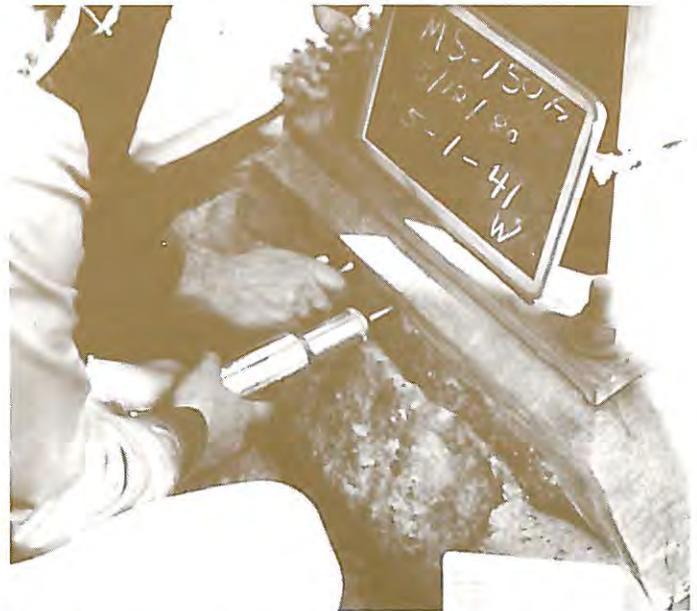
Fig. 9. Nondestructive sonic tests are one way of determining the location and soundness of internal reinforcing bars and the hardness of the concrete. There are a variety of other nondestructive tests provided by professional consultants that will help in the evaluation of the structural integrity of concrete prior to major repair work. Photo: Feld, Kaminetzky and Cohen and American Concrete Institute.

Testing. Two types of testing, on-site and laboratory, can supplement the field condition survey as necessary. On-site, nondestructive testing may include use of a calibrated metal detector or sonic tests to locate the position, depth, and direction of reinforcing bars (see fig. 9). Voids can frequently be detected by "sounding" with a metal hammer. Chains about 30 inches long attached to a 2-foot-long crossbar, dragged over the slabs while listening for hollow reverberations, can locate areas of slabs that have delaminated. In order to find areas of walls that allow moisture to penetrate to the building interior, areas may be tested from the outside by spraying water at the walls and then inspecting the interior for water. If leaks are not readily apparent, sophisticated equipment is available to measure the water permeability of concrete walls.

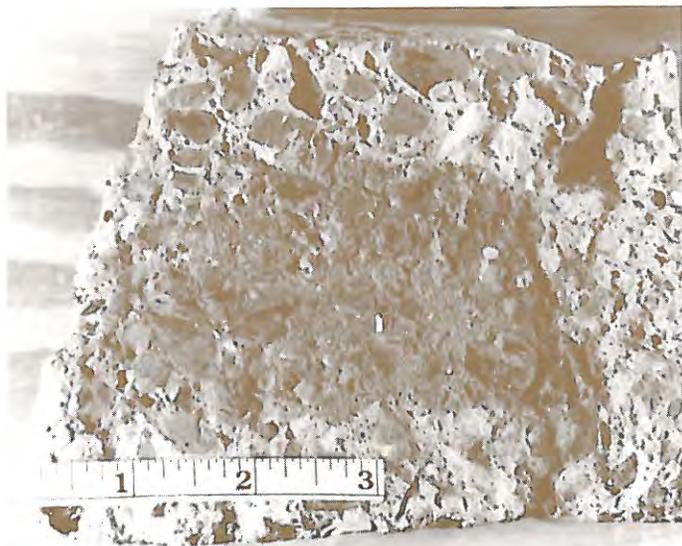
Fig. 10. Testing of actual samples of concrete in the lab may be necessary to determine the strength and condition of the concrete. In this sample, the surface, which is lighter than the sound concrete core, shows that carbonation has taken place. Carbonation reduces the alkalinity in concrete and may hasten corrosion of reinforcing bars close to the surface. Photo: Stella L. Marusin.

for repair materials (see fig. 10). These tests, however, are expensive. A well-equipped concrete laboratory can analyze concrete samples for strength, alkalinity, carbonation, porosity, alkali-aggregate reaction, presence of chlorides, and past composition.

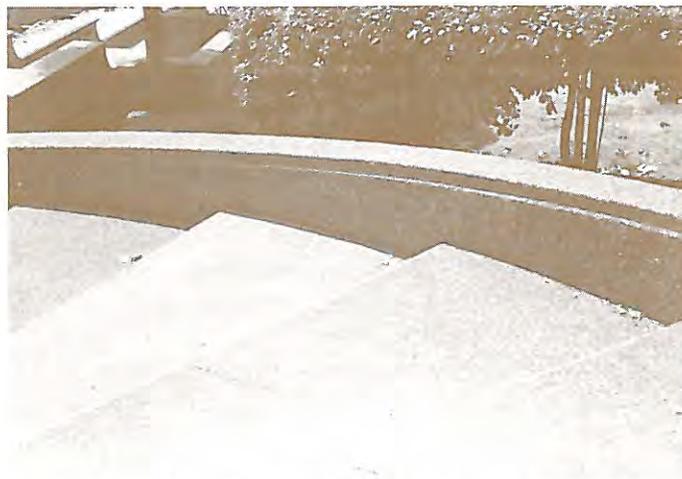
Fig. 11. Meridian Hill, Washington, D.C. (1934). It is important to match the visual qualities, such as color and texture, when repairs or replacement sections are undertaken. In this case, the new replacement step, located second from the left, matches the original pebble-finish surface of the adjacent historic steps. Photo: Sharon C. Park, AIA.

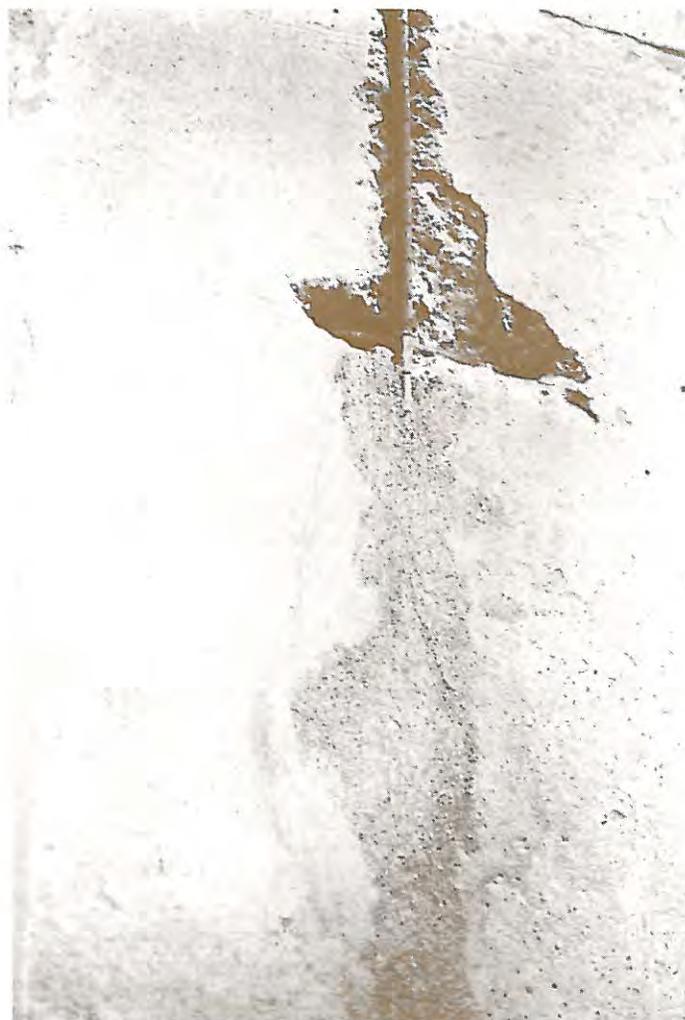
Fig. 12. Without proper preparation and correction of a pre-existing problem, repairs will fail. Insufficient concrete at the surface caused this patch around a reinforcing bar to fail within a year. In this case, a structural engineer should have assessed the need for this rod so close to the surface. Redundant rods are often cut out prior to patching. Photo: Alonzo White.

Repairs should be undertaken only after the planning measures outlined above have been followed. Repair of historic concrete may consist of either patching the historic material or filling in with new material worked to match the historic material. If replacement is necessary, duplication of historic materials and detailing should be as exact as possible to assure a repair that is functionally and aesthetically acceptable (see fig. 11). The correction and elimination of concrete problems can be difficult, time-consuming, and costly. Yet the temptation to resort to temporary solutions should be avoided, since their failure can expose a building to further and more serious deterioration, and in some cases can mask underlying structural problems that could lead to serious safety hazards (see fig. 12).

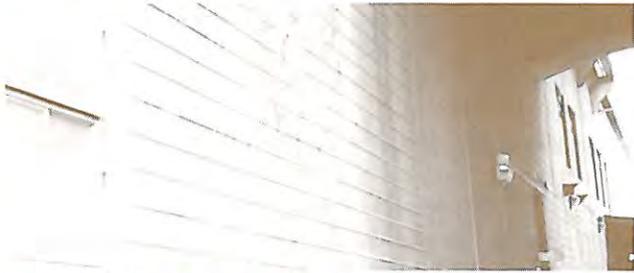
Fig. 13a. Buckling concrete under a painted surface indicates underlying deterioration. It is often difficult to assess the amount of deterioration until the area has been cleaned and examined closely.

Fig. 13a-i. Virginia Heating Plant, Arlington, Virginia (1941). This reinforced concrete building exhibits several serious problems, including cracking, spalling, and corrosion of reinforcing bars. As a result of careful planning and close supervision, successful repairs have been carried out. Photos: Alonzo White and Sharon C. Park, AIA.

Principal concrete repair treatments are discussed below. While they are presented separately here, in practice, preservation projects typically incorporate multiple treatments (see figs. 13a-i).

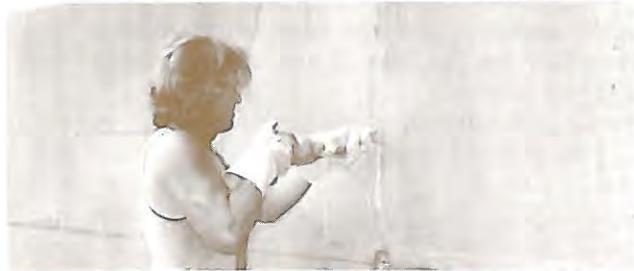
Fig. 13c. Narrow cracks often need to be widened to receive concrete patches. Here a pneumatic chisel is being used.
