COMMENTS AND RESPONSES ON THE DRAFT EIR

THE 34TH AMERICA'S CUP

JAMES R. HERMAN CRUISE TERMINAL AND NORTHEAST WHARF PLAZA

SAN FRANCISCO PLANNING DEPARTMENT CASE NO. 2010.0493E
STATE CLEARINGHOUSE NO. 2011022040

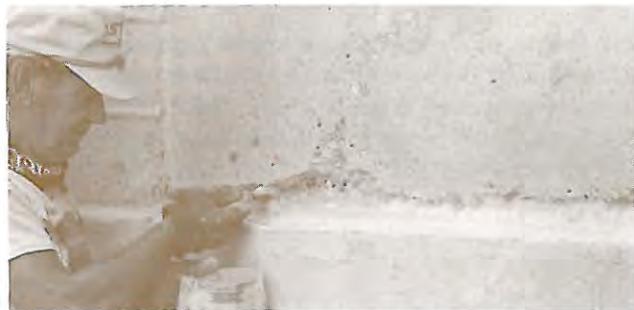
Fig. 13e. A spalled area of concrete has been cleaned back to a sound surface, and is being coated with a bonding agent to increase adherence of the new concrete patch.

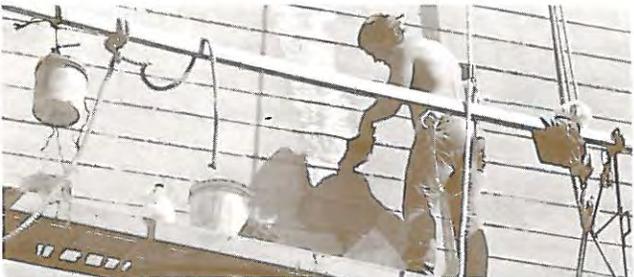
Fig. 13g. A soft brush is used to smooth the patch and to blend it with the adjacent historic concrete.

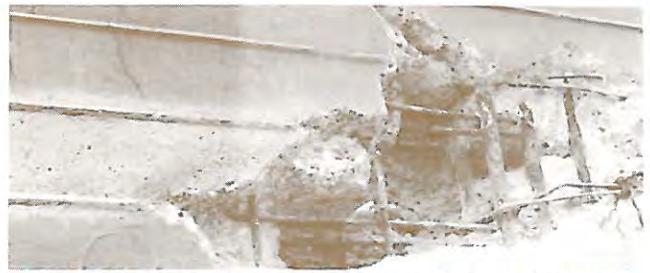
Fig. 13b. Upon removal of the deteriorated surface, a pocket of poorly mixed concrete (mostly sand and gravel) was easily chiseled out. The reinforcing rods were in good condition.

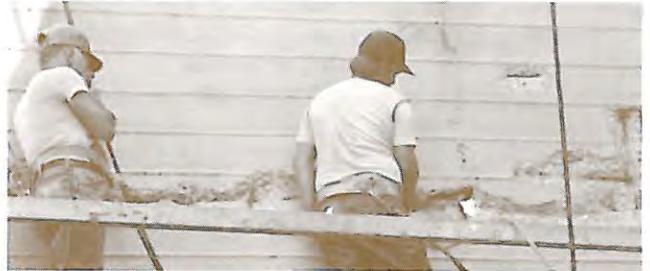
Fig. 13d. Deteriorated or redundant reinforcing bars are removed after evaluation by a structural engineer. An acetylene torch is being used to cut out the bars.

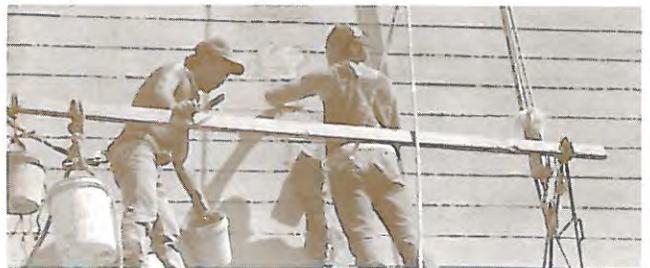
Fig. 13f. Workmen are applying patching concrete and using a trowel to form ridges to match the appearance of the historic concrete ridges that were originally created by the form boards.

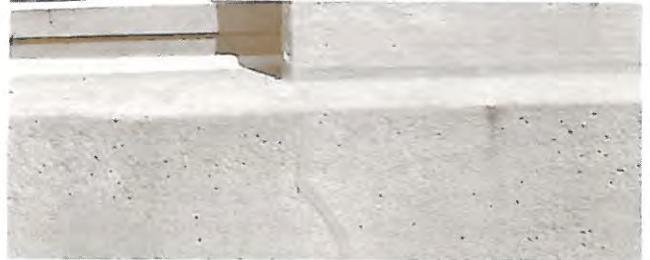
Fig. 13h. This active crack at a window sill and in the foundation wall has been filled with a flexible sealant. This area was subsequently painted with a masonry paint compatible with the sealant.

Other cracks are active, changing their width and length. Active structural cracks will move as loads are added or removed. Thermal cracks will move as temperatures fluctuate. Thus, expansion-contraction joints may have to be introduced before repair is undertaken. Active cracks should be filled with sealants that will adhere to the sides of the cracks and will compress or expand during crack movement. The design, detailing, and execution of sealant-filled cracks require considerable attention, or else they will detract from the appearance of the historic building.

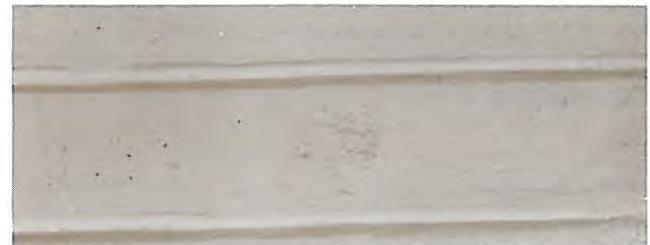
Fig. 13a-i. Virginia Heating Plant, Arlington, Virginia (1941). This reinforced concrete building exhibits several serious problems, including cracking, spalling, and corrosion of reinforcing bars. As a result of careful planning and close supervision, successful repairs have been carried out. Photos: Alonzo White and Sharon C. Park, AIA.

Fig. 13i. Upon completion of all repairs, the building was painted. The finished repair of the deterioration seen in 13a and b is shown in this photograph. The patch matches the texture and detailing of the historic concrete.

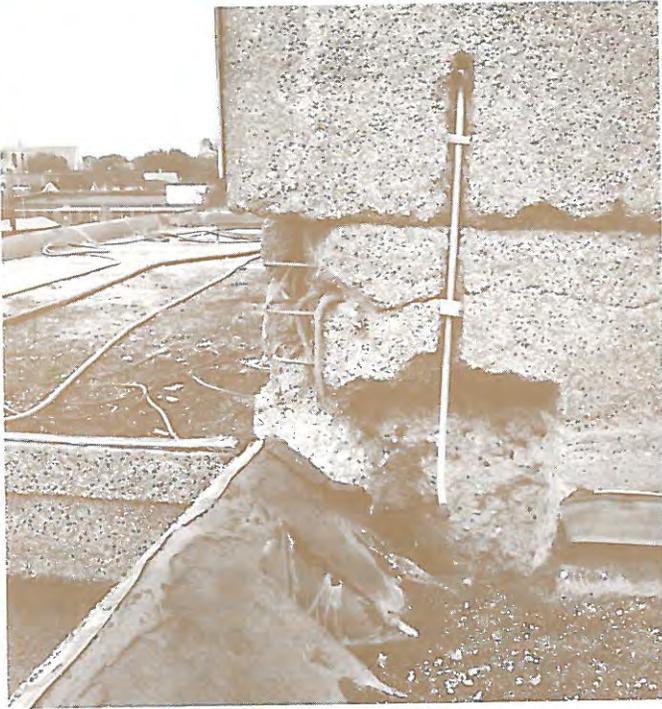
Fig. 14a. Spalled concrete was most noticeable at locations of concentrated rebars. Deteriorated concrete, the 1960s stucco finish, and corrosion were removed by grit-blasting. Photo: Robert Bell.

Fig. 14a-c. Unity Temple, Oak Park, Illinois (1906). Architect Frank Lloyd Wright used cast-in-place concrete with an exposed aggregate finish. However, reinforcing bars placed too close to the surface resulted in corrosion, cracking, and spalling. A superficial repair in the 1960s coated the surface with a concrete mix and Portland cement paint which produced a stucco-like finish and accelerated deterioration. Repair work was undertaken in 1971.

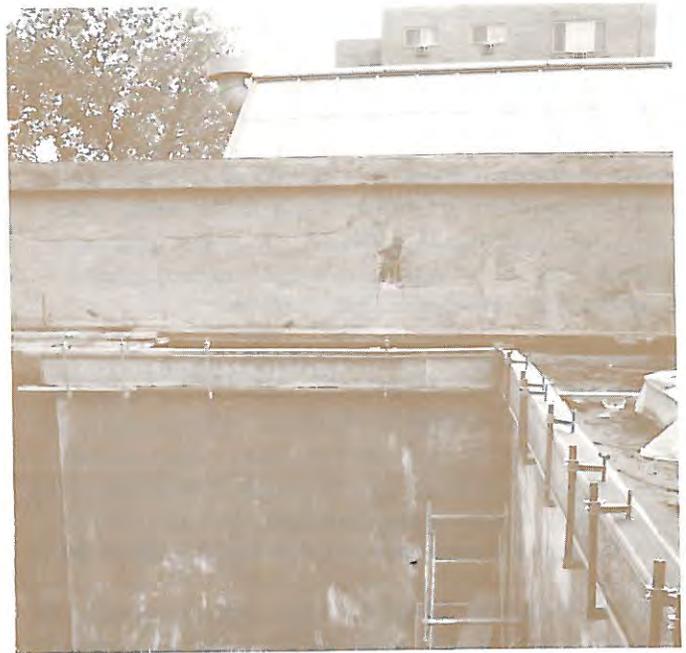
Fig. 14b. Board screeds were attached to the building to recreate the sharp edges of the original detail. Photo: Robert Bell.

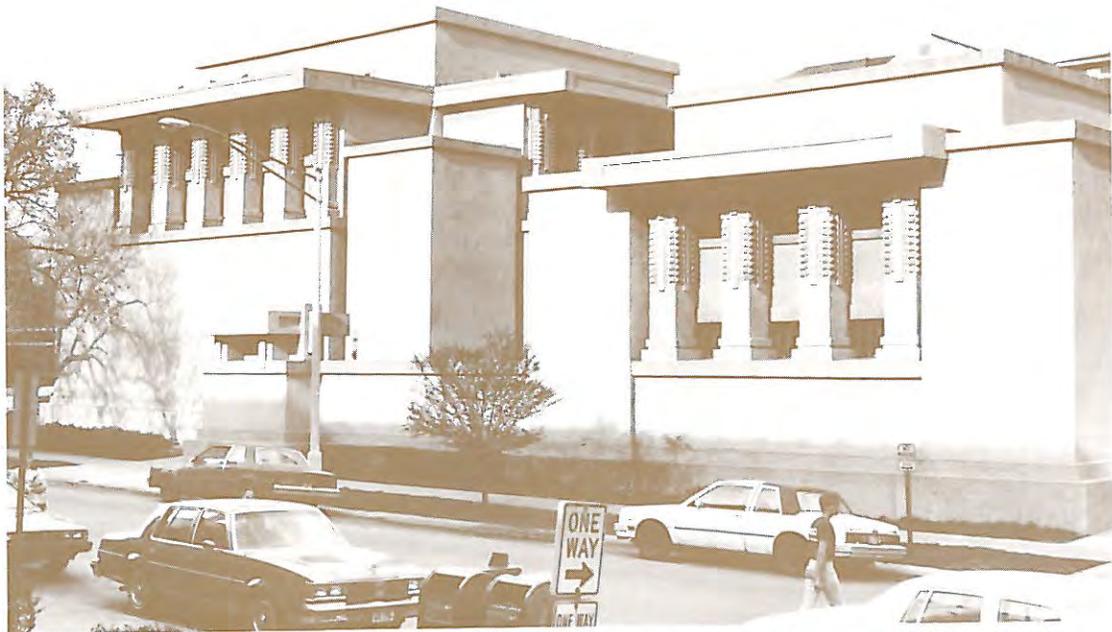
Fig. 14c. Once the repair work was complete, the entire building was sprayed with a concrete mixture consisting of pea-gravel, cement, and sand, which was then hand-

troweled. Finally, the building was lightly grit-blasted to remove the cement paste and reproduce the exposed aggregate finish. Photo: Harry J. Hunderman.

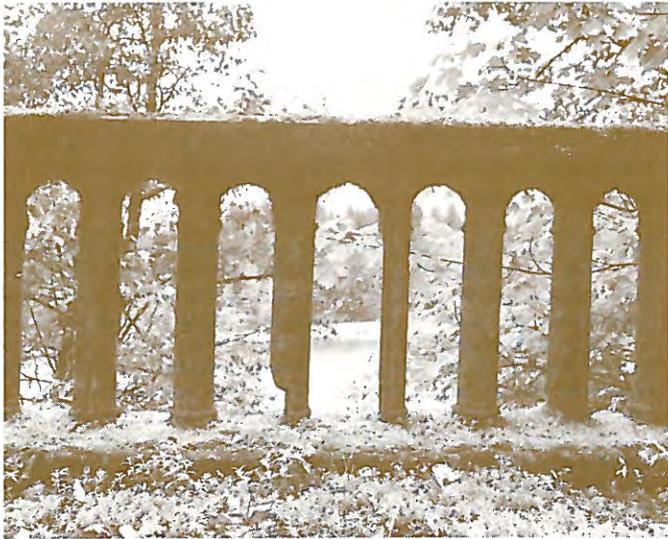
Fig. 15a. The spindle-type railings were deteriorated beyond repair. The concrete was cracked or broken and the center reinforcing rods were exposed and badly rusted.

Fig. 15a-c. Columbia River Highway, Oregon. This historic highway overlooking the Columbia River Gorge was constructed from 1913 to 1922 and contains a number of significant concrete bridges. These photos illustrate the sensitive replacement of the concrete spindle-type balusters on the Young Creek (Shepperd's Dell) Bridge of 1914. Photos: James Norman, Oregon Department of Transportation.

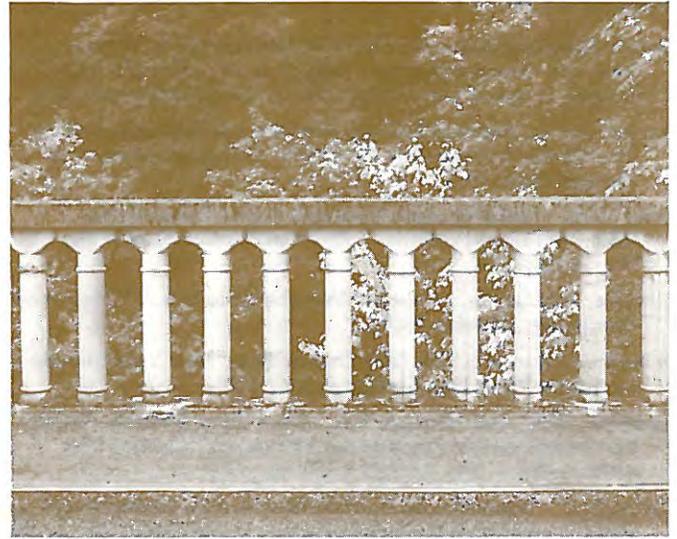
Fig. 15b. Deteriorated spindles were removed. The original 1914 molds were still available and used in casting new concrete spindles, but had they not been available, new molds could have been made to match the originals.

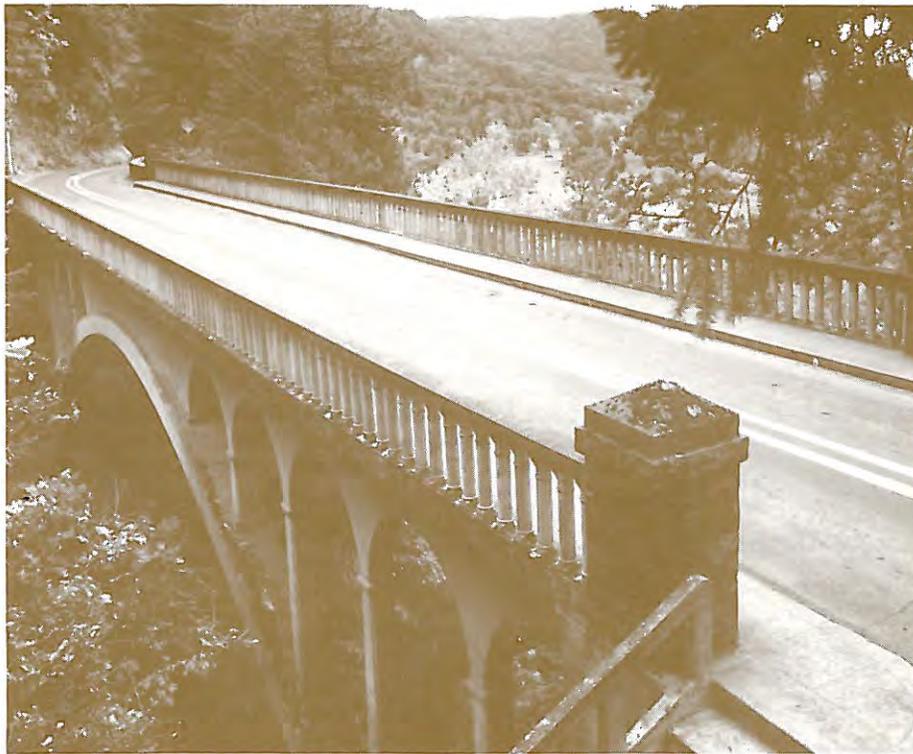
Fig. 15c. The new concrete spindles have been installed. This sensitive renovation reused the historic concrete cap railing and stone piers, as they were still in sound condition.

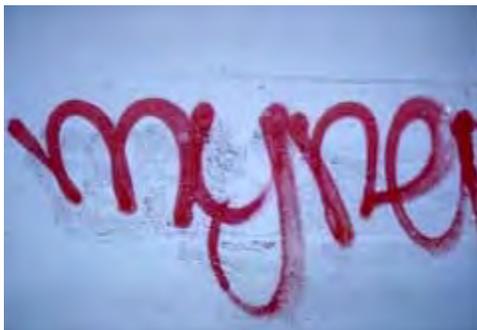
Inappropriate abrasive blasting to remove the graffiti has permanently etched the graffiti into the stone. Photo: NPS files.

Mechanical or Abrasive Methods. Mechanical treatments include dry or wet blasting, using abrasive grits, such as sand, dolomite powder, aluminum oxide, ground-walnut shells, sodium bicarbonate (baking soda), and others; high-pressure water washing; and mechanical sanding or grinding. All of these abrasive methods will cause damage to masonry and, in most instances, should never be considered as a method of removing graffiti from historic masonry. Abrasive methods used mistakenly by untrained workers to remove graffiti usually result in etching the outline of the graffiti permanently into the masonry. Some historic masonry materials can be easily damaged by pressure washing even at low or moderate

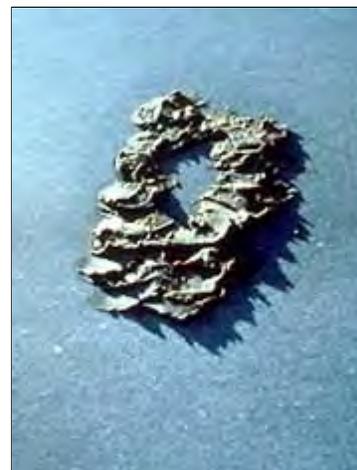
A poultice is often the preferred method of graffiti removal.

The most effective method of removing graffiti from masonry usually involves the use of a poultice. A poultice consists of an absorbent material or powder-inert clays such as kaolin or sepiolite, diatomaceous earth (fuller's earth); or cellulose products such as fluff pulp cellulose or shredded paper-mixed with a cleaning solution (a liquid reagent such as water, organic solvent, paint stripper or bleach) to form a paste or slurry. The purpose of a poultice is twofold: it enables a cleaning solution to be kept in contact with the stained area as long as possible, while allowing the cleaning solution to pull the staining material out of the substrate via the poultice without redepositing it in, or restraining, the masonry. A poultice is often covered with a plastic sheet to retard evaporation. With some extremely porous types of stone, such as marble, although a poultice may remove a stain from one side of the stone, stains can pass completely through the stone and be redeposited on the other side of the masonry slab. Thus, caution should always be exercised in stain and graffiti removal.

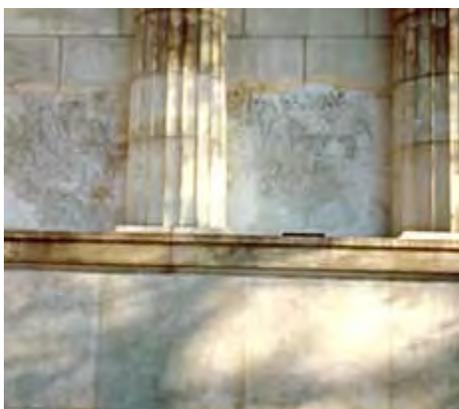
Damaging graffiti removal methods have scarred the marble. Photo: NPS files.

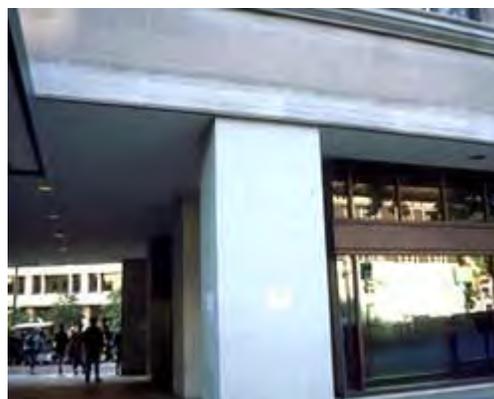
The difference in color between the bottom and the top of the stone spandrel is the only clue to the presence of a clear barrier coating. Photo: NPS files.

Transparent Coatings. Transparent coatings serve as a barrier between the masonry surface and graffiti, preventing graffiti from penetrating into the masonry. They are also intended to make graffiti removal easier since most graffiti does not adhere well to them. Generally, graffiti applied over transparent barrier coatings can be removed with low-pressure water and a detergent, or with a solvent.

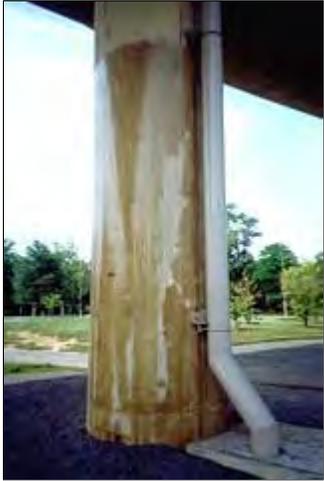
This formerly clear barrier coating is very shiny and has discolored as it has aged.
Photo: NPS files.

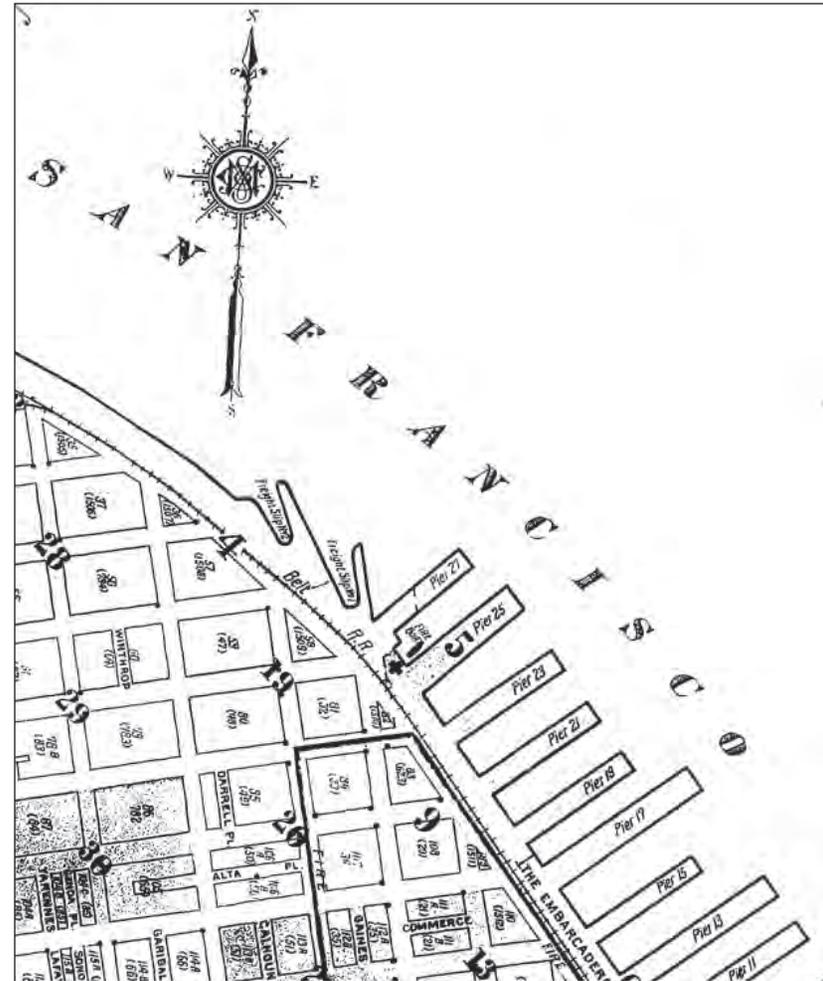
Map of northern waterfront in 1915. Pier 27 is the northernmost pier, and the Belt Line Railroad is a dominant feature along the Embarcadero. Source: Sanborn Fire Insurance Company, 1915.

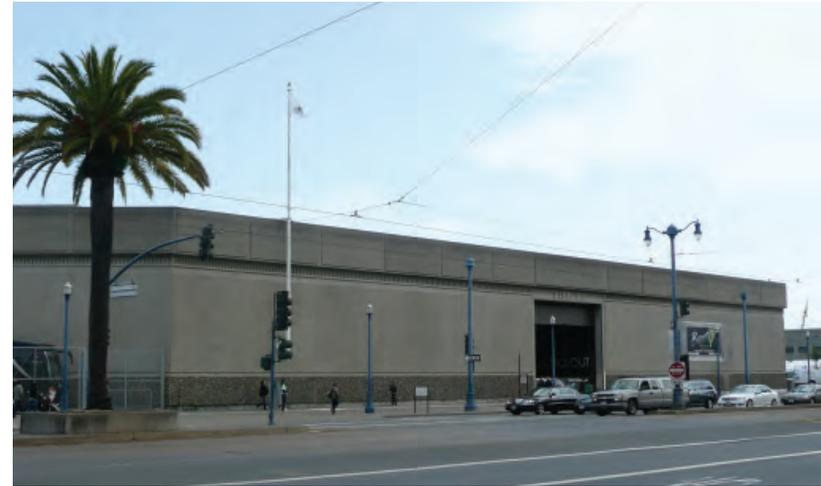
View of Pier 27, Embarcadero façade. Photo Source: ARG

The façade of the Pier 27 bulkhead, built in 1965-66, represents a departure from the City Beautiful inspired bulkheads constructed in the 1910s. Pier 27 has an approximately four-foot-high base of exposed aggregate with unpainted reinforced concrete above. A heavy cornice of exposed concrete projects approximately one foot beyond the main façade. The west (Embarcadero) side has no penetrations, except for a large steel rolling door. A flag pole is present at the north end of this façade.

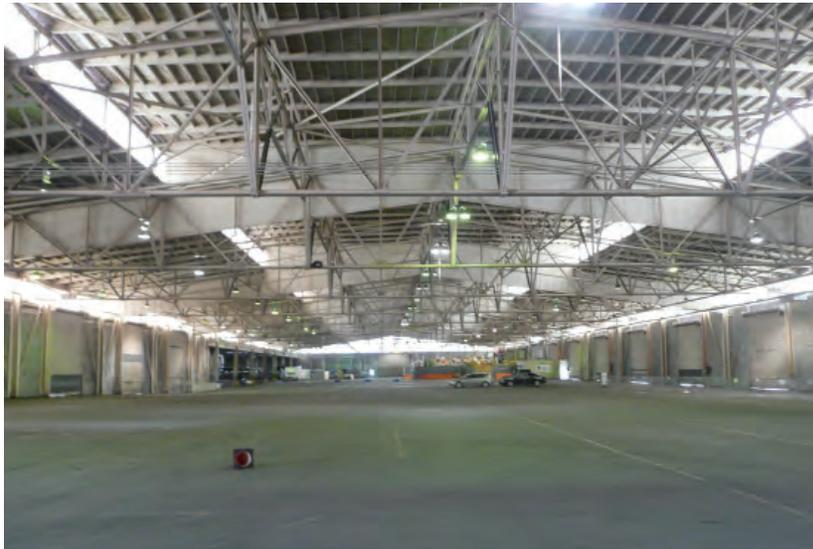
Interior view of Pier 27, looking north. Photo Source: ARG

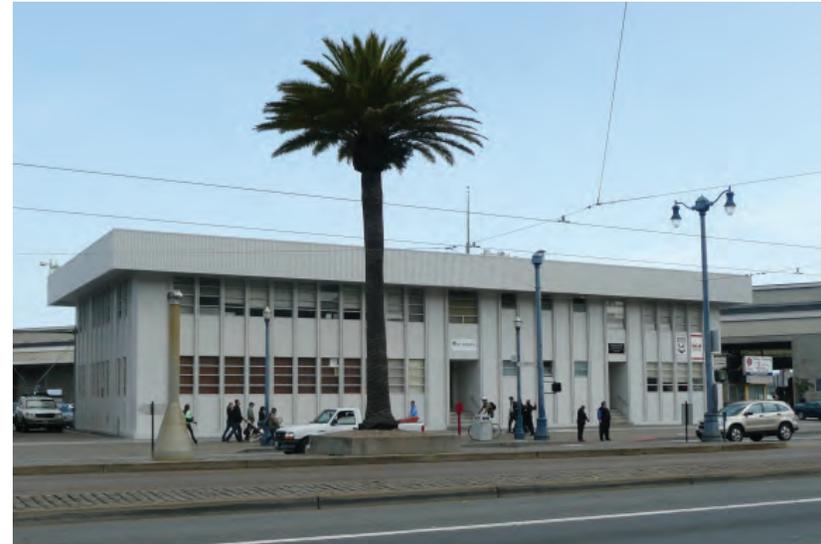
Pier 27 Annex, Embarcadero Façade. Photo Source: ARG

The Pier 27 Annex is two stories high with a cement plaster exterior and decorative redwood mullions stretching the full height of the façades. A large cornice with ribbed aluminum fascia projects approximately five feet out from the façade. The first floor is raised several feet off the ground plane, and the two entry doors on the Embarcadero side are accessed via several concrete steps. Windows on the first and second floors are four rectangular panes high, arranged between the redwood mullions. A flagpole is attached behind the cornice line and centered over the main entrance door. Multiple tenants have mounted signs between the first and second floor windows.

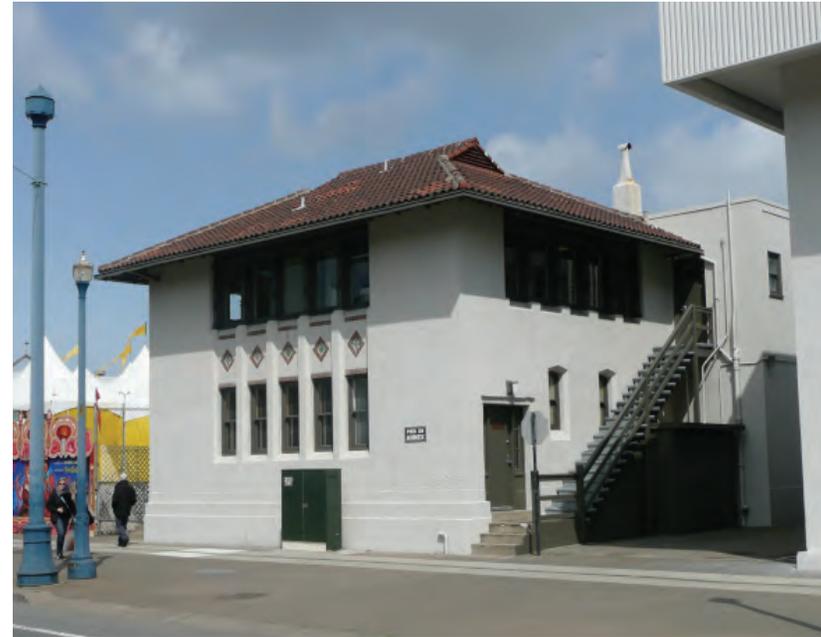
The Pier 29 Annex, Embarcadero façade, with the newer Pier 27 Annex at the far right. Photo Source: ARG

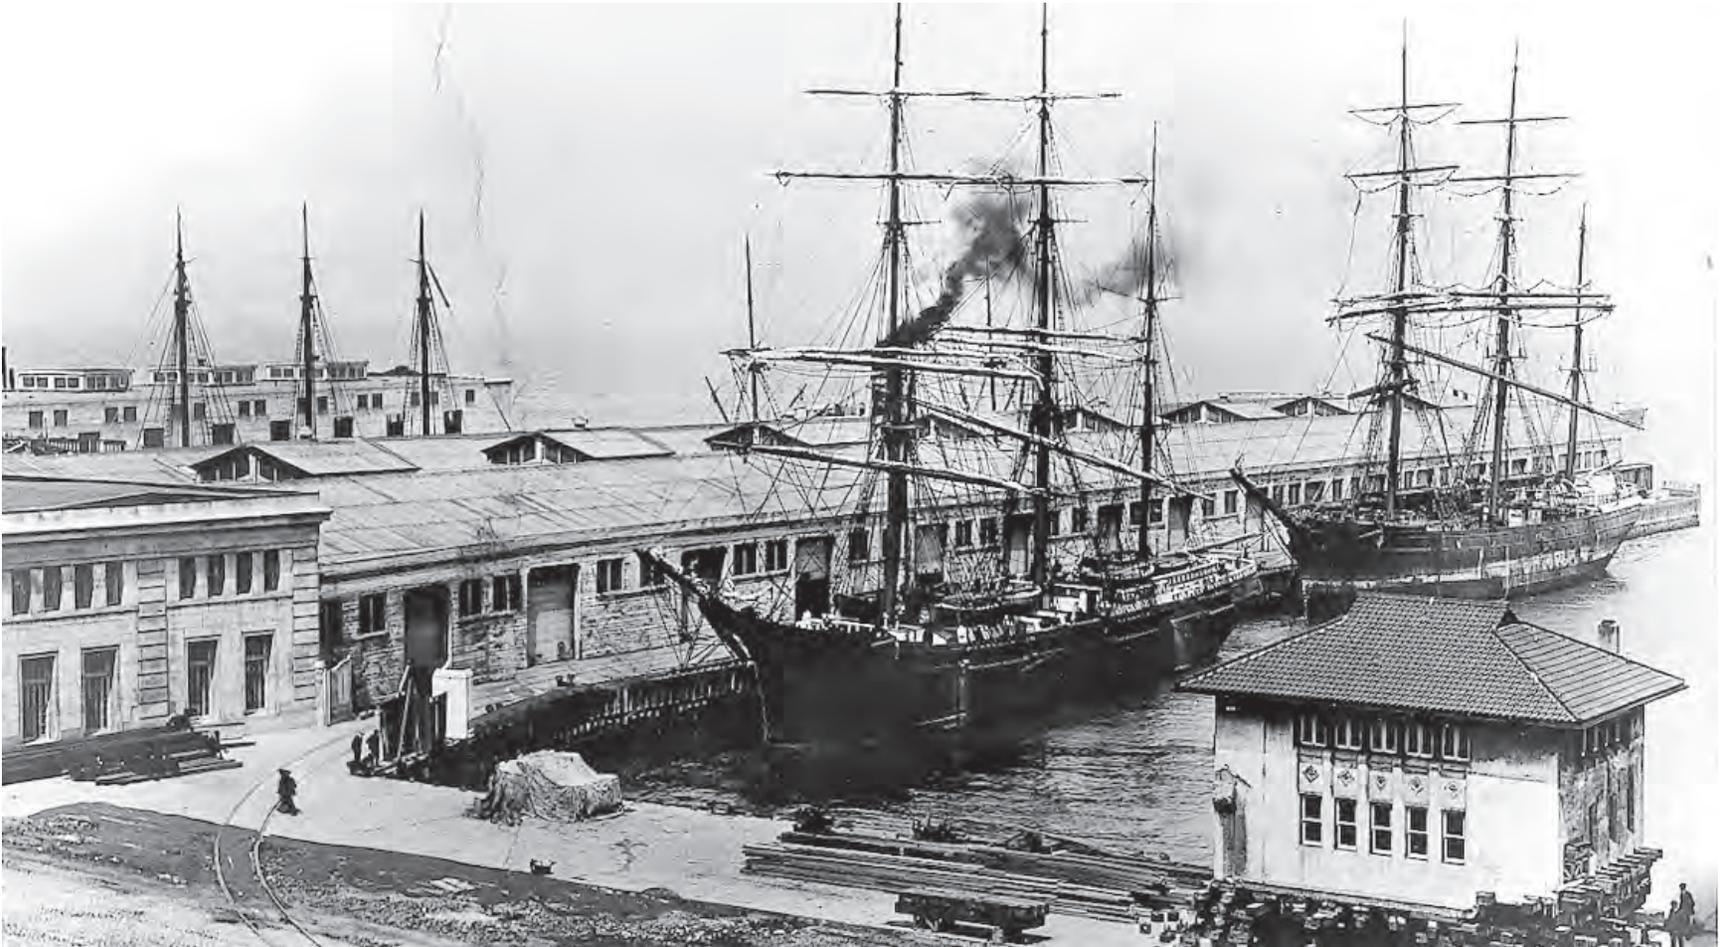
The Belt Line Railroad Building being moved into place at its new location next to Pier 29 (left), in 1919. Photo Source: Port of San Francisco and San Francisco Maritime National Historic Park, San Francisco Chronicle Collection.

Following relocation, the Pier 29 Annex served as the Belt Line Railroad Superintendent's office, conveniently located directly across the Embarcadero from the Belt Line Railroad Round House complex. Historic photographs and Sanborn Maps indicate that building was rotated 90 degrees when relocated, so that the longer, more ornate façade now faces the Embarcadero. At its original Pier 3 location, the building

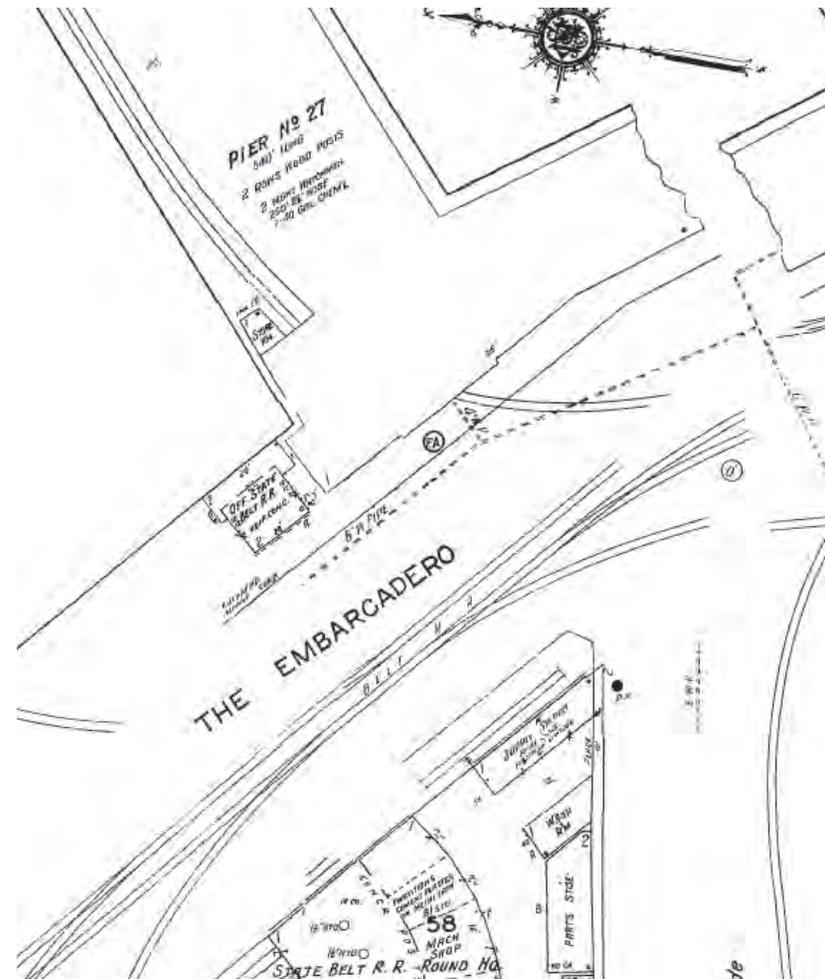
This 1949 map shows the Pier 29 Annex in its current site next to the original Pier 27. The Belt Line Round House is visible across the Embarcadero. Map Source: Sanborn Fire Insurance Company, 1949

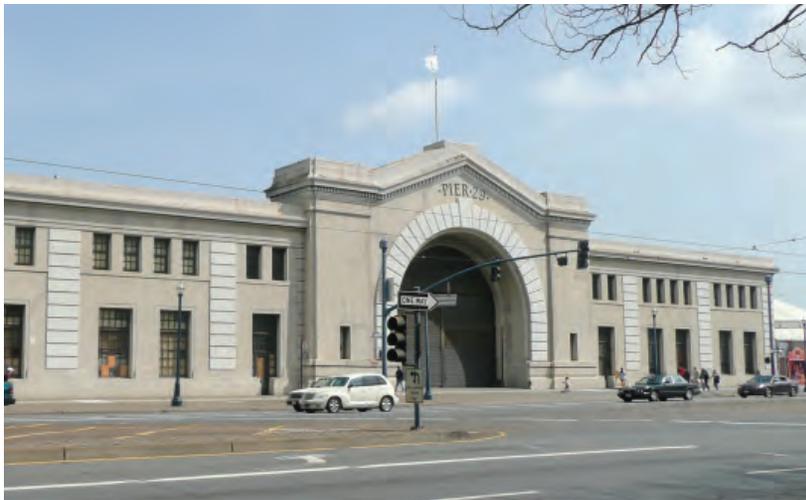
The Pier 29 bulkhead façade. Photo Source: ARG

Unlike most San Francisco bulkheads, which are only one bay deep, the Pier 29 bulkhead is two bays deep. The bulkhead has a central monumental arched entrance with a rusticated keystone and voussoirs. The arch is filled with a roll-up metal door. The bulkhead extends two and a half bays to the south and three and a half to the north. (There were originally four and a half, but one was destroyed when a second truck entrance was added.) The façade is cement plaster scored to resemble ashlar and molded in places to form rusticated pilas-

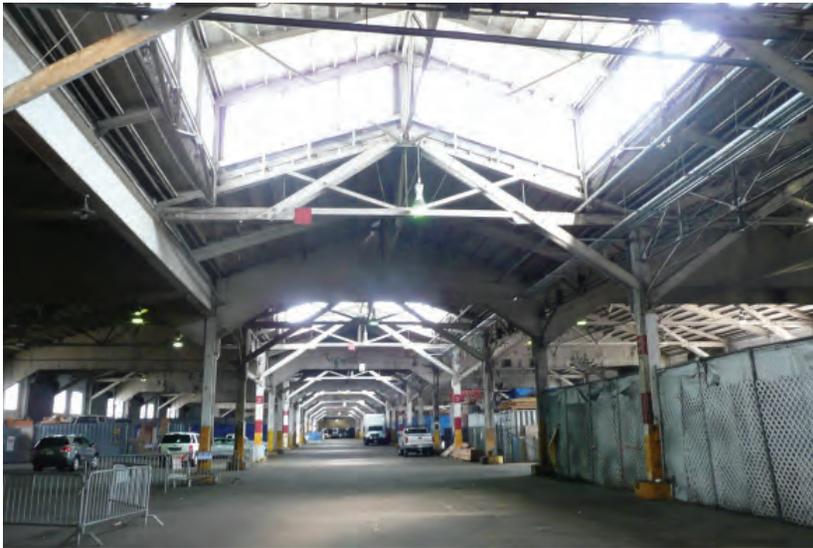
Natural light pours in through Pier 29's roof monitors and side windows. Photo Source: ARG

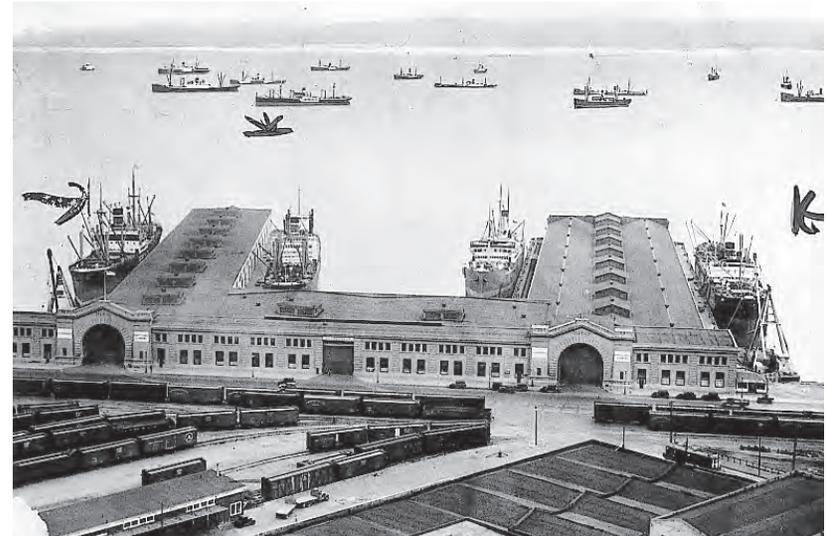
Piers 29-31 during World War I. Note trains in foreground and Navy ships in Bay. Photo Source: San Francisco Public Library

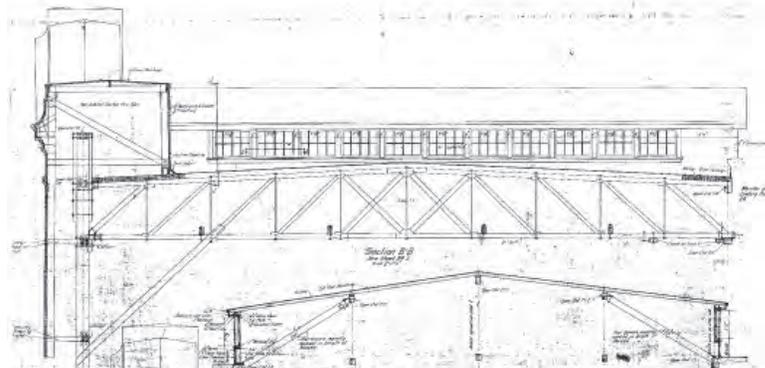
*Section of the Pier 29 bulkhead, as designed by A. A. Pyle.
Drawing Source: Port of San Francisco*

The Pier 29 bulkhead building, completed in 1918, is made of a reinforced concrete base with a timber frame covered in metal lath and concrete plaster. The bulkhead was designed by A.A. Pyle under the supervision of Chief Engineer Frank White. The Pier 29 bulkhead building was built in conjunction with the Pier 31 bulkhead and the eleven-bay connector between them.

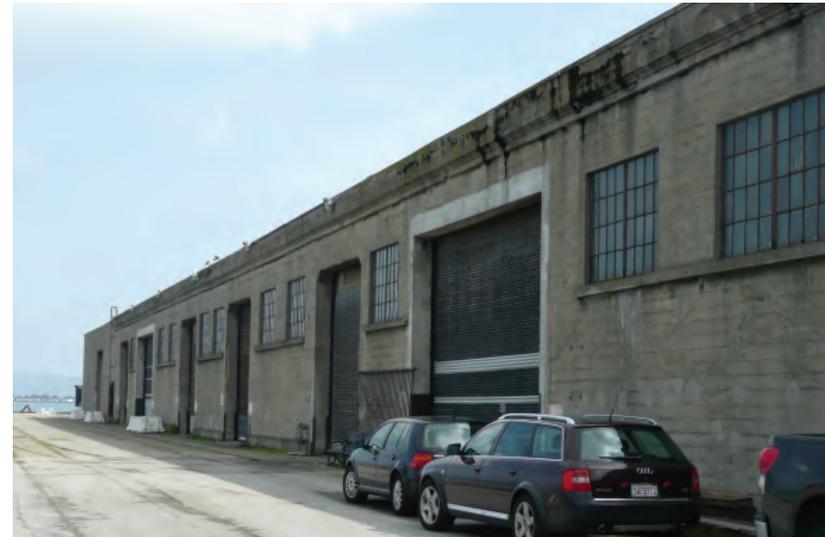
North wall, Pier 29 shed, looking northeast. Photo Source: ARG

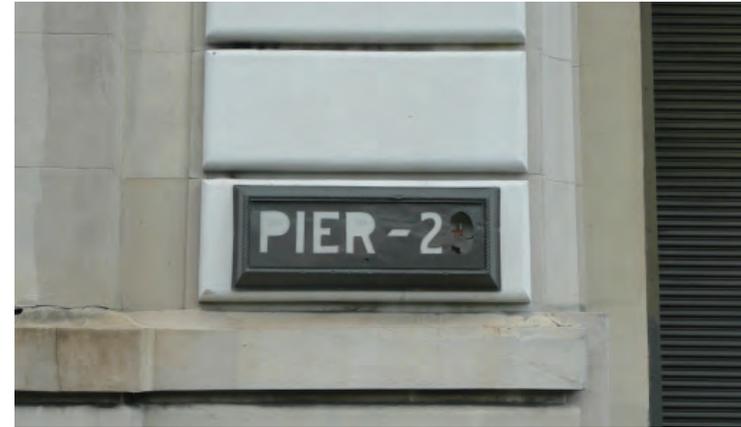
Cracking, spalling and off-color patches are visible on the exterior plaster, as is deterioration of the Pier 29 sign. Photo Source: ARG

exposed on both the interior and exterior of the building and there is a significant amount of grime and efflorescence on both surfaces. Inappropriate attempts at patching – using mixtures with a high gray Portland-cement content – are visible on the exterior. The concrete plaster of the bulkhead façade shows spalling and cracking. Patching materials of varying colors and textures have been added over the years.

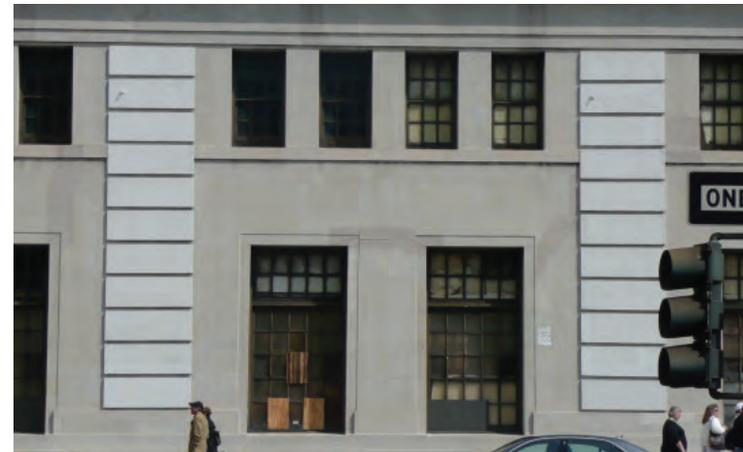
Multi-light wood windows, Pier 29 bulkhead building. Photo Source: ARG

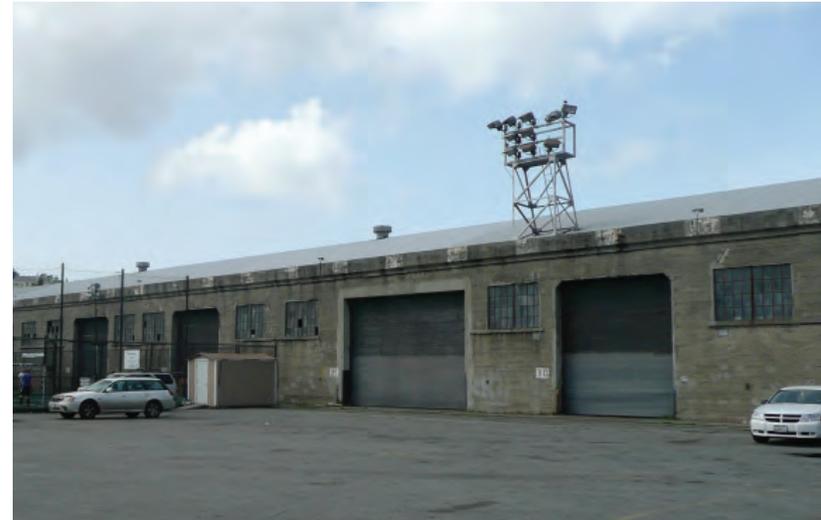
Pier 29 shed, south side. Alterations include widening of doors and lighting fixtures mounted on the roof. Photo Source: ARG

More recent alterations include the widening of several truck entryways in the pier shed. These have interrupted the original rhythm of the shed façades, removing the simple original corner details, and have been finished with a light gray cement which does not match the original. On the bulkhead, two pedestrian doors have been cut into windows on the Embarcadero façade. The rails along the south side of the shed have been paved over and are no longer visible.

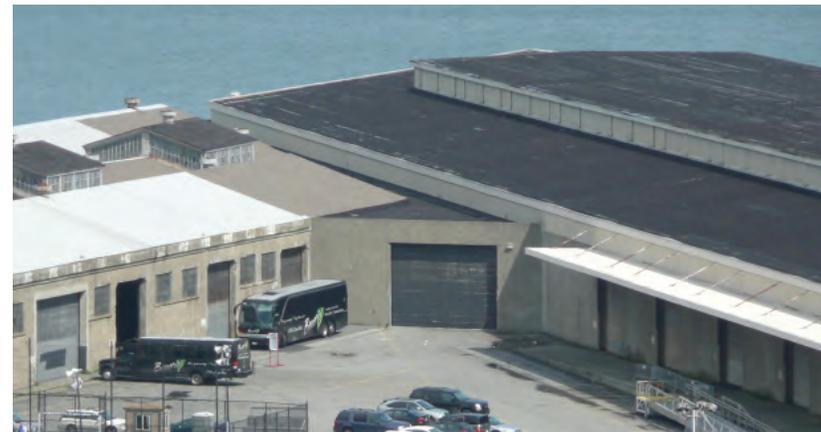
Intersection of Piers 27 (right) and 29 (left). Source: ARG

The construction of Pier 27 in 1965 caused the most significant alterations to Pier 29. To enable the outshore end of Pier 29 to open directly into Pier 27, the reinforced concrete wall at the outshore end of Pier 29 and several bays along the south wall of the Pier 29 shed were removed. At the same time, Pier 29's substructure was extended to accommodate the end of

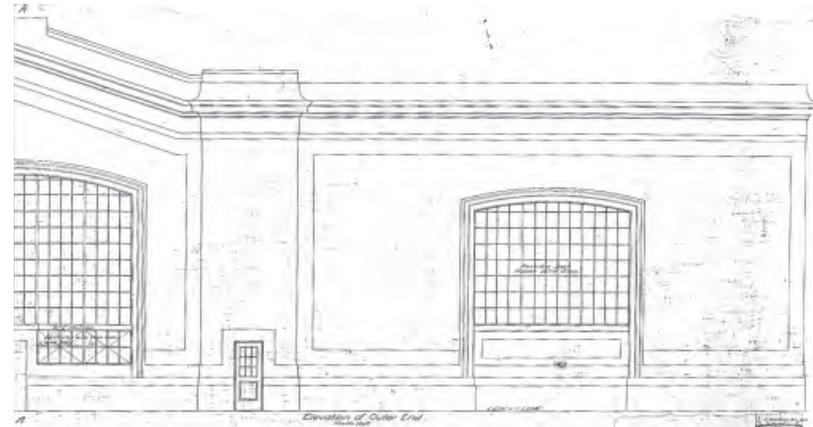
Partial elevation of the outshore façade of Pier 29, as drawn by Oliver Jones. Drawing Source: Port of San Francisco

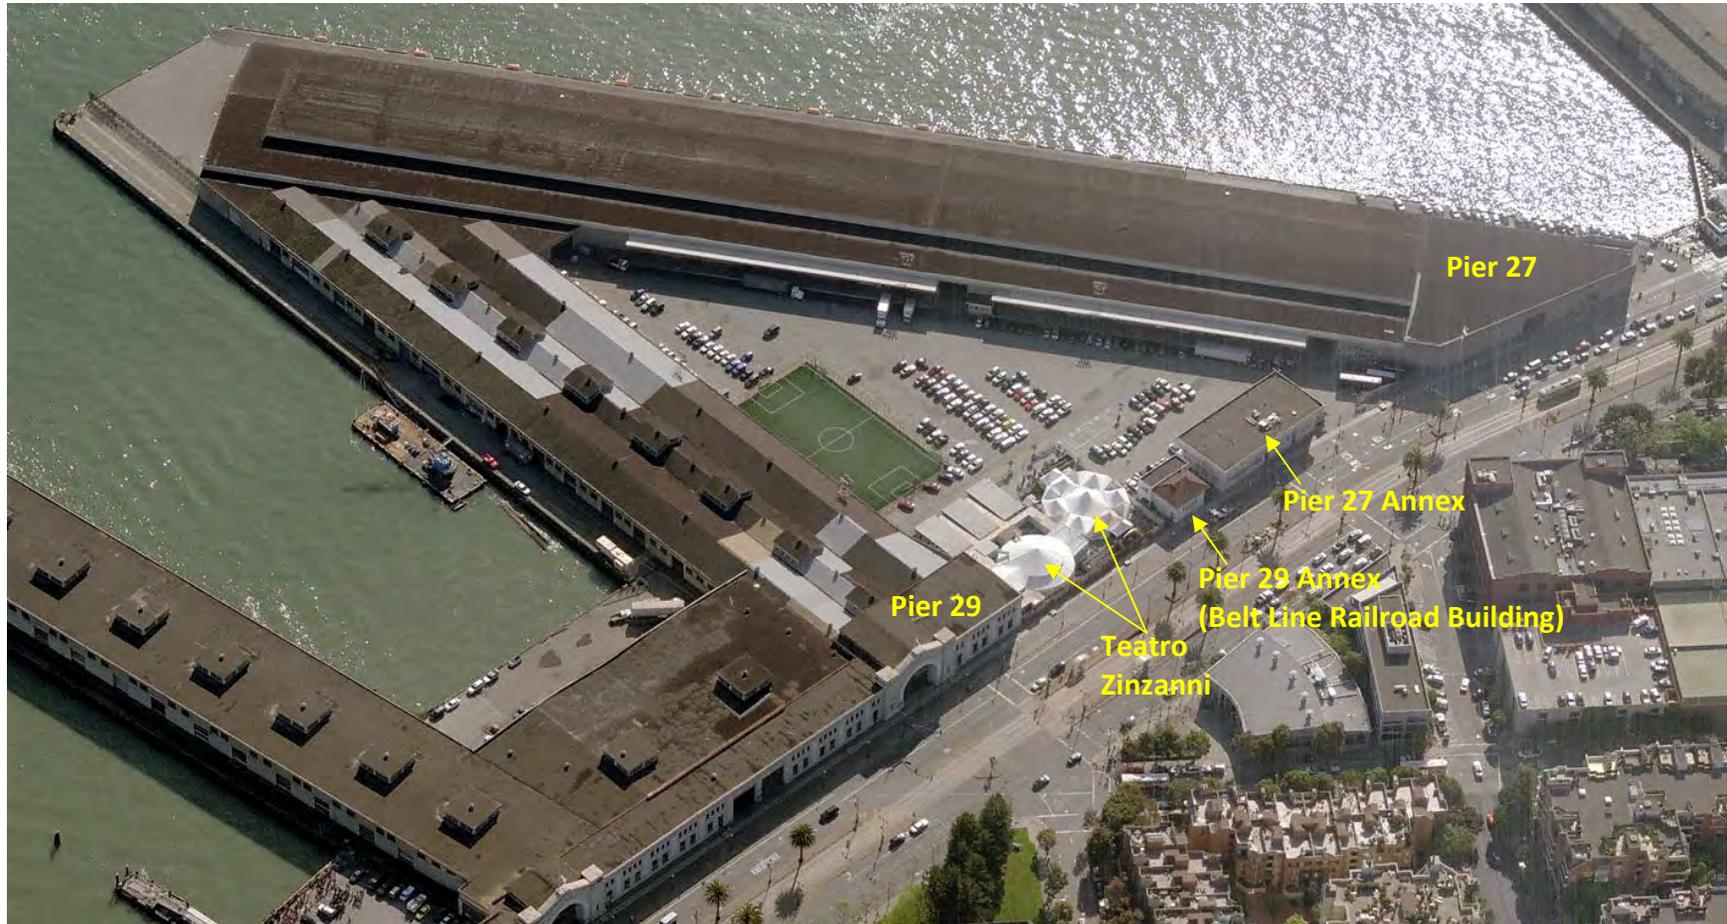
CP7-11

Aerial view of project site existing conditions, looking east. (Aerial source: www.bing.com)

An existing conditions aerial photograph and a site plan of the proposed Northeast Wharf Plaza are included below at the end of this report.

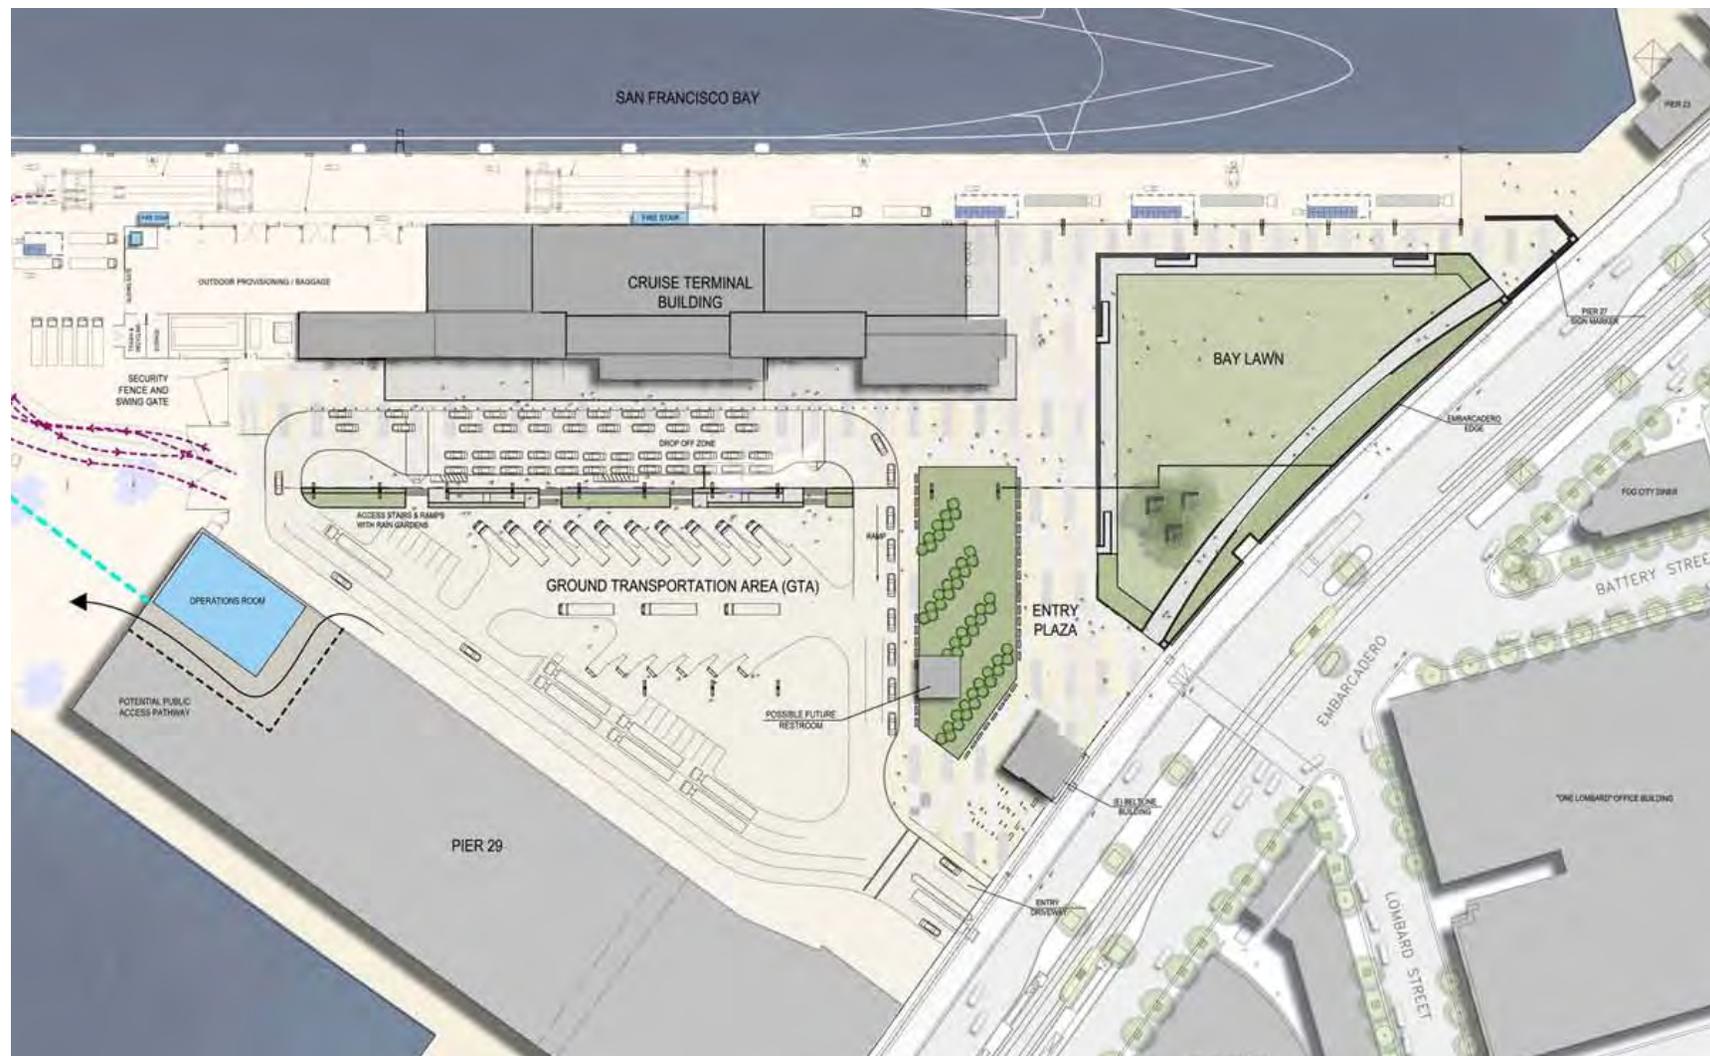
CP7-12

Site Plan of proposed Northeast Wharf Plaza (Source: Port of San Francisco dated November 18, 2011).
