## **APPENDIX 10: SCREENING-LEVEL WIND ASSESSMENT**

# BETTER MARKET STREET

SCREENING-LEVEL WIND ASSESSMENT - FINAL

RWDI # 1700387

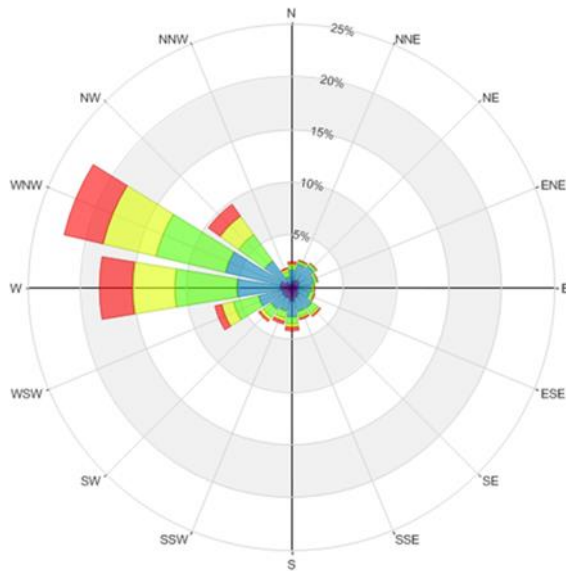
**Image 4a: Annual distribution of winds approaching San Francisco International Airport (1948 to 2017)**

Long-term wind data recorded at a height of 33 feet at San Francisco International Airport between 1948 and 2017 are used as a reference for this wind assessment. They are presented as an annual wind rose in Image 4a. Of the primary wind directions, four have the greatest frequencies of occurrence and make up the majority of the strong

winds that occur as shown in Image 4a. These wind directions are west-northwest, west, northwest and west-southwest.

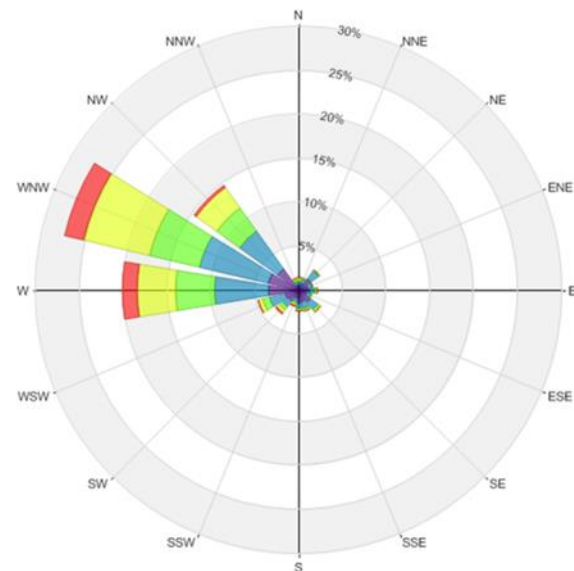
**Image 4b: Annual distribution of winds approaching San Francisco Downtown Station (6:00 to 20:00, 1945 to 1950)**

Another set of wind data is often used in San Francisco for projects that are subject to the San Francisco planning code requirements. It was gathered at the old San Francisco Federal Building at 50 United Nations Plaza (Weather Service Office) at a height of 132 feet above grade during the period of 1945 to 1950. Image 4b shows a similar distribution of wind speeds and directions as those in Image 4a.

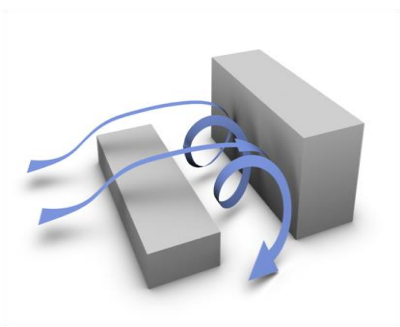
(a) Downwashing Flow

**Images 5a-c: General wind flow phenomena around buildings**

In the following discussion of anticipated wind conditions, reference is made to the following generalized wind flows. Tall buildings tend to intercept the stronger winds at higher elevations and redirect them to the ground level (Image 5a). Such a downwashing flow is often the main cause for wind accelerations around tall buildings at the pedestrian level. These winds can be relatively strong and turbulent, especially around the exposed building corners (Image 5b). These downwashed winds may subsequently channel along street canyons between buildings and make these areas windy (Image 5c).

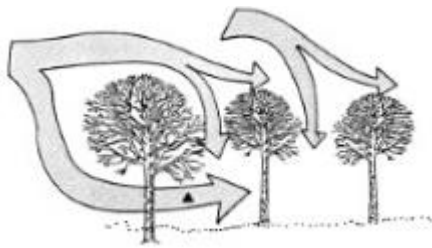
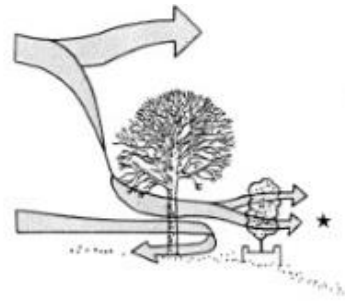
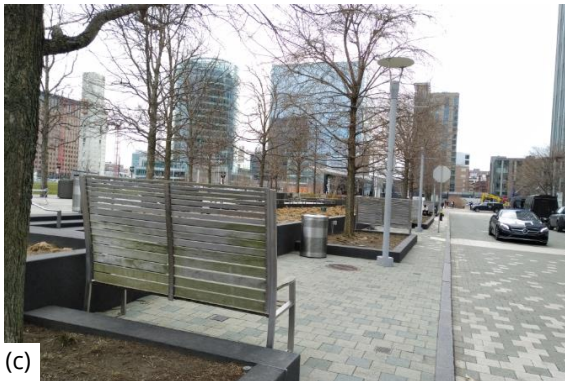
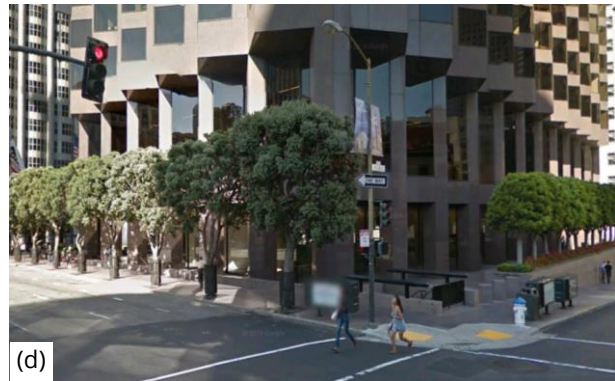
Images 6a-d: Wind control by trees and other streetscape features

As discussed below, there are various types of streetscape features used for wind control (e.g., trees, landscaping, hardscaping, and street art). Tree leaves and branches form three-dimensional obstacles that reduce downwashing winds off nearby buildings (Image 6a). Horizontal wind flows above the pedestrian level can also be reduced by canopy-type trees; however, local wind acceleration may occur under tree canopies, as shown in Image 6a. For trees to be effective in controlling winds at the pedestrian level, under-planting or the placement of other features is typically required. These may include low bushes and shrubs (Image 6b) and benches with high backs (Image 6c). In addition, trees should be dense (or mature) and able to keep their foliage reasonably well through the winter months (Image 6d) to be effective in controlling winds at the pedestrian level. Trees are considered effective as wind control measures due to the porosity of the foliage. Similarly, porous windscreens and street art are considered effective as wind control measures. When wind travels through a porous object (e.g., trees, porous windscreens, and porous street art), the wind speed is reduced as the energy of the wind is separated from one strong stream to several weaker streams of wind.

For reasons stated above, it is unlikely that removing and/or replacing trees along sidewalks would result in wind hazard exceedances. However, the comfort conditions in the vicinity of the several outdoor seating areas, such as those close to the Taylor Street intersection (Area F1 in Image 9c), would benefit from street trees of denser foliage and other wind control measures, such as windscreens or street art (Image 6) to the west of the areas.

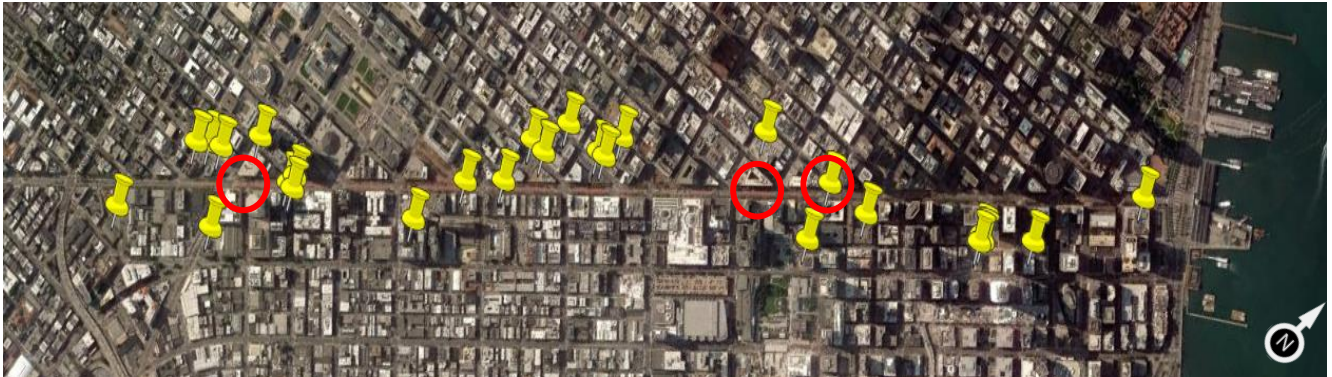
**Image 7: Wind studies conducted by RWDI along Market Street (yellow pins), including three segments of higher wind activity (red circles)**

RWDI has conducted various wind studies in the City of San Francisco, including many along Market Street. Wind tunnel studies that have been carried out by RWDI and have been referenced to inform the conclusions made in this assessment are listed below and are marked by yellow pins in Image 7:

Wind conditions along Market Street generally do not exceed the wind hazard criterion for the most of the west (Octavia Boulevard to Franklin Street) and mid portions (9<sup>th</sup> to 4<sup>th</sup> streets) between relatively low buildings, and for the entire east portion (2<sup>nd</sup> Street to The Embarcadero) due to dense surroundings in the downtown. However, higher wind activity that may exceed the wind hazard criterion were previously detected at three areas along Market Street (marked by red circles in Image 7):

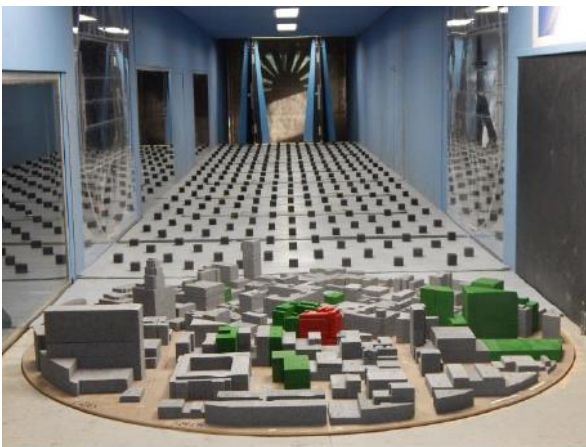
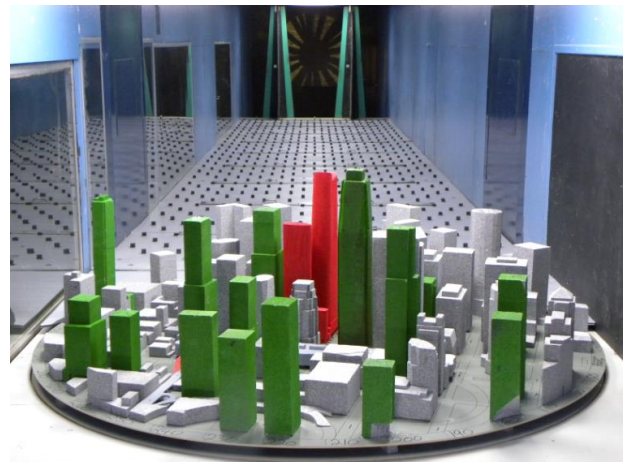
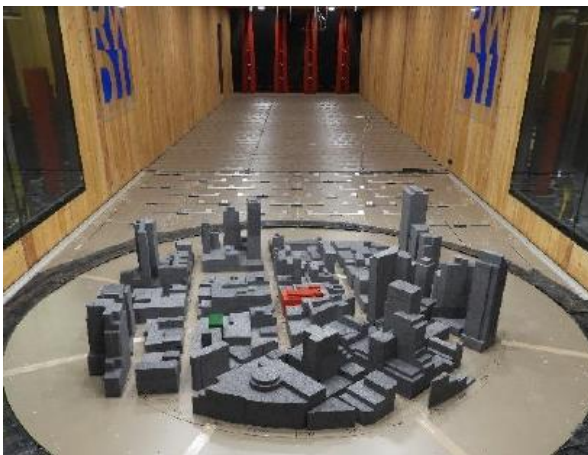
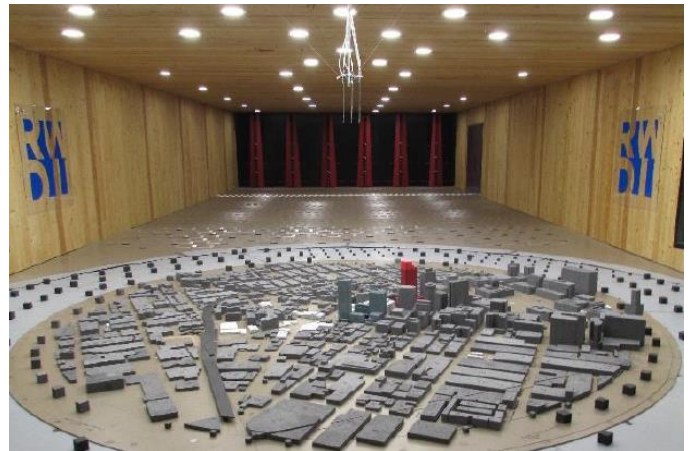
**Image 8: Photos of wind tunnel models of select projects along Market Street (1028 Market Street – top left, First and Mission – top right, 120 Stockton Street – bottom left & 30 Van Ness – bottom right)**

Photos of wind tunnel models of select projects along Market Street are shown in Image 8 to provide context of the area and buildings around the proposed project. These wind tunnel models informed the description of existing conditions provided in this assessment.
