**Appendix 4.18A SCS Engineers, Phase I Environmental
Site Assessment and Limited Asbestos
and Lead Paint Sampling, August 7,
2009**

**Phase I Environmental Site Assessment
and Limited Asbestos and Lead Paint
Sampling**

**Potrero Terrace and Potrero Annex
Redevelopment
San Francisco, California**

August 7, 2009
Project Number: 01208471.00

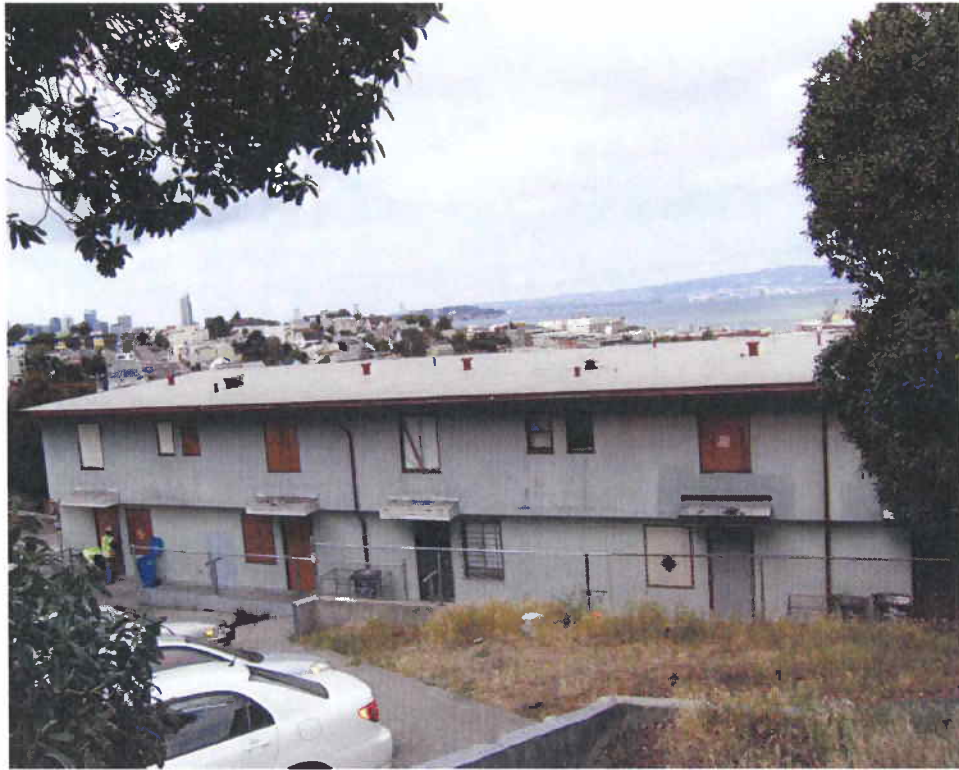
1) View of rear elevation of building, looking northeast.

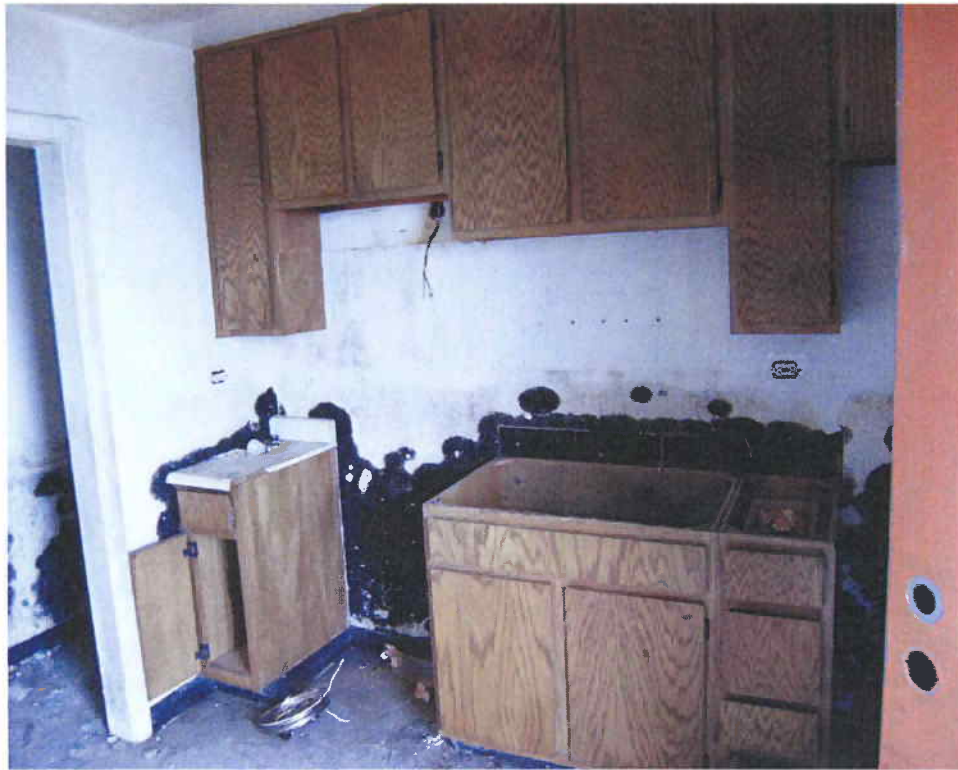
1) Interior view of a typical vacant unit.

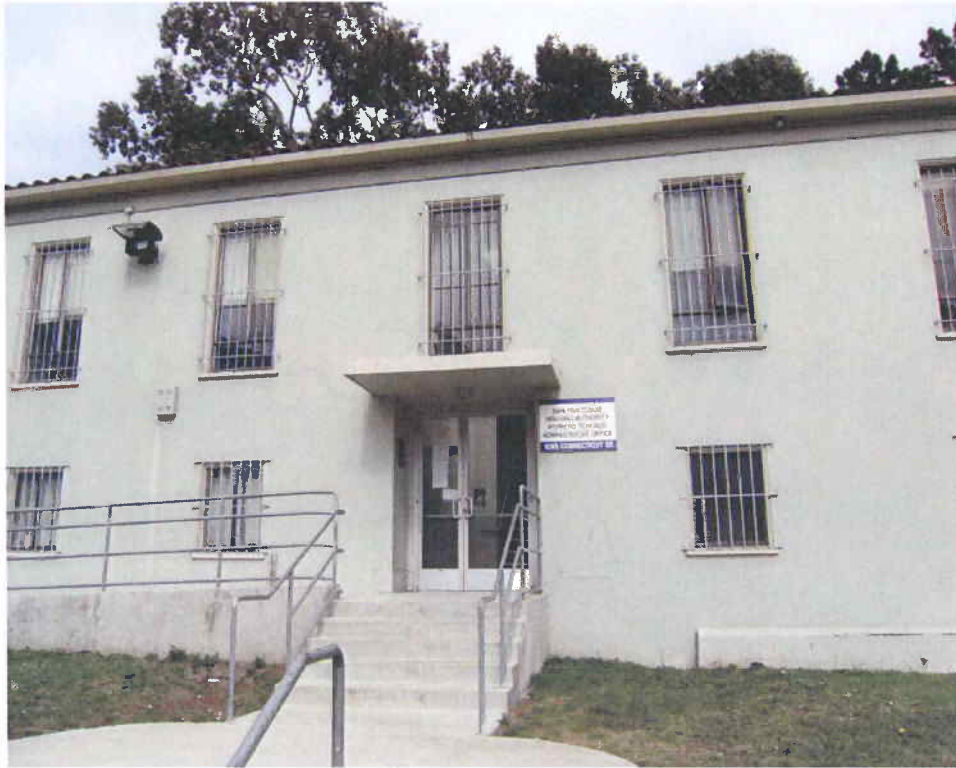
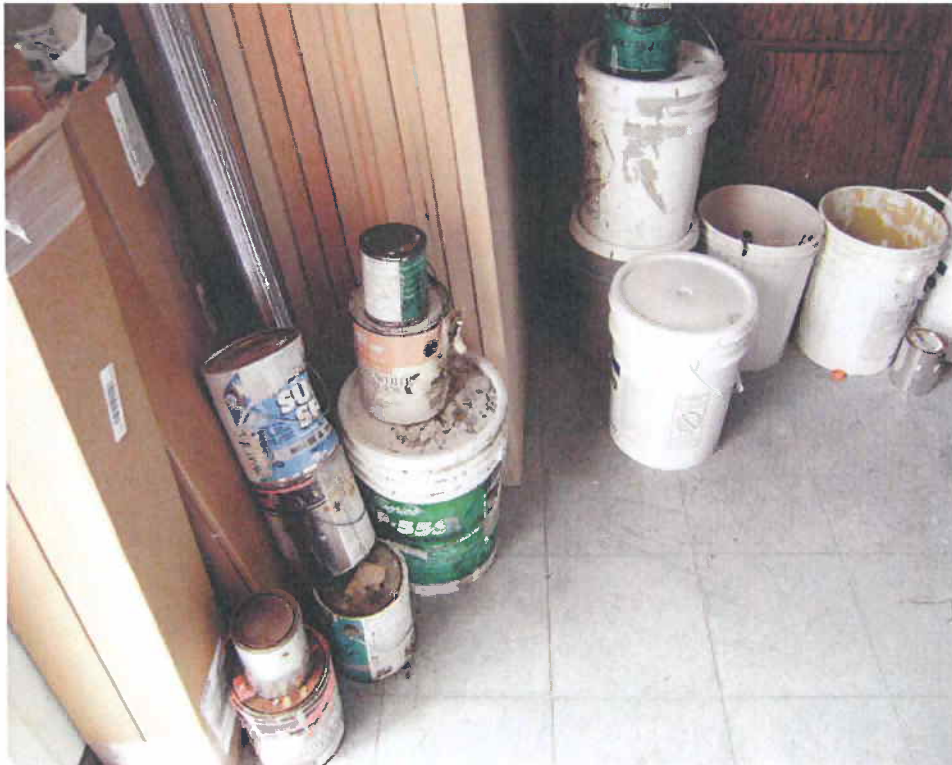
1) View of Potrero Terrace administrative office.

2) View of small retail quantities of maintenance supplies (paint, paint thinner) observed at the Site.

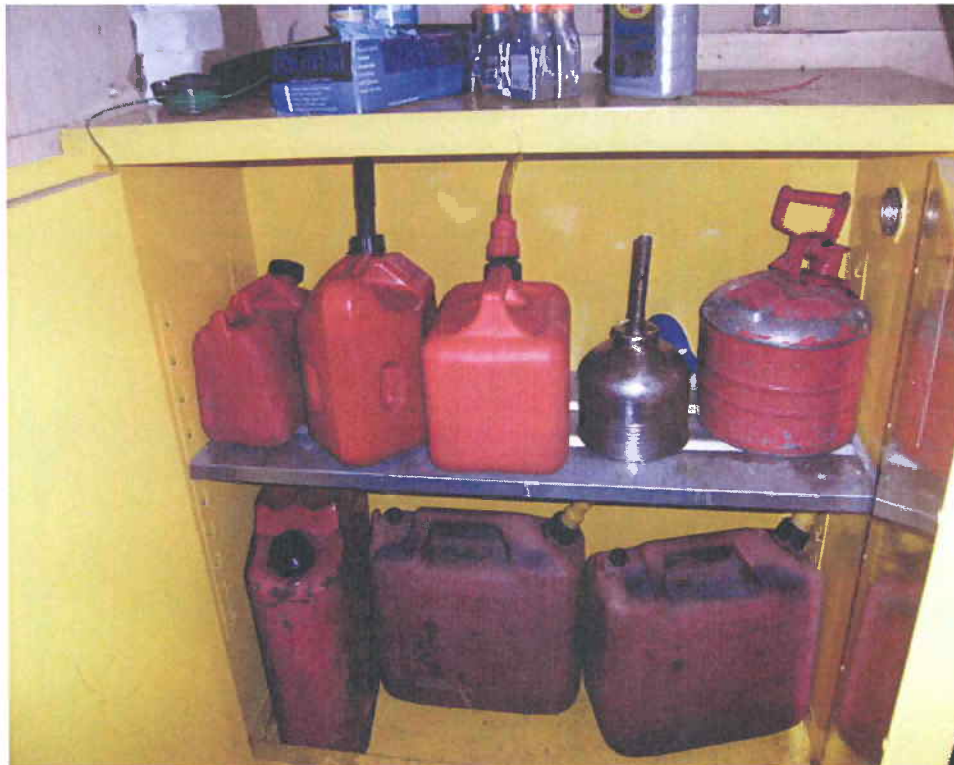
2) View of hazardous materials storage at the Site.

Hazardous Materials/Petroleum Products	Storage Location	Approximate Amount
Fiber reactive dye	Storage area, Unit 79 Potrero Annex	Small retail quantities (SRQs) ⁴
Paint		SRQs
Detergent		One 25-pound bag
Fabric softener		Two 5-gallon containers
Liquid laundry bleach		Two 5-gallon containers
Stain cleaner		SRQs
Janitorial supplies (e.g. Windex, Joy, Clorox, etc.)		SRQs
Maintenance products (paint, paint thinner,)	Storage shed for Potrero Terrace area (Figure 3k-2)	SRQs
Gasoline	Storage area Potrero Terrace Administrative Office (Figure 3l-2)	Three 5-gallon and four-3-gallon containers

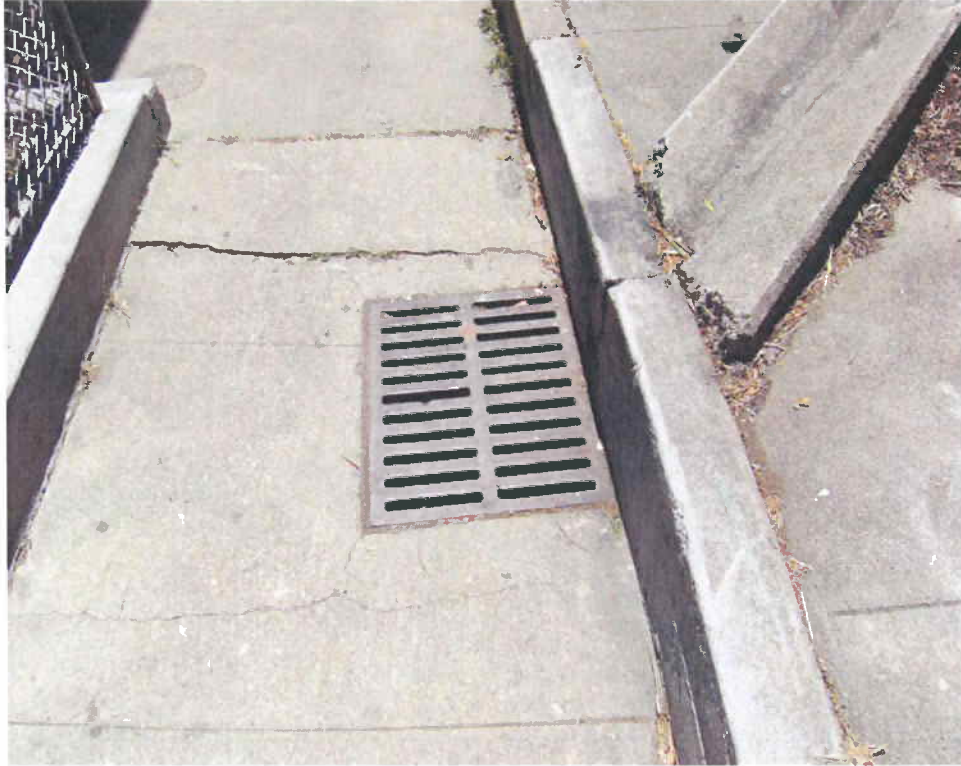
1) View of storm drain observed at the southwest area of the Site.

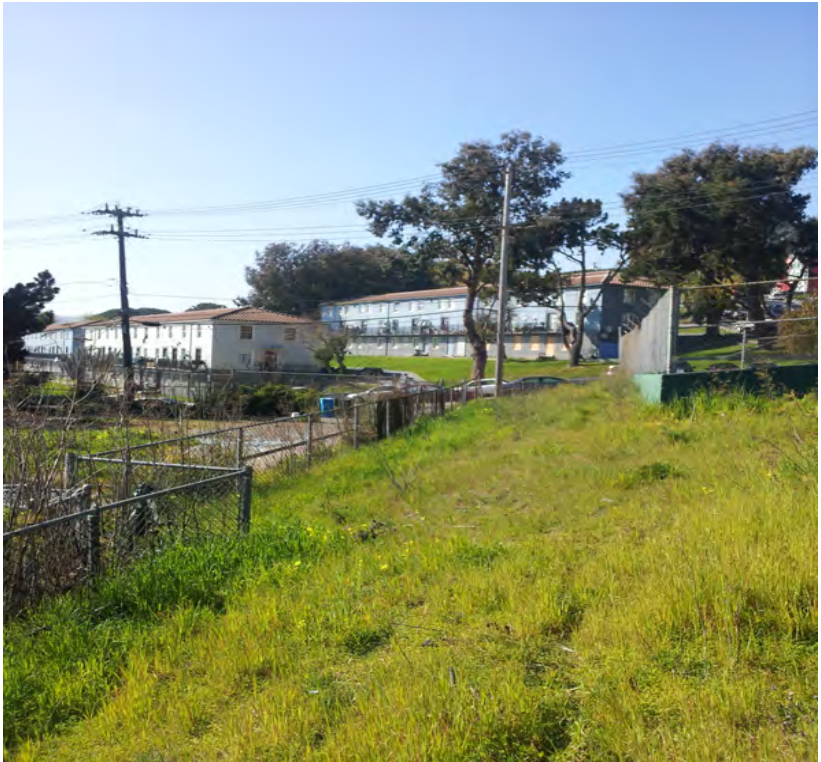
Client: Asian Neighborhood Design		Project: SFMOH	
Name: 1101 Connecticut Street		Site Location: San Francisco, California	
Photograph ID: 1

Photo Location: 1101 Connecticut Street			
Direction: West			
Survey Date: 02/13/2013			
Comments: Grassy slope on the right and fence enclosure on the left, fence encloses concrete foundation of former building. Note: In background, multi-family apartment buildings on property across the street from the subject property			
Photograph ID: 2

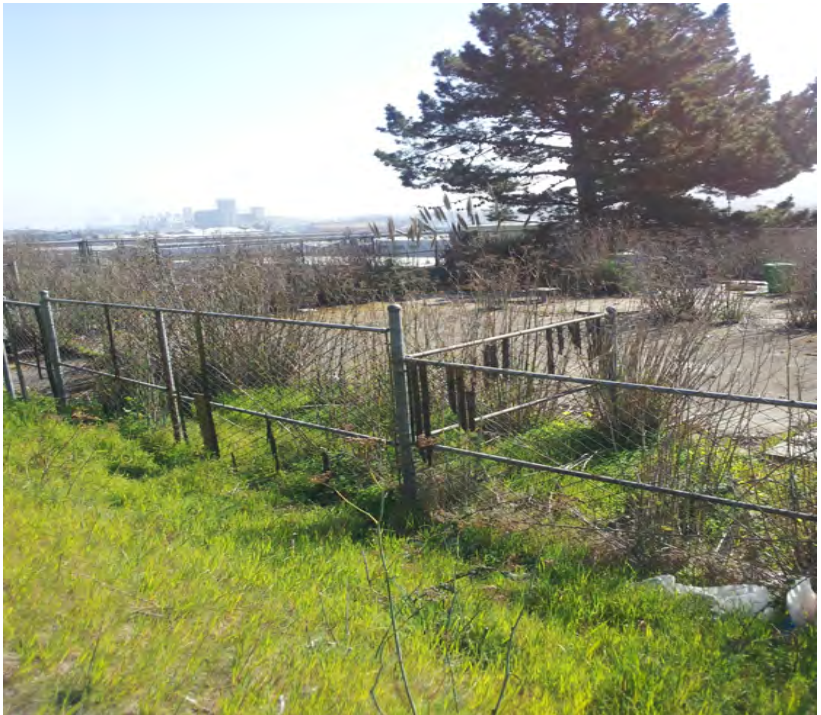
Photo Location: 1101 Connecticut Street			
Direction: Southeast			
Survey Date: 02/13/2013			
Comments: Fence enclosure around concrete foundation of former building, south side of subject property
